# Pavement Condition Report

## Crawfordsville Municipal Airport

Project 16801839

**January 2016**

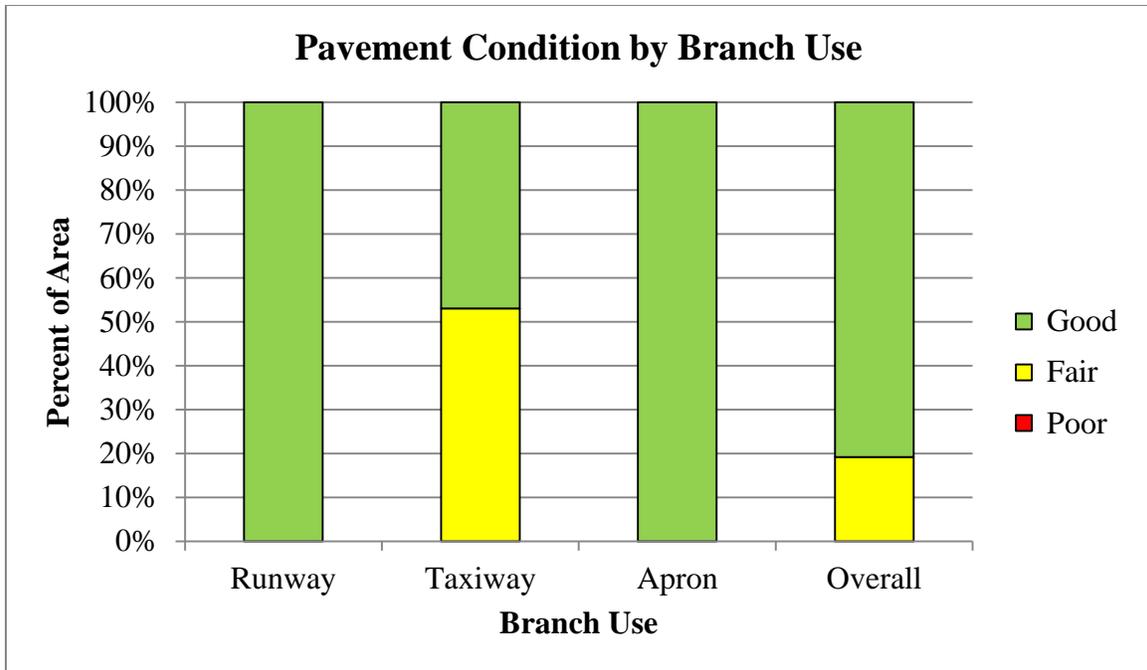
Figure 2-2. Pavement Condition by Branch Use

The pavement within each of the PCI condition categories is shown in Figure 2-1. The inspected PCI is summarized by branch use in Figure 2-2, and the photographs in Figure 2-3 through Figure 2-5 provide examples of the condition categories.

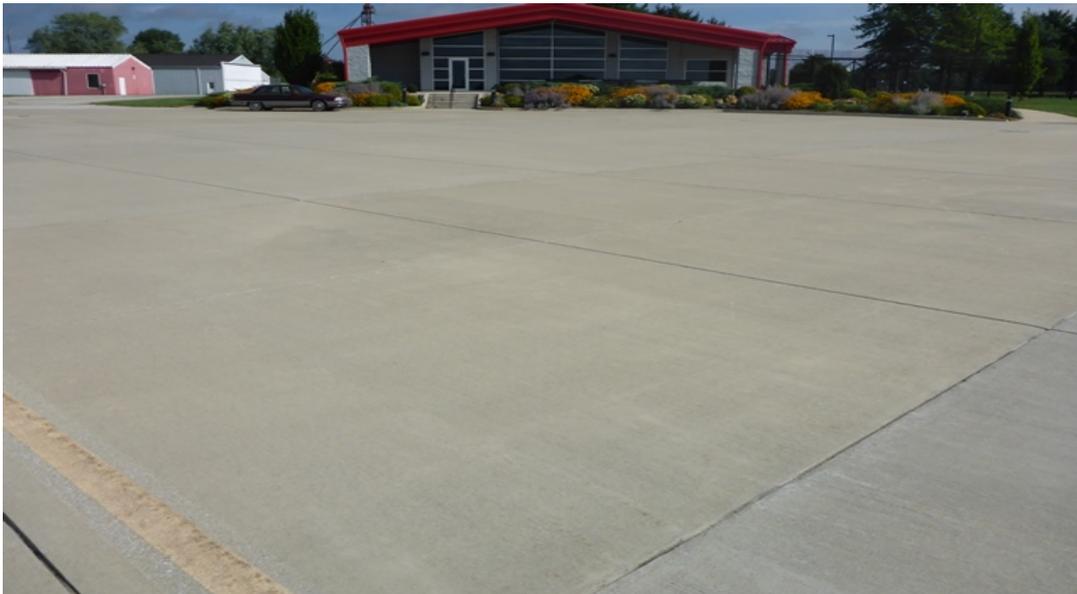
DISTRESS TYPE	SEVERITY	MEASURED QUANTITY	ESTIMATED TOTAL QUANTITY	UNITS	PERCENTAGE OF All DISTRESS
PATCH<5 SF	LOW	1	3	SLABS	2.3
SPALLING-JOINTS	MED	4	12	SLABS	53
SPALLING-CORNERS	MED	3	9	SLABS	36.3
SPALLING-CORNERS	LOW	1	3	SLABS	8.2

APPROXIMATE AMOUNT OF DISTRESS RELATED TO LOAD ON THE PAVEMENT IS:	50 %
APPROXIMATE AMOUNT OF DISTRESS RELATED TO MATERIALS PROBLEMS IN THE FEATURE IS:	16 %
APPROXIMATE AMOUNT OF DISTRESS RELATED TO AGE OF PAVEMENT AND TRAFFIC REPETITIONS IS:	33 %

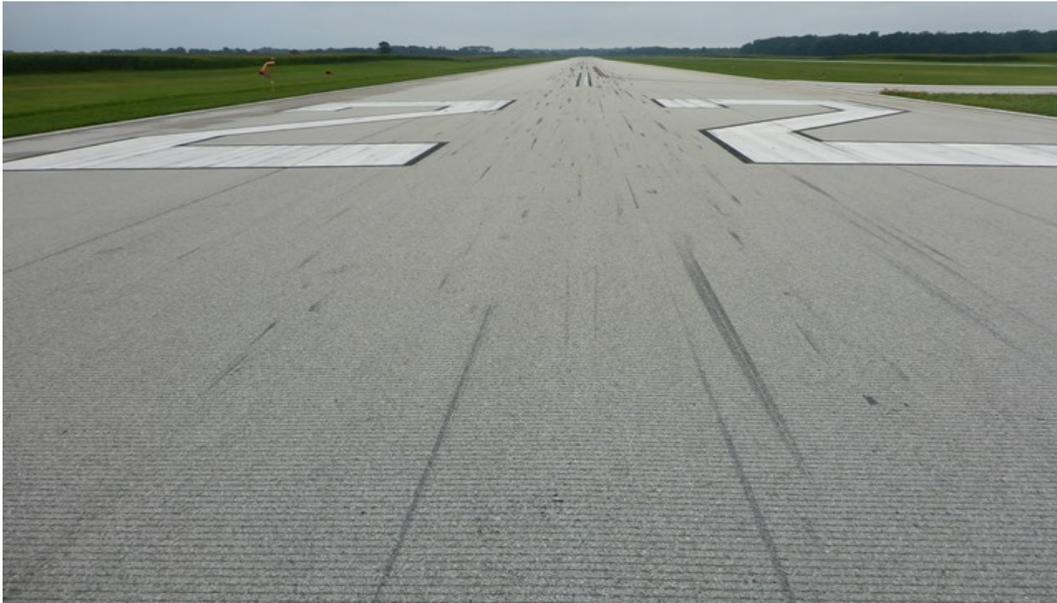
DISTRESS TYPE	SEVERITY	MEASURED QUANTITY	ESTIMATED TOTAL QUANTITY	UNITS	PERCENTAGE OF All DISTRESS
LONG.& TRANS. CRACK	MED	109	654	L.F.	23.1
LONG.& TRANS. CRACK	LOW	1,572	9,445	L.F.	76.8

APPROXIMATE AMOUNT OF DISTRESS RELATED TO LOAD ON THE PAVEMENT IS:	0 %
APPROXIMATE AMOUNT OF DISTRESS RELATED TO MATERIALS PROBLEMS IN THE FEATURE IS:	67 %
APPROXIMATE AMOUNT OF DISTRESS RELATED TO AGE OF PAVEMENT AND TRAFFIC REPETITIONS IS:	33 %
