# Pavement Condition Report

## Frankfort Municipal Airport

Project 16801839

**January 2016**

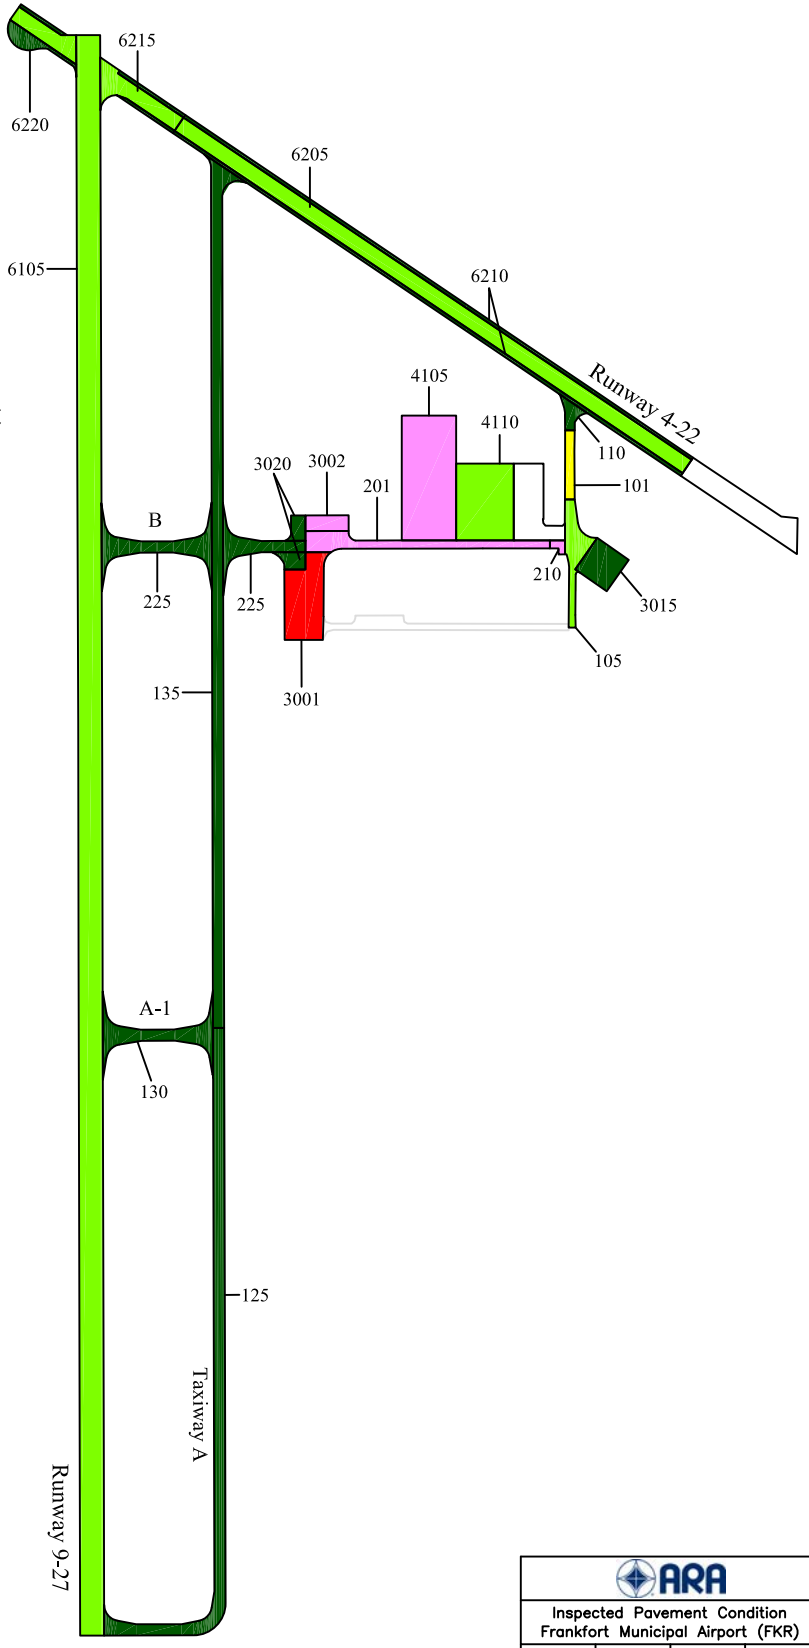
Figure 2-1. Inspected Pavement Condition at Frankfort Municipal Airport (FKR).

The pavement within each of the PCI condition categories is shown in Figure 2-1. The inspected PCI is summarized by branch use in Figure 2-2, and the photographs in Figure 2-3 through Figure 2-6 provide examples of the condition categories.

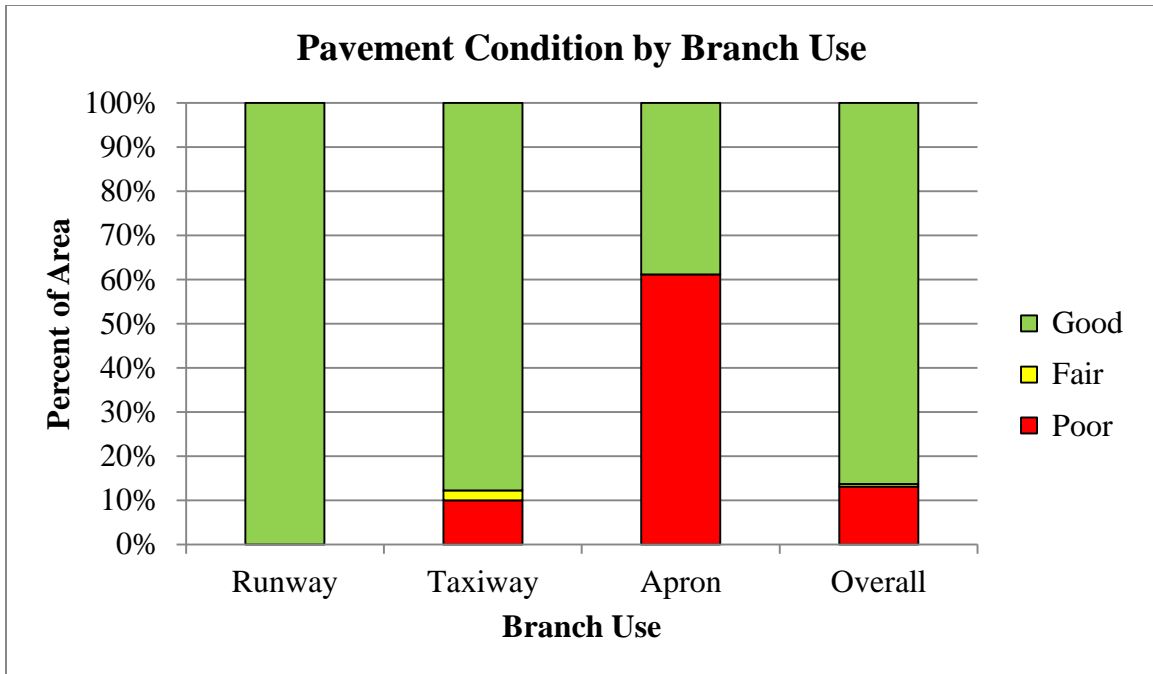
Figure 2-2. Pavement Condition by Branch Use

The average inspected Pavement Condition Index (PCI) for all the airfield pavements was 80. Runways had an average inspected PCI of 83 and were above the desired MSL of 60. Taxiways had an average inspected PCI of 87, and ramps had an average inspected PCI of 60.

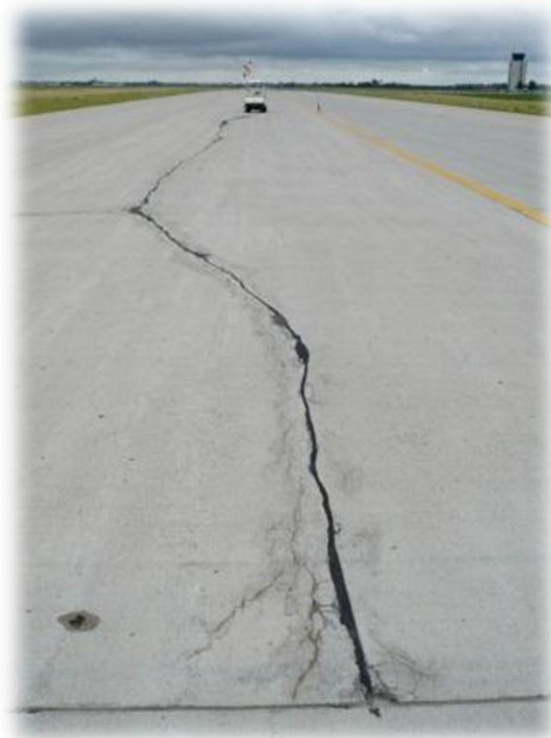
#### *Longitudinal, Transverse & Diagonal Cracking*

LTD cracking is often a result of load or temperature deformations. External loads cause flexure. Temperature changes can cause curling. When any of these stresses exceed the slab strength, cracking occurs.

LTD cracking is recorded at low, medium, or high severity, depending on the width of crack opening and degree of deterioration.

At low severity, a crack is less than 1/8 inch wide with little spalling, and no corrective action is indicated. At medium severity, LTD cracks can be up to 1 inch wide with moderate spalling and should be repaired using procedures similar to joint sealing. At high severity, cracks exceed 1 inch in width and may be severely spalled. High-severity LTD cracking is evidence of serious load failure, and correction may require patching or slab replacement. If distress occurs in several adjacent slabs at medium or high severity, major rehabilitation of that area is indicated.

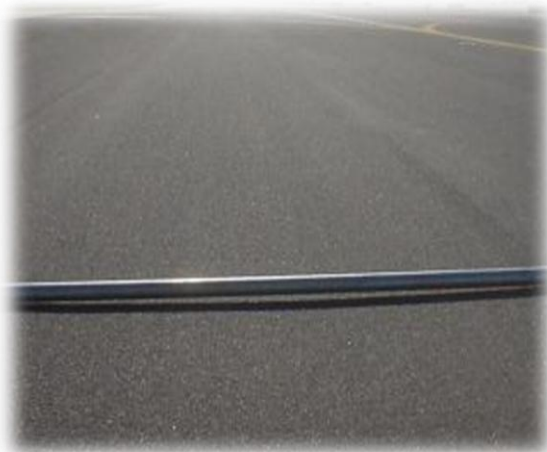
### Rutting

Ruts are localized areas of pavement having elevations lower than the surrounding sections.

Rutting is due to base and subgrade consolidation caused by excessive wheel loads or poor compaction. Ruts indicate structural failure and can cause hydroplaning.

At low severity, ruts have an average depth of ¼ to ½ inches. At medium severity, ruts have an average depth of ½ to 1 inch. At high severity, ruts have an average depth greater than 1 inch. Patching is the appropriate repair for ruts.
