Pavement Condition Report

Greencastle-Putnam County Airport

Project 16801839

January 2016

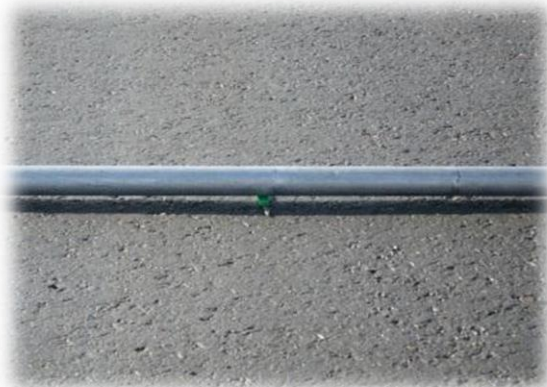
Ruts are localized areas of pavement having elevations lower than the surrounding sections.

Rutting is due to base and subgrade consolidation caused by excessive wheel loads or poor compaction. Ruts indicate structural failure and can cause hydroplaning.

At low severity, ruts have an average depth of ¼ to ½ inches. At medium severity, ruts have an average depth of ½ to 1 inch. At high severity, ruts have an average depth greater than 1 inch. Patching is the appropriate repair for ruts.
