Pavement Condition Report

Indianapolis Executive Airport

Project 16801839

January 2016

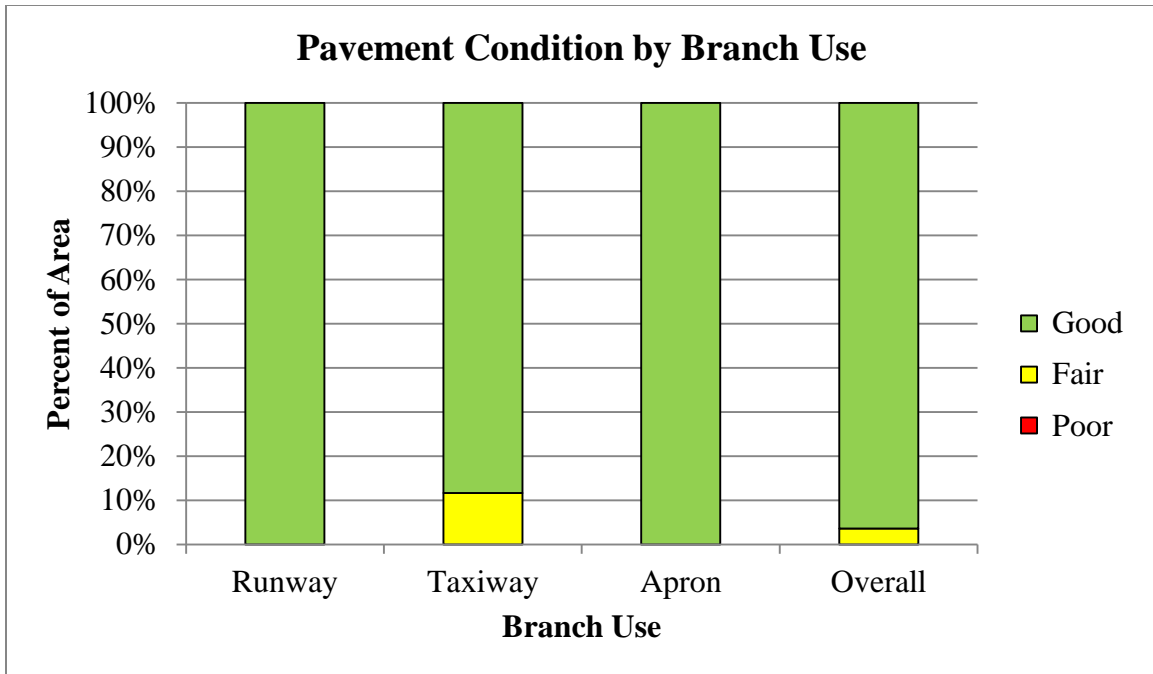
Figure 2-2. Pavement Condition by Branch Use

The pavement within each of the PCI condition categories is shown in Figure 2-1. The inspected PCI is summarized by branch use in Figure 2-2, and the photographs in Figure 2-3 through Figure 2-5 provide examples of the condition categories.

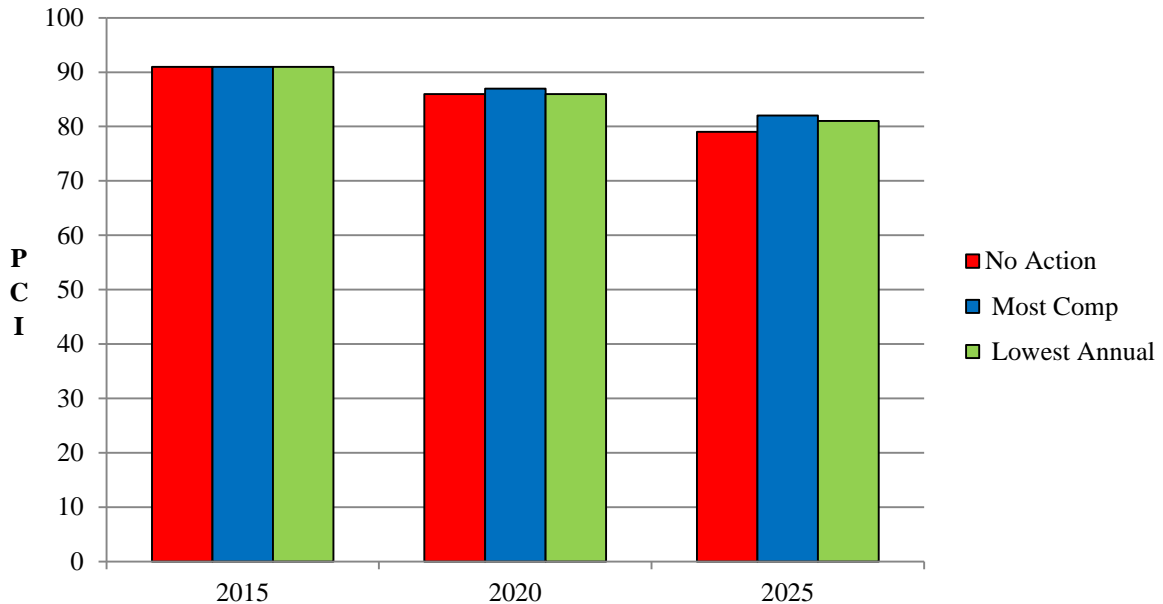
Figure 3-1. Programmed CIP

The longest life CIP scenario for all of the pavement projected to fall below the MSL is projected to cost approximately **\$136,000** over the next 10 years. The corresponding lowest annual cost scenario is also projected to cost approximately **\$82,000** over the next 10 years. Examples of each capital improvement strategy and a complete listing of all viable capital projects are presented in Table 3-2 through Table 3-4.

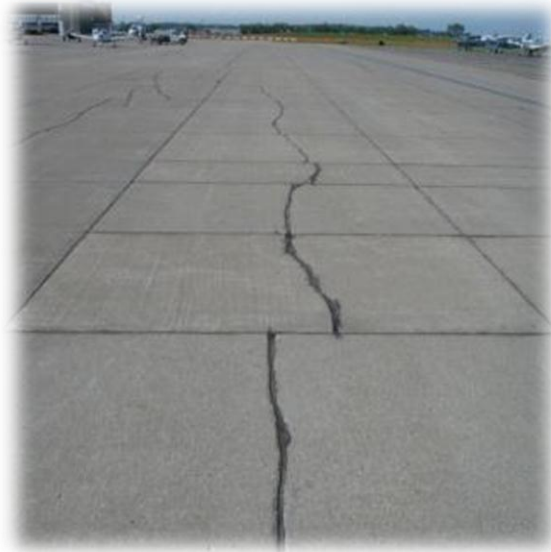
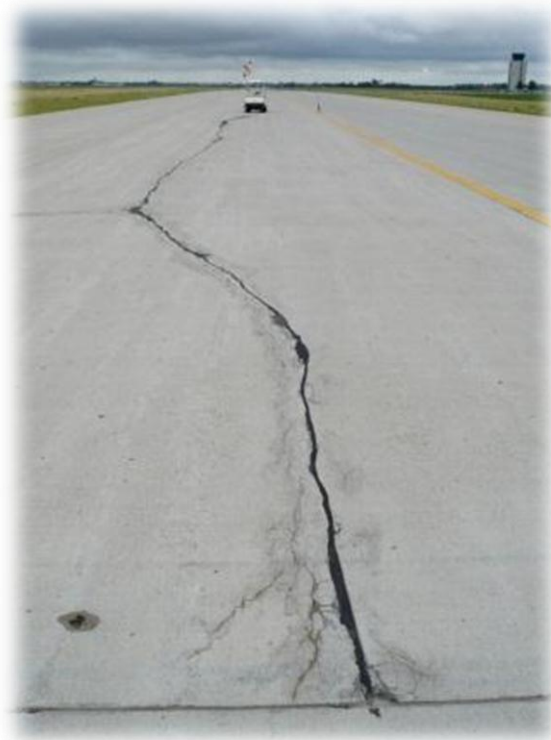
Longitudinal, Transverse & Diagonal Cracking

LTD cracking is often a result of load or temperature deformations. External loads cause flexure. Temperature changes can cause curling. When any of these stresses exceed the slab strength, cracking occurs.

LTD cracking is recorded at low, medium, or high severity, depending on the width of crack opening and degree of deterioration.

At low severity, a crack is less than 1/8 inch wide with little spalling, and no corrective action is indicated. At medium severity, LTD cracks can be up to 1 inch wide with moderate spalling and should be repaired using procedures similar to joint sealing. At high severity, cracks exceed 1 inch in width and may be severely spalled. High-severity LTD cracking is evidence of serious load failure, and correction may require patching or slab replacement. If distress occurs in several adjacent slabs at medium or high severity, major rehabilitation of that area is indicated.

A slab divided into four or more pieces is said to be “divided” or “shattered.” Shattered slab is a separate distress category and indicates a significant structural failure. A shattered slab has lost its ability to distribute loads. Shattered slabs are rated in three severities, but the recommended action in any case is slab replacement.

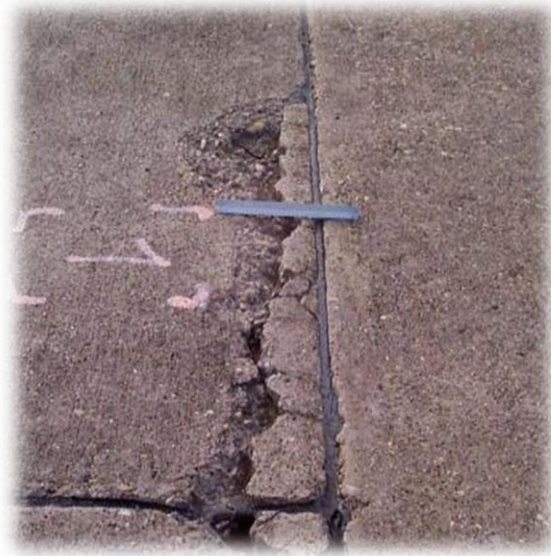
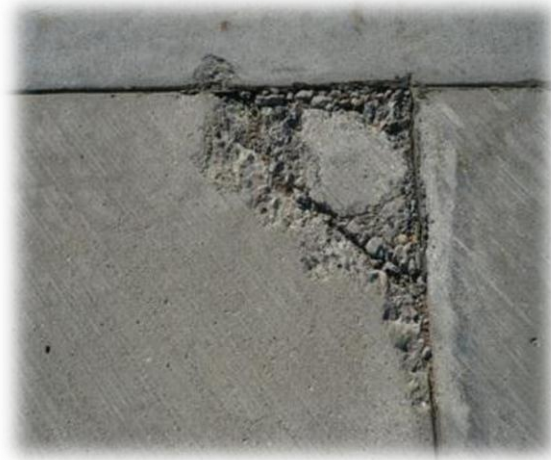
Joint Spall and Corner Spall

Spalls at slab joints and corners are caused by excessive internal stress in the pavement. Spalls occur when these stresses exceed the shear strength of the concrete.

Spalling usually results from thermal expansion during hot weather when slabs push and expand against one another. If the joints are filled with incompressible material, such as sand, stresses can become severe, causing spalls. Spalling can be reduced significantly by maintenance of joint sealant.

Spall repair requires patching. The extent and severity of spalling suggests the appropriate action. At low severity, spalled concrete remains securely in place in the slab. A low-severity spall should be monitored closely for further deterioration and should be patched when spalled particles become loose, or during the next scheduled patching activity. Medium- and high-severity spalls should be repaired immediately to prevent FOD. If the pavement can be restored to serviceable condition, spalls should be patched for long-term service. If the pavement is beyond repair, temporary patching should be considered to control FOD.

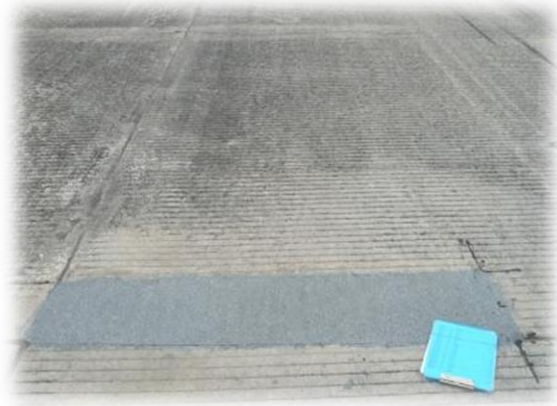
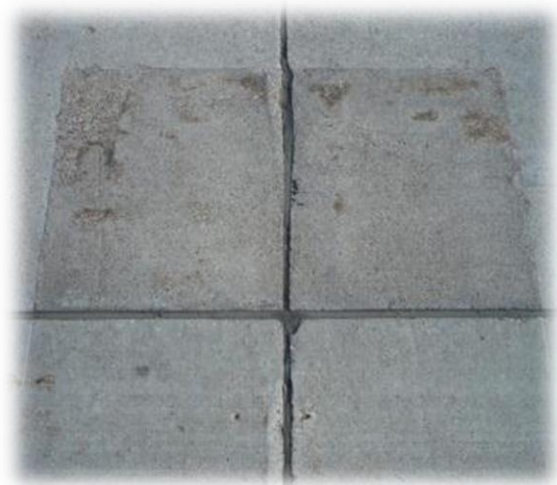
Patches, Large and Small

Large and small patches, by PCI inspection criteria, are distress conditions. Patches indicate deterioration and aging of pavement that contributes to shortened service life. However, patching also indicates that pavement is being maintained.

A patch that is performing well and shows no outward distress is recorded at low severity, and no corrective action is required. Medium-severity patches are serviceable but are beginning to deteriorate. Maintenance or replacement is indicated. At high severity, replacement is indicated.

By definition, small patches are smaller than 5 square feet in surface area, and they usually result from spall repair at slab joints and corners.

Large patches also may be the result of spall repair, but they often indicate more serious deficiencies, such as corner breaks or other full-depth failure smaller than panel size.

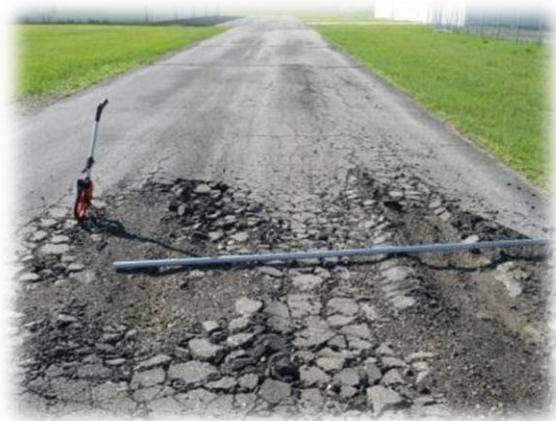
Alligator Cracking

Alligator cracks are a series of interconnected load-related cracks caused by fatigue of the asphalt surface. Alligator cracking is a significant structural distress and develops only in places subject to traffic loads. These cracks typically initiate at the bottom of the asphalt layer and propagate upward. Once a fatigue crack is visible at the surface, significant damage has already occurred.

At low severity, alligator cracks are evidenced by a series of parallel hairline cracks (usually in a wheel path). Medium-severity alligator cracking is a well-defined pattern of interconnected cracks, and some spalling may be present. High-severity alligator cracks have lost aggregate interlock between adjacent pieces, and the cracks may be severely spalled with FOD potential. Most likely, the pieces will move freely under traffic.

Alligator cracking is a serious structural failure that cannot be repaired with sealant. The proper repair is patching.

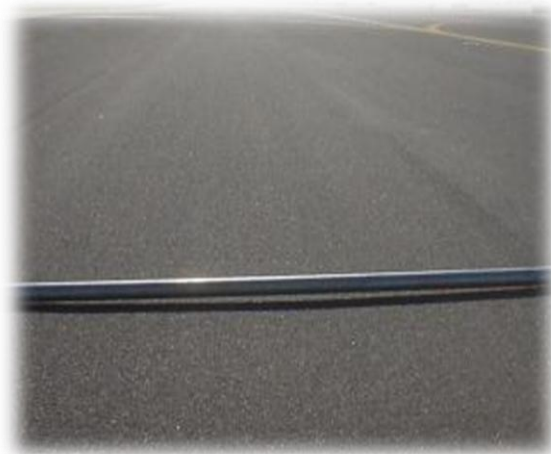
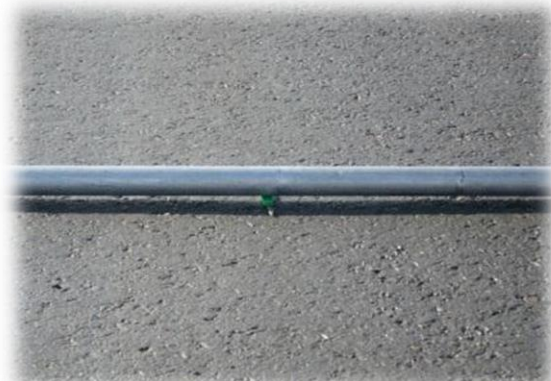
Ruts are localized areas of pavement having elevations lower than the surrounding sections.

Rutting is due to base and subgrade consolidation caused by excessive wheel loads or poor compaction. Ruts indicate structural failure and can cause hydroplaning.

At low severity, ruts have an average depth of ¼ to ½ inches. At medium severity, ruts have an average depth of ½ to 1 inch. At high severity, ruts have an average depth greater than 1 inch. Patching is the appropriate repair for ruts.
