Pavement Condition Report

Kendallville Municipal Airport

Project 16801839

January 2016

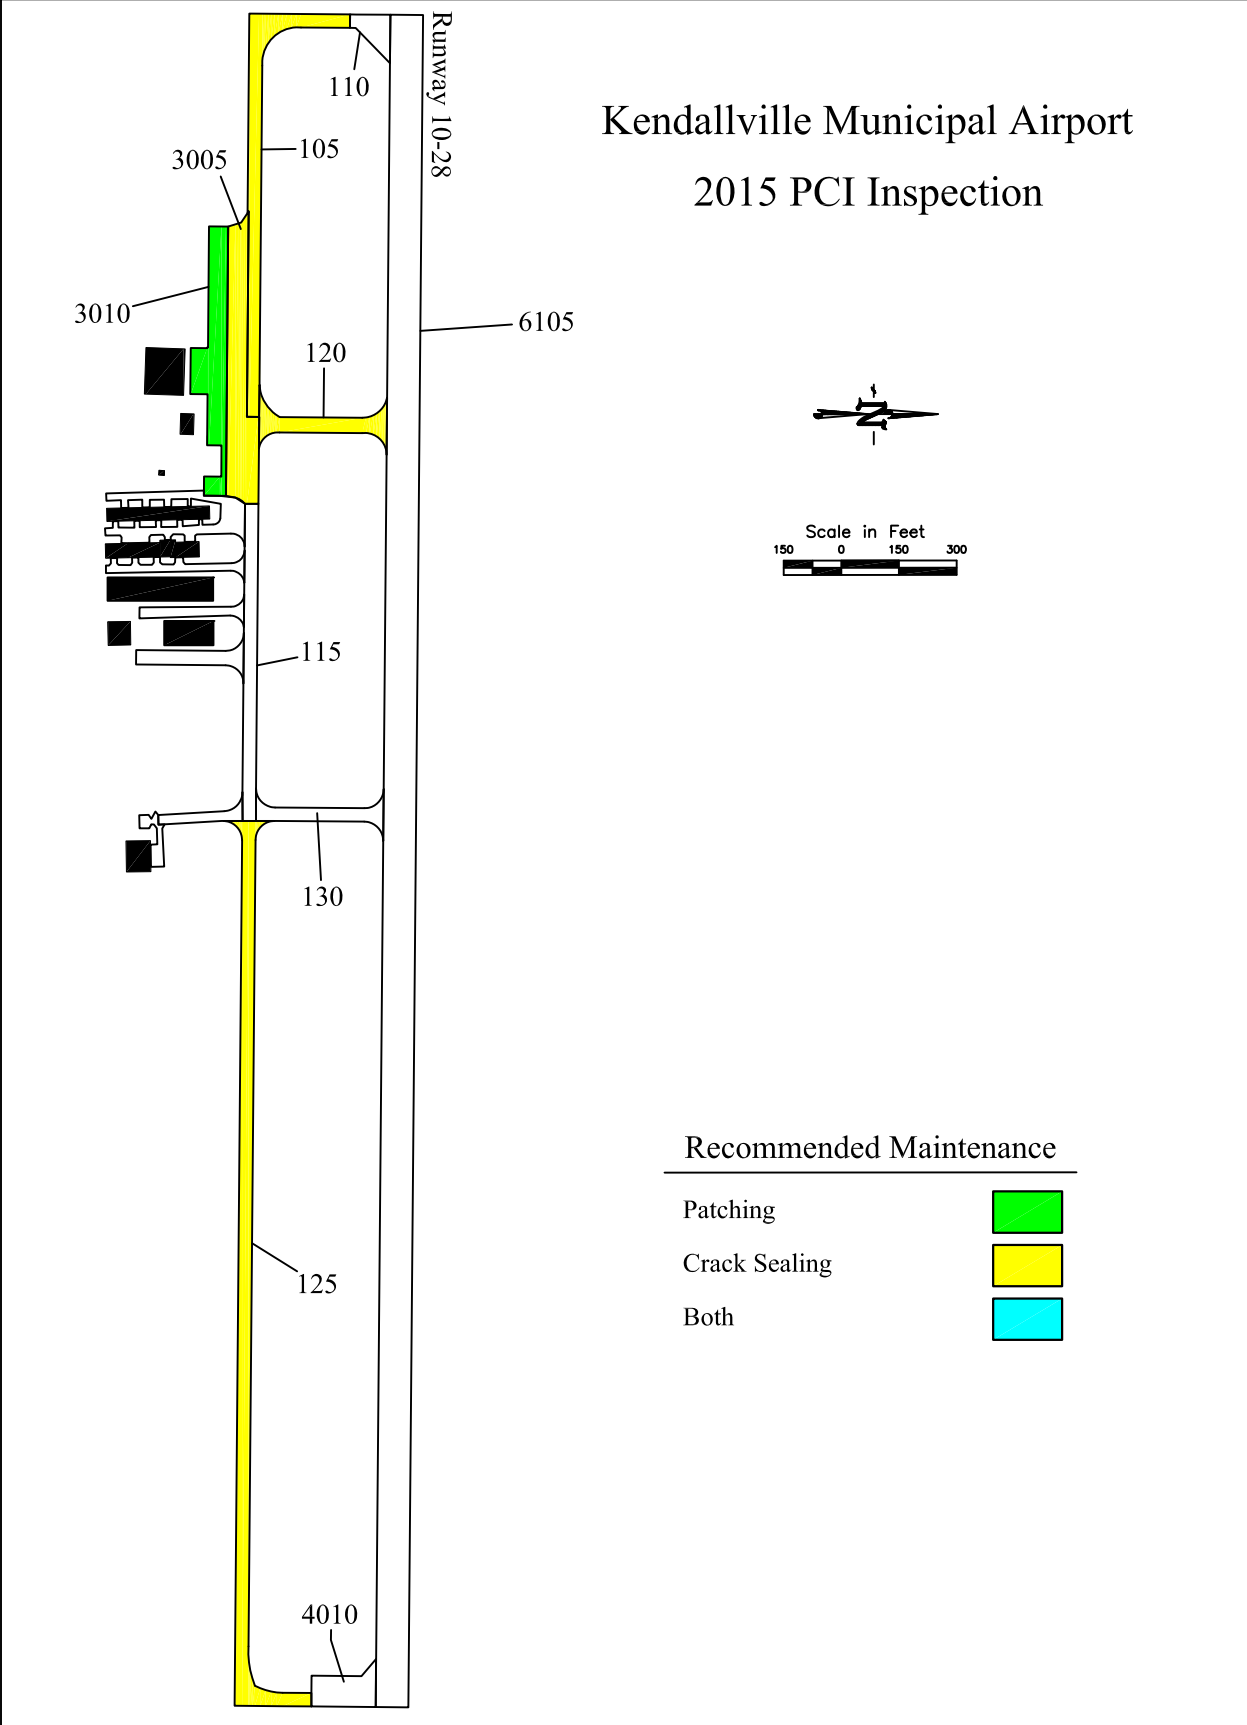
Kendallville Municipal Airport 2015 PCI Inspection

Analysis of potential maintenance projects identified less than 100 square feet of patching needs and approximately 3,300 linear feet of crack sealing and crack repair needs, at an estimated total cost of approximately \$4,000.

Work Item	Quantity	Unit	Cost
AC RESTORATIVE CRACK REPAIR	2,363	LF	\$2,930
AC SUSTAINING CRACK REPAIR	957	LF	\$829
PCC PATCH	6	SF	\$100
Total:			\$3,859

Specific recommendations to help prioritize airfield maintenance are found in chapter 4 of this report. A summary of all identified maintenance needs is shown in the table below and in the figure on the following page.

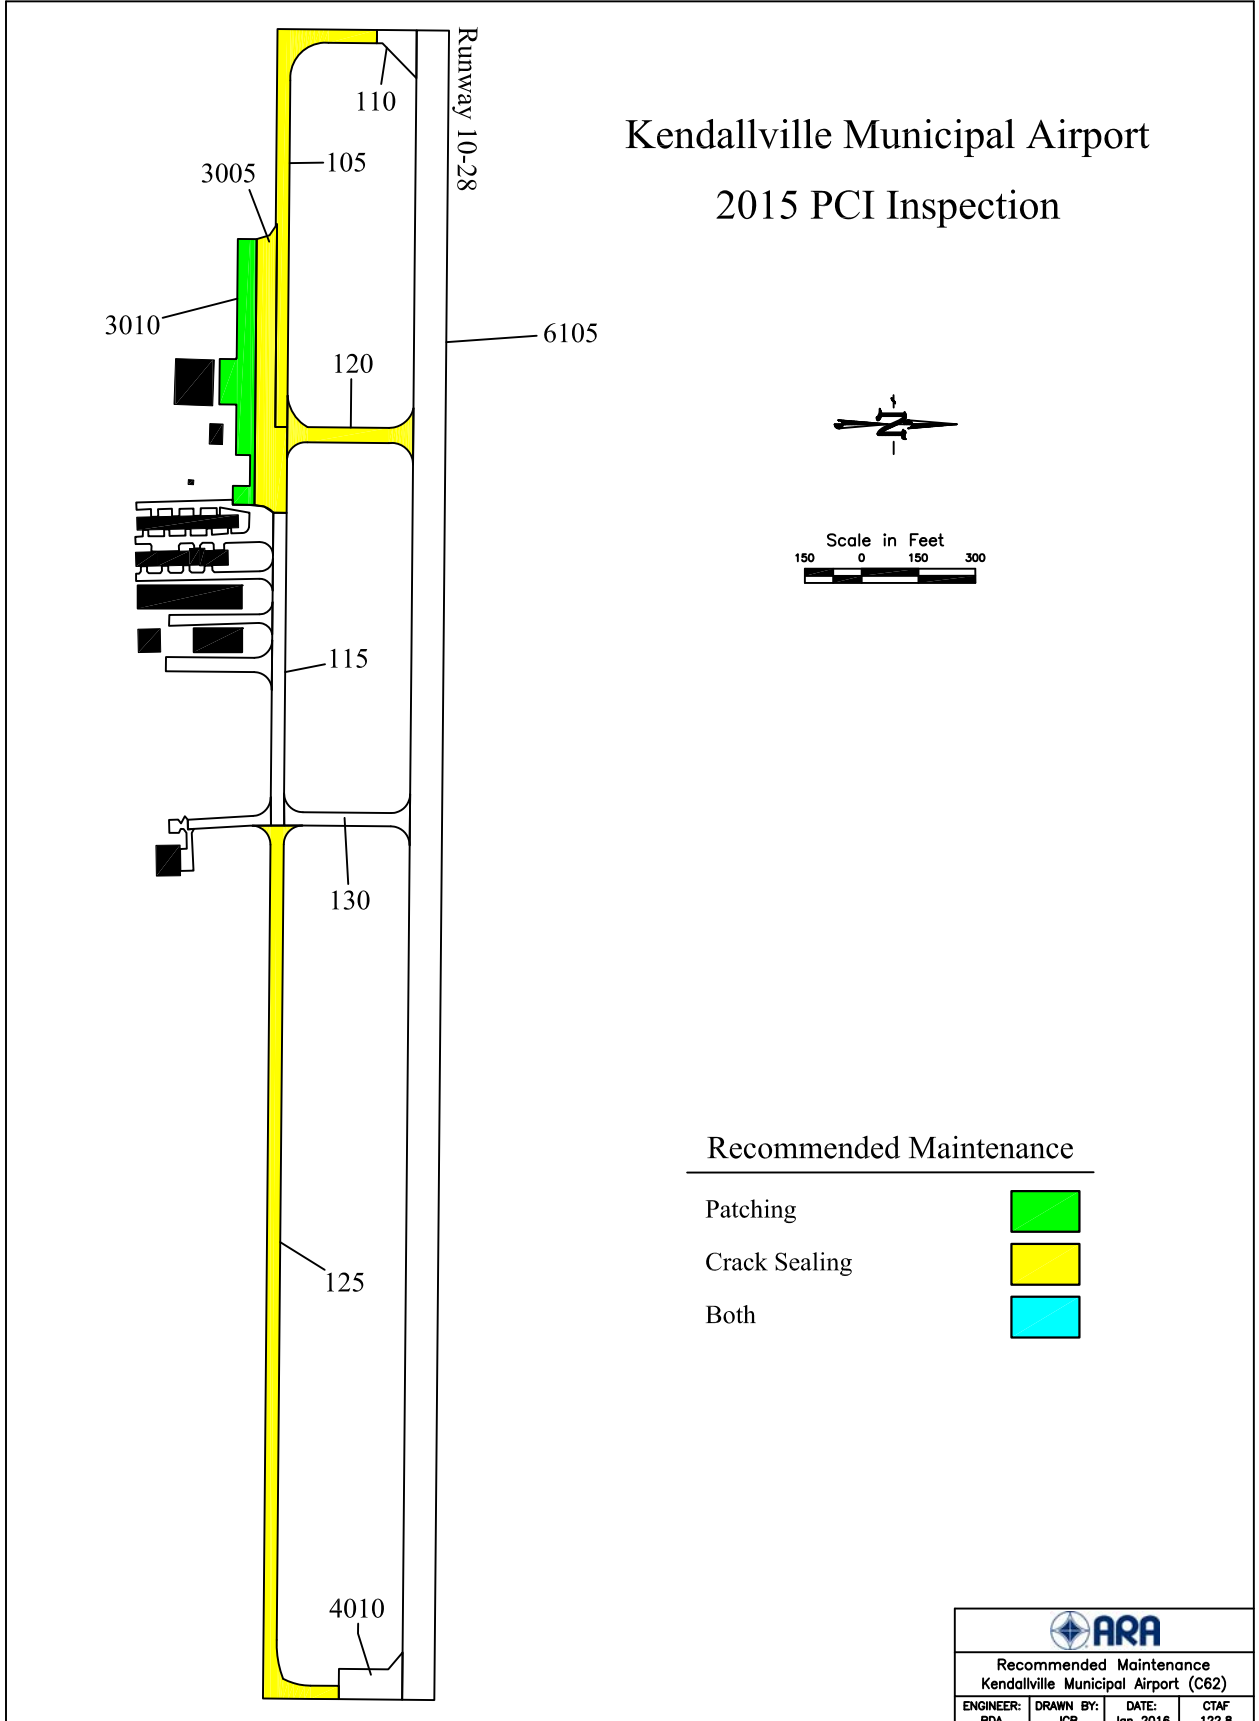
Kendallville Municipal Airport 2015 PCI Inspection

Feature	Work Item	Amount	Insp. PCI	Change	Est. PCI
3010	PCC PATCHING	6	95	2	97
	TOTAL:	6	S.F.		
EQUIPMENT: SAW, AIR COMPRESSOR, JACK HAMMER, MIXER, HAND TOOLS					
EST. MATERIALS: 0 CUBIC YARDS CONCRETE MIX					
EST. MATERIAL COST: \$15					
EST. CREW HOURS: .6					
EST. CREW COST: \$84					
EST. PROJECT COST: \$100

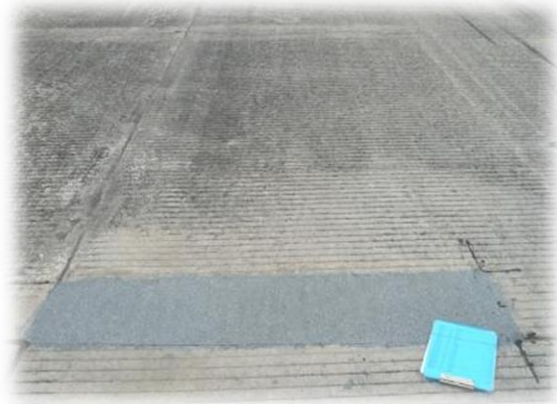
Patches, Large and Small

Large and small patches, by PCI inspection criteria, are distress conditions. Patches indicate deterioration and aging of pavement that contributes to shortened service life. However, patching also indicates that pavement is being maintained.

A patch that is performing well and shows no outward distress is recorded at low severity, and no corrective action is required. Medium-severity patches are serviceable but are beginning to deteriorate. Maintenance or replacement is indicated. At high severity, replacement is indicated.

By definition, small patches are smaller than 5 square feet in surface area, and they usually result from spall repair at slab joints and corners.

Large patches also may be the result of spall repair, but they often indicate more serious deficiencies, such as corner breaks or other full-depth failure smaller than panel size.

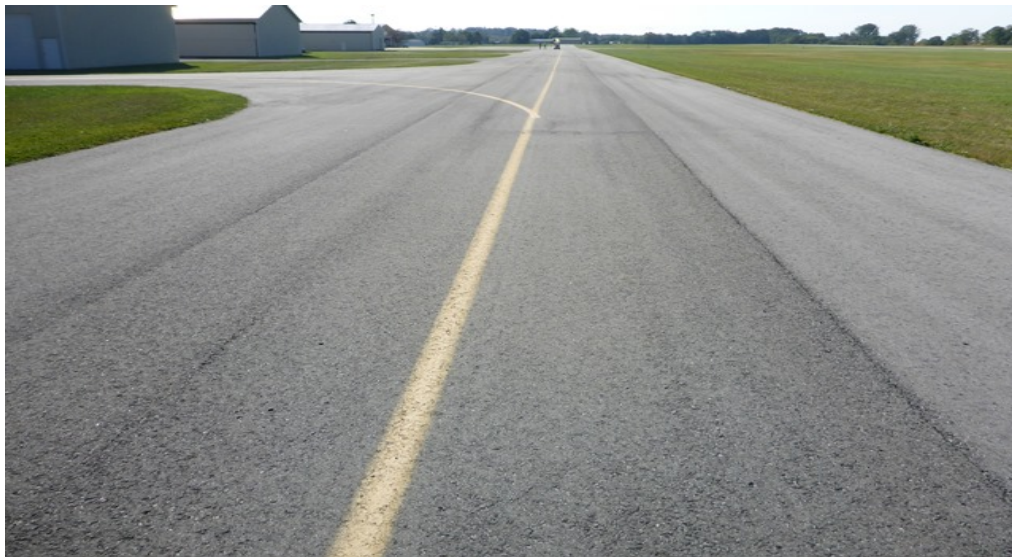
DISTRESS TYPE	SEVERITY	MEASURED QUANTITY	ESTIMATED TOTAL QUANTITY	UNITS	PERCENTAGE OF All DISTRESS
LONG.& TRANS. CRACK	MED	4	8	L.F.	11.8
LONG.& TRANS. CRACK	LOW	310	640	L.F.	80.7
SWELL	LOW	22	45	S.F.	6.4
WEATHERING	LOW	100	206	S.F.	.8

APPROXIMATE AMOUNT OF DISTRESS RELATED TO LOAD ON THE PAVEMENT IS:	0 %
APPROXIMATE AMOUNT OF DISTRESS RELATED TO MATERIALS PROBLEMS IN THE FEATURE IS:	69 %
APPROXIMATE AMOUNT OF DISTRESS RELATED TO AGE OF PAVEMENT AND TRAFFIC REPETITIONS IS:	31 %

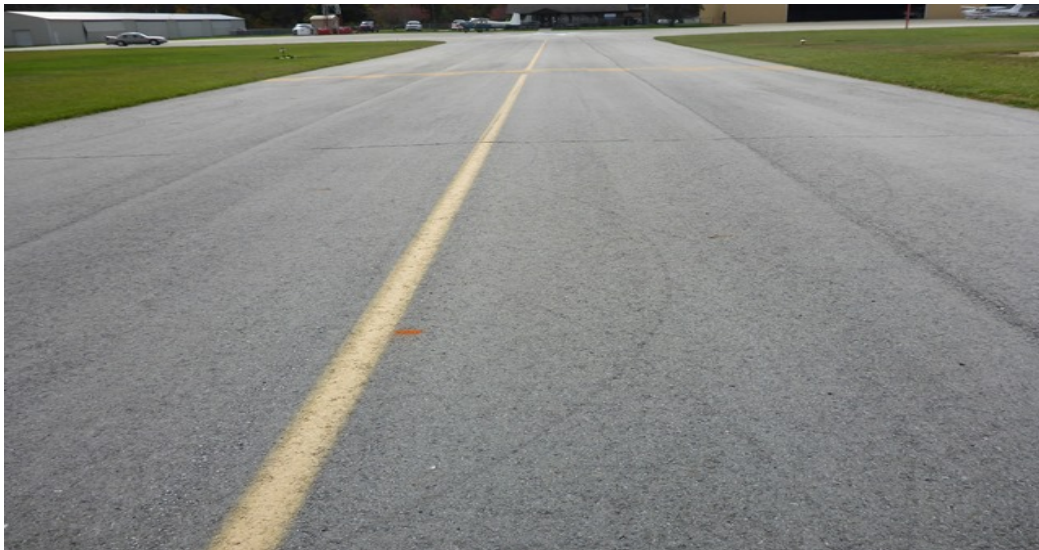
DISTRESS TYPE	SEVERITY	MEASURED QUANTITY	ESTIMATED TOTAL QUANTITY	UNITS	PERCENTAGE OF All DISTRESS
LONG.& TRANS. CRACK	MED	30	62	L.F.	44.2
LONG.& TRANS. CRACK	LOW	94	196	L.F.	46.3
WEATHERING	LOW	600	1,253	S.F.	9.3

APPROXIMATE AMOUNT OF DISTRESS RELATED TO LOAD ON THE PAVEMENT IS:	0 %
APPROXIMATE AMOUNT OF DISTRESS RELATED TO MATERIALS PROBLEMS IN THE FEATURE IS:	64 %
APPROXIMATE AMOUNT OF DISTRESS RELATED TO AGE OF PAVEMENT AND TRAFFIC REPETITIONS IS:	36 %

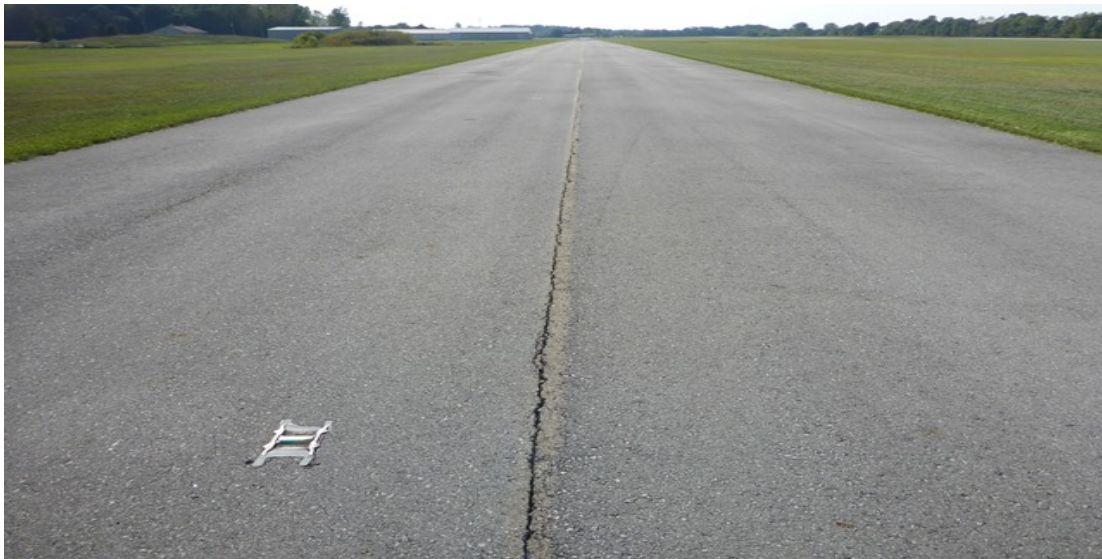
DISTRESS TYPE	SEVERITY	MEASURED QUANTITY	ESTIMATED TOTAL QUANTITY	UNITS	PERCENTAGE OF All DISTRESS
DEPRESSION	LOW	133	421	S.F.	13.9
LONG.& TRANS. CRACK	MED	204	646	L.F.	44.6
LONG.& TRANS. CRACK	LOW	542	1,717	L.F.	35.8
WEATHERING	MED	250	792	S.F.	2.6
WEATHERING	LOW	1,100	3,486	S.F.	2.9

APPROXIMATE AMOUNT OF DISTRESS RELATED TO LOAD ON THE PAVEMENT IS: 0 %
 APPROXIMATE AMOUNT OF DISTRESS RELATED TO MATERIALS PROBLEMS IN THE FEATURE IS: 69 %
 APPROXIMATE AMOUNT OF DISTRESS RELATED TO AGE OF PAVEMENT AND TRAFFIC REPETITIONS IS: 31 %

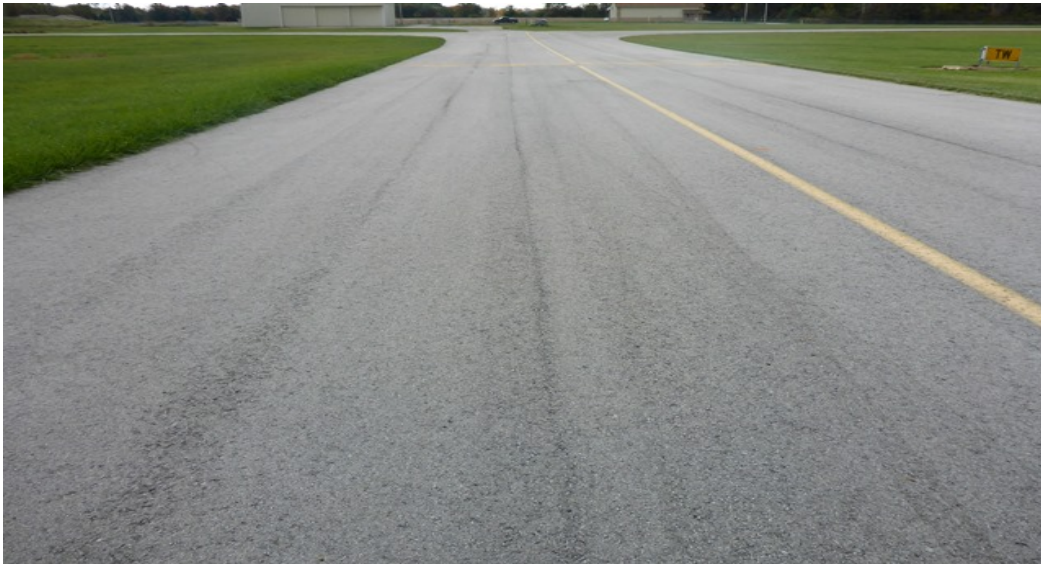
DISTRESS TYPE	SEVERITY	MEASURED QUANTITY	ESTIMATED TOTAL QUANTITY	UNITS	PERCENTAGE OF All DISTRESS
LONG.& TRANS. CRACK	LOW	86	162	L.F.	80.3
WEATHERING	LOW	700	1,322	S.F.	19.6

APPROXIMATE AMOUNT OF DISTRESS RELATED TO LOAD ON THE PAVEMENT IS:	0 %
APPROXIMATE AMOUNT OF DISTRESS RELATED TO MATERIALS PROBLEMS IN THE FEATURE IS:	60 %
APPROXIMATE AMOUNT OF DISTRESS RELATED TO AGE OF PAVEMENT AND TRAFFIC REPETITIONS IS:	40 %

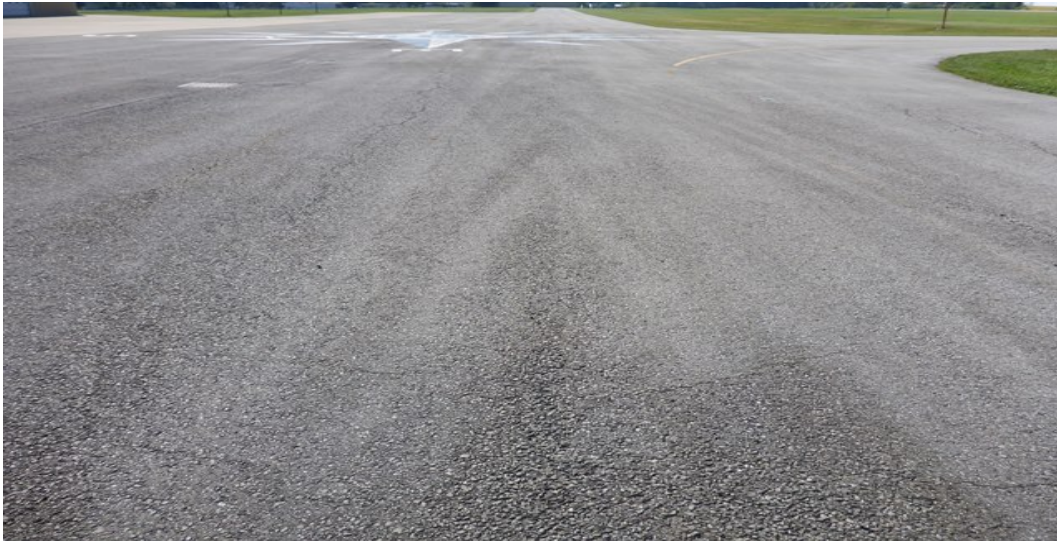
DISTRESS TYPE	SEVERITY	MEASURED QUANTITY	ESTIMATED TOTAL QUANTITY	UNITS	PERCENTAGE OF All DISTRESS
LONG.& TRANS. CRACK	MED	357	878	L.F.	27
LONG.& TRANS. CRACK	LOW	1,719	4,228	L.F.	42.8
SWELL	LOW	145	356	S.F.	3.8
WEATHERING	HIGH	70	172	S.F.	5.2
WEATHERING	MED	2,780	6,838	S.F.	14.6
WEATHERING	LOW	6,700	16,480	S.F.	6.2

APPROXIMATE AMOUNT OF DISTRESS RELATED TO LOAD ON THE PAVEMENT IS:	0 %
APPROXIMATE AMOUNT OF DISTRESS RELATED TO MATERIALS PROBLEMS IN THE FEATURE IS:	59 %
APPROXIMATE AMOUNT OF DISTRESS RELATED TO AGE OF PAVEMENT AND TRAFFIC REPETITIONS IS:	41 %

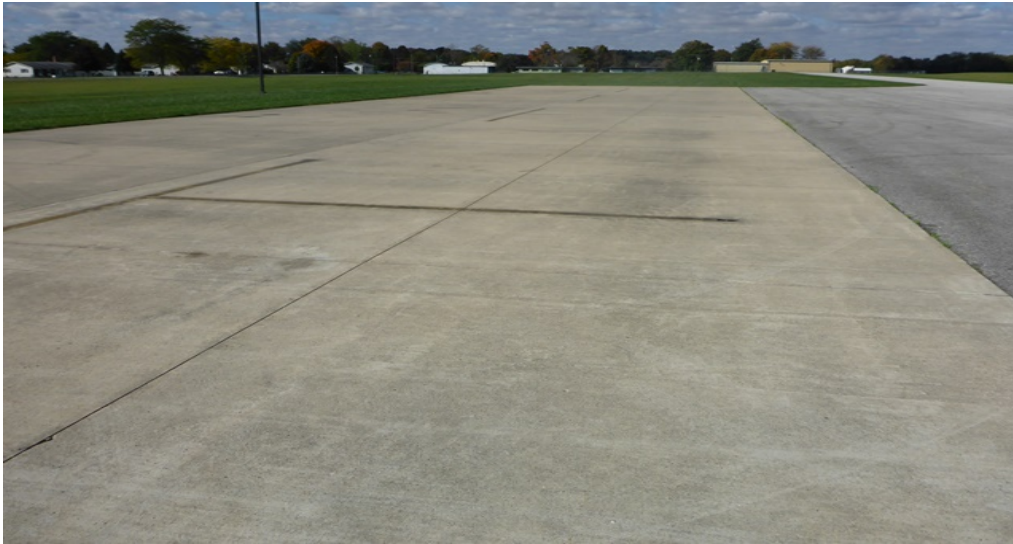
DISTRESS TYPE	SEVERITY	MEASURED QUANTITY	ESTIMATED TOTAL QUANTITY	UNITS	PERCENTAGE OF All DISTRESS
JOINT SEAL DAMAGE	LOW	20	60	SLABS	31.8
SHRINKAGE CRACKS	N/A	1	1	SLABS	1.5
SPALLING-JOINTS	MED	2	2	SLABS	12.6
SPALLING-JOINTS	HIGH	2	2	SLABS	36.7
SPALLING-CORNERS	MED	1	3	SLABS	58.2

APPROXIMATE AMOUNT OF DISTRESS RELATED TO LOAD ON THE PAVEMENT IS:	37 %
APPROXIMATE AMOUNT OF DISTRESS RELATED TO MATERIALS PROBLEMS IN THE FEATURE IS:	22 %
APPROXIMATE AMOUNT OF DISTRESS RELATED TO AGE OF PAVEMENT AND TRAFFIC REPETITIONS IS:	41 %

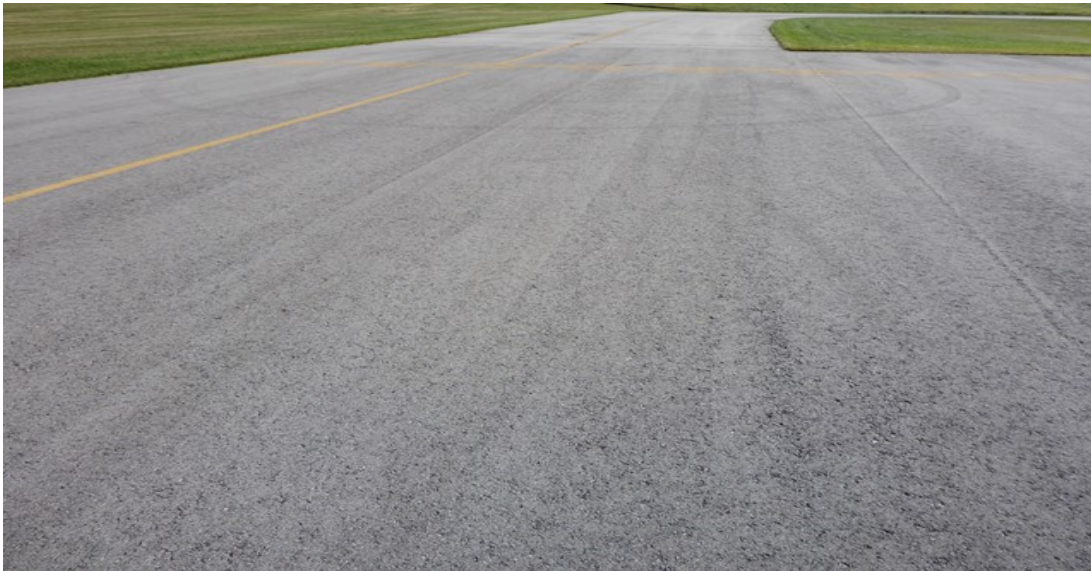
DISTRESS TYPE	SEVERITY	MEASURED QUANTITY	ESTIMATED TOTAL QUANTITY	UNITS	PERCENTAGE OF ALL DISTRESS
LONG.& TRANS. CRACK	LOW	100	200	L.F.	78.6
WEATHERING	MED	40	80	S.F.	4.5
WEATHERING	LOW	500	1,003	S.F.	16.7

APPROXIMATE AMOUNT OF DISTRESS RELATED TO LOAD ON THE PAVEMENT IS:	0 %
APPROXIMATE AMOUNT OF DISTRESS RELATED TO MATERIALS PROBLEMS IN THE FEATURE IS:	60 %
APPROXIMATE AMOUNT OF DISTRESS RELATED TO AGE OF PAVEMENT AND TRAFFIC REPETITIONS IS:	40 %

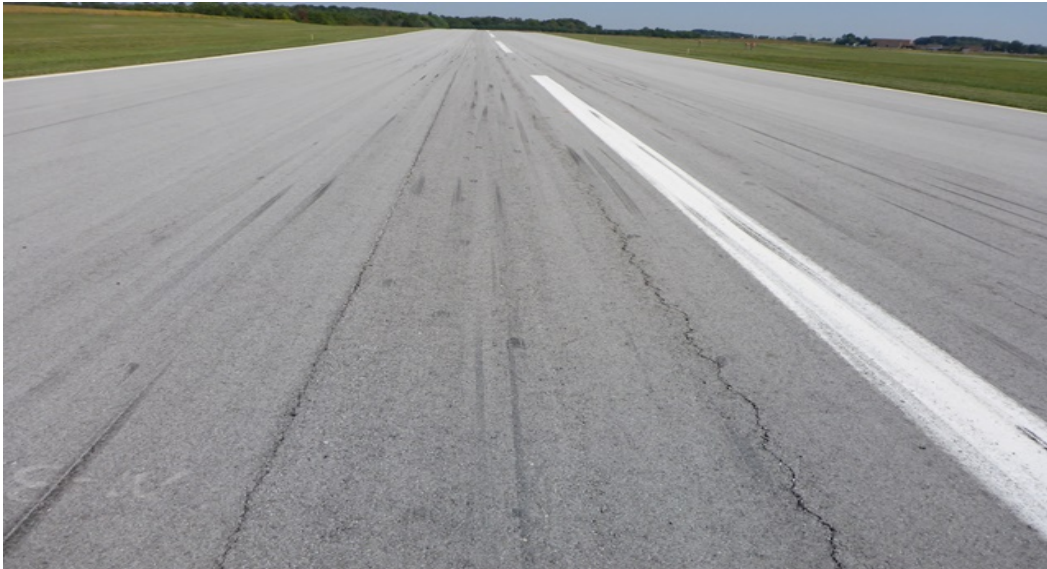
DISTRESS TYPE	SEVERITY	MEASURED QUANTITY	ESTIMATED TOTAL QUANTITY	UNITS	PERCENTAGE OF All DISTRESS
LONG.& TRANS. CRACK	LOW	2,234	17,164	L.F.	100

APPROXIMATE AMOUNT OF DISTRESS RELATED TO LOAD ON THE PAVEMENT IS:	0 %
APPROXIMATE AMOUNT OF DISTRESS RELATED TO MATERIALS PROBLEMS IN THE FEATURE IS:	67 %
APPROXIMATE AMOUNT OF DISTRESS RELATED TO AGE OF PAVEMENT AND TRAFFIC REPETITIONS IS:	33 %
