Pavement Condition Report

Kentland Municipal Airport

Project 16801839

January 2016

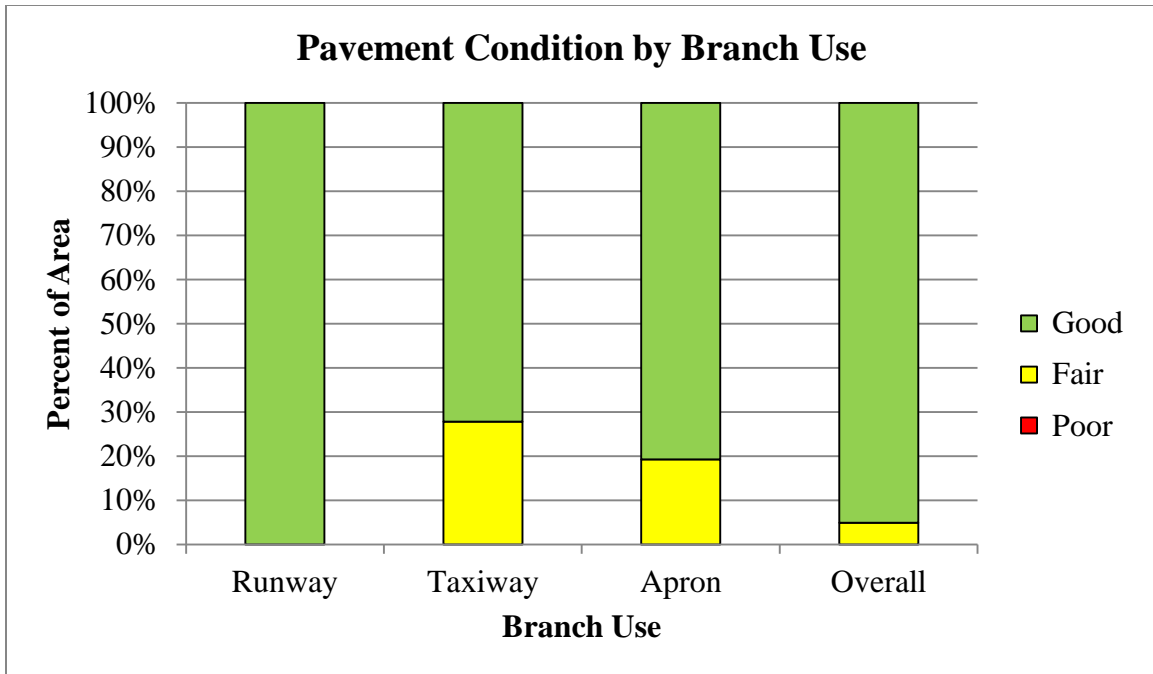
Figure 2-2. Pavement Condition by Branch Use

The pavement within each of the PCI condition categories is shown in Figure 2-1. The inspected PCI is summarized by branch use in Figure 2-2, and the photographs in Figure 2-3 through Figure 2-5 provide examples of the condition categories.

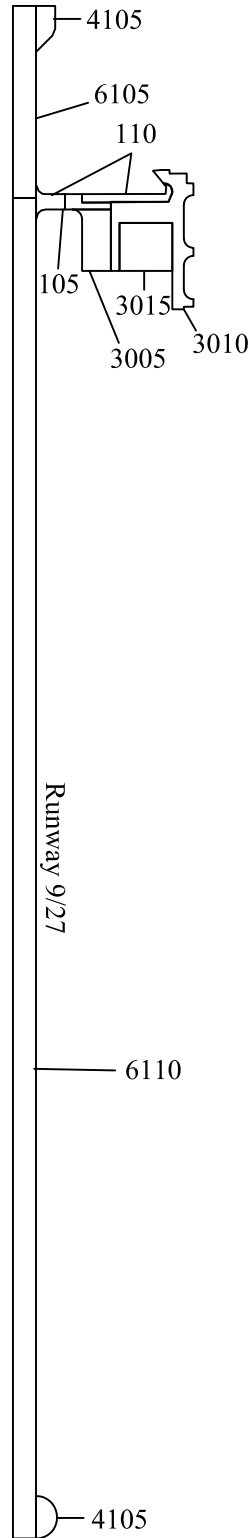
Figure 4-1. Recommended Maintenance at Kentland Municipal Airport (50I).

Analysis of potential maintenance projects identified no repair needs at this time.

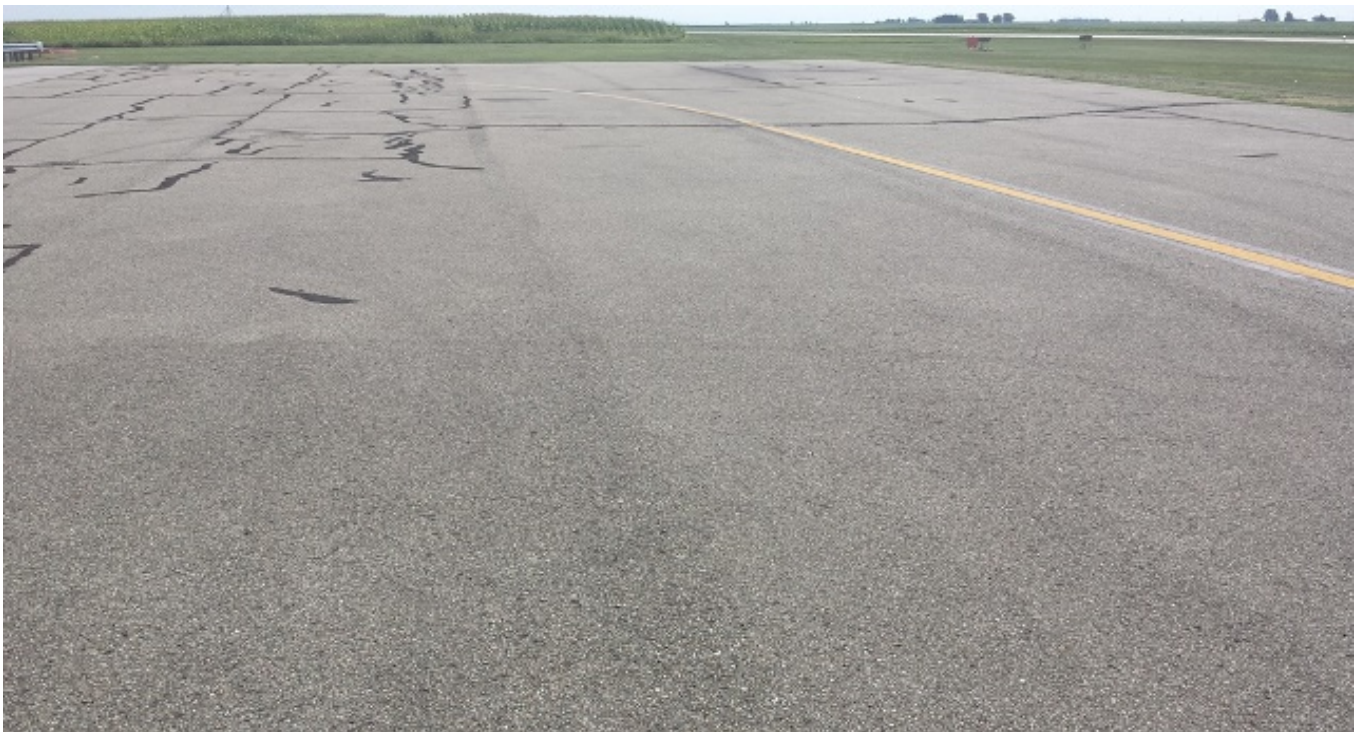
DISTRESS TYPE	SEVERITY	MEASURED QUANTITY	ESTIMATED TOTAL QUANTITY	UNITS	PERCENTAGE OF All DISTRESS
LONG.& TRANS. CRACK	LOW	804	1,300	L.F.	76.3
RAVELING	LOW	200	323	S.F.	16
WEATHERING	MED	300	485	S.F.	7.5

APPROXIMATE AMOUNT OF DISTRESS RELATED TO LOAD ON THE PAVEMENT IS:	0 %
APPROXIMATE AMOUNT OF DISTRESS RELATED TO MATERIALS PROBLEMS IN THE FEATURE IS:	59 %
APPROXIMATE AMOUNT OF DISTRESS RELATED TO AGE OF PAVEMENT AND TRAFFIC REPETITIONS IS:	41 %

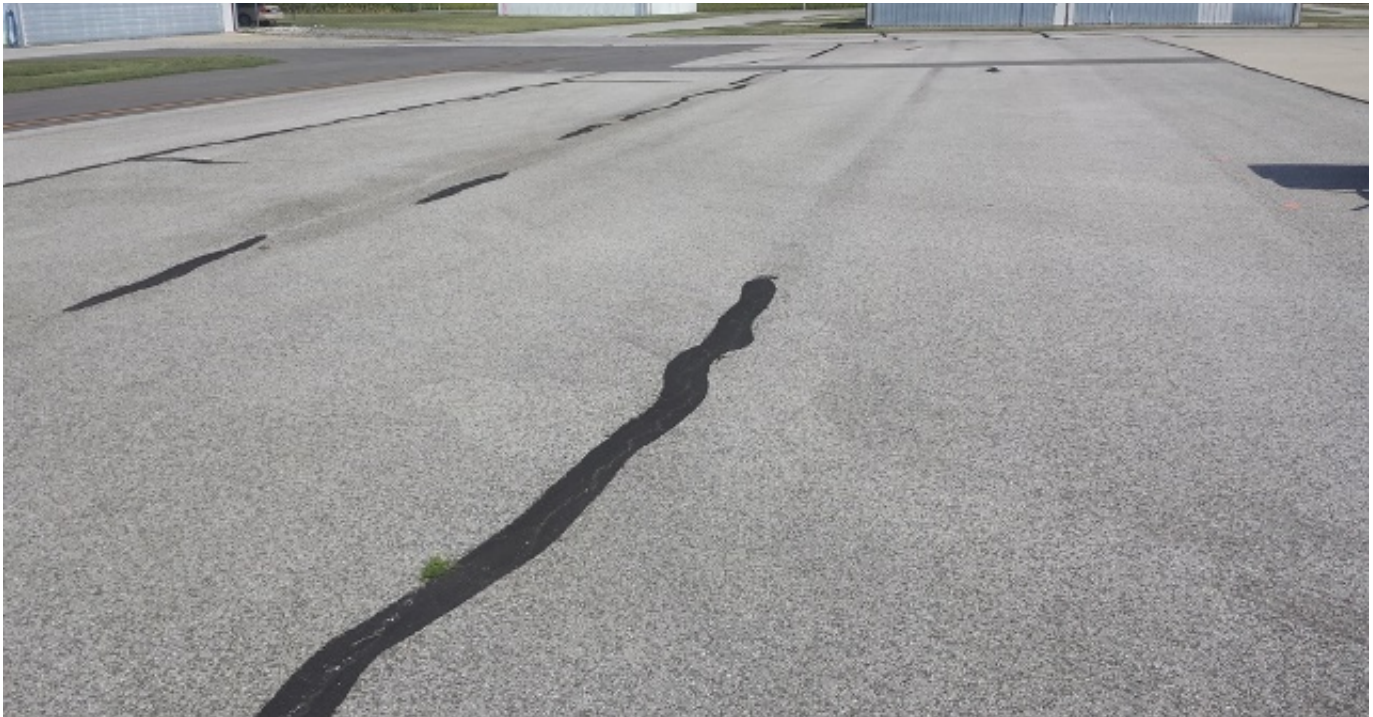
DISTRESS TYPE	SEVERITY	MEASURED QUANTITY	ESTIMATED TOTAL QUANTITY	UNITS	PERCENTAGE OF ALL DISTRESS
LONG.& TRANS. CRACK	MED	20	36	L.F.	7.3
LONG.& TRANS. CRACK	LOW	911	1,656	L.F.	70.1
OIL SPILLAGE	N/A	12	21	S.F.	2.3
WEATHERING	MED	700	1,273	S.F.	10.2
WEATHERING	LOW	5,640	10,257	S.F.	9.9

APPROXIMATE AMOUNT OF DISTRESS RELATED TO LOAD ON THE PAVEMENT IS:	0 %
APPROXIMATE AMOUNT OF DISTRESS RELATED TO MATERIALS PROBLEMS IN THE FEATURE IS:	58 %
APPROXIMATE AMOUNT OF DISTRESS RELATED TO AGE OF PAVEMENT AND TRAFFIC REPETITIONS IS:	42 %
