Pavement Condition Report

Logansport-Cass County Airport

Project 16801839

January 2016

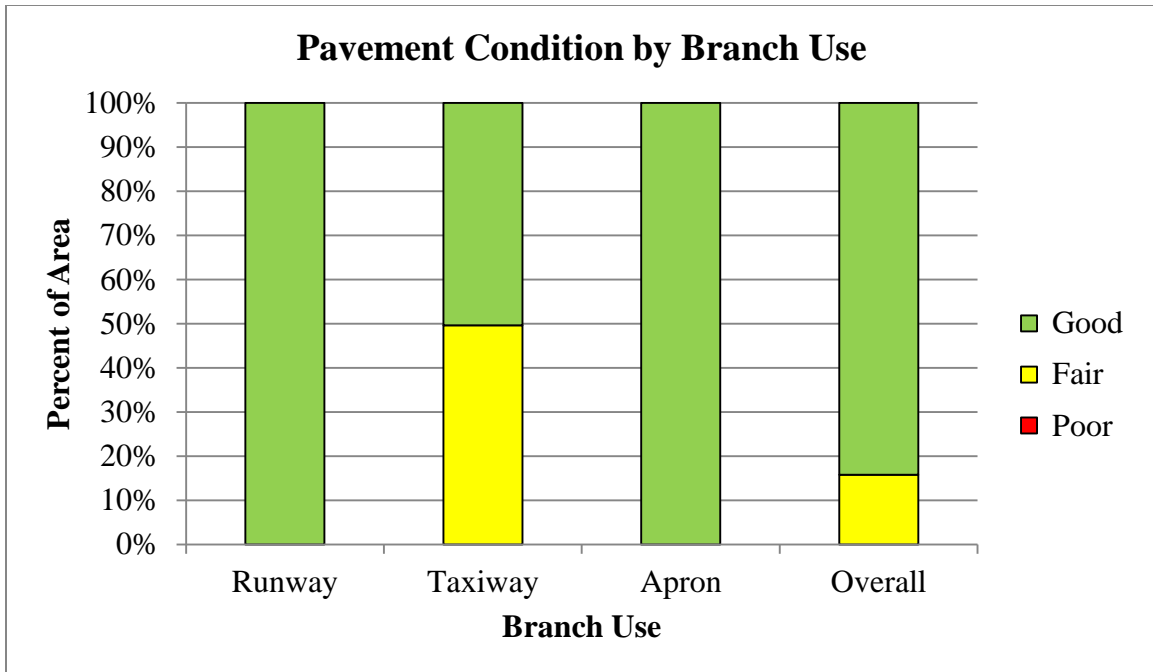
Figure 2-2. Pavement Condition by Branch Use

The pavement within each of the PCI condition categories is shown in Figure 2-1. The inspected PCI is summarized by branch use in Figure 2-2, and the photographs in Figure 2-3 through Figure 2-5 provide examples of the condition categories.

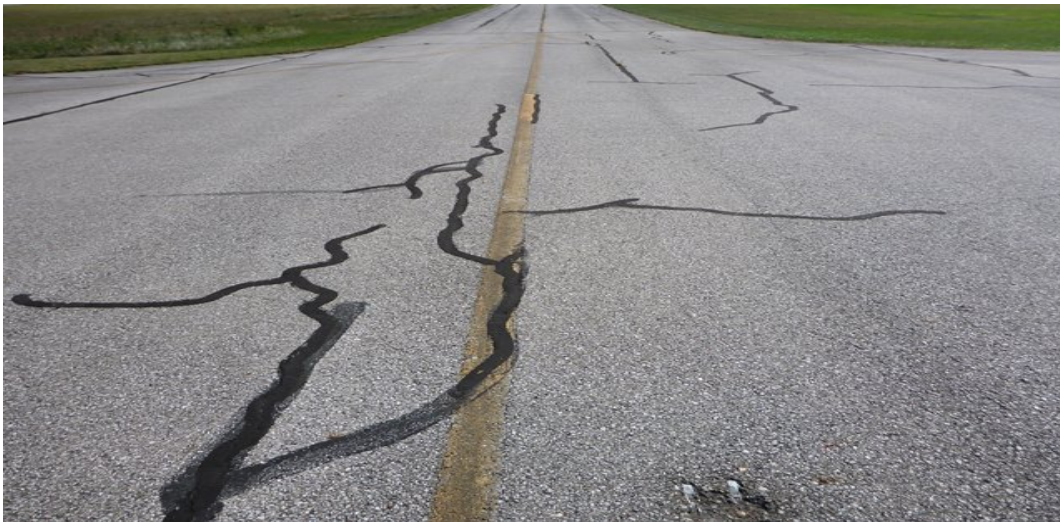
DISTRESS TYPE	SEVERITY	MEASURED QUANTITY	ESTIMATED TOTAL QUANTITY	UNITS	PERCENTAGE OF All DISTRESS
DEPRESSION	MED	2	3	S.F.	6.1
DEPRESSION	LOW	36	70	S.F.	8.5
LONG.& TRANS. CRACK	MED	1	1	L.F.	4.9
LONG.& TRANS. CRACK	LOW	485	944	L.F.	46
RUTTING	LOW	12	23	S.F.	15.6
WEATHERING	MED	400	778	S.F.	8.3
WEATHERING	LOW	3,700	7,202	S.F.	10.1

APPROXIMATE AMOUNT OF DISTRESS RELATED TO LOAD ON THE PAVEMENT IS:	10 %
APPROXIMATE AMOUNT OF DISTRESS RELATED TO MATERIALS PROBLEMS IN THE FEATURE IS:	60 %
APPROXIMATE AMOUNT OF DISTRESS RELATED TO AGE OF PAVEMENT AND TRAFFIC REPETITIONS IS:	29 %

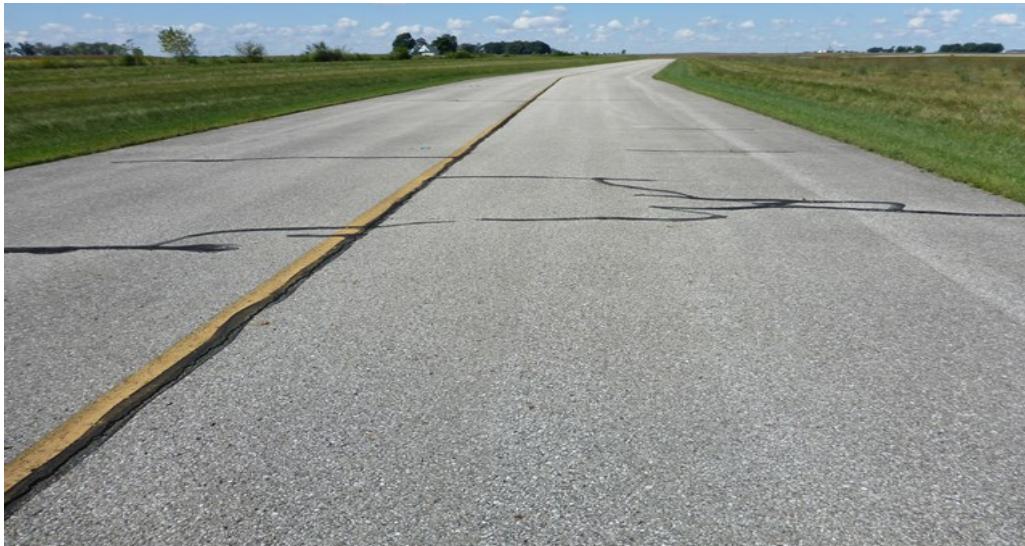
DISTRESS TYPE	SEVERITY	MEASURED QUANTITY	ESTIMATED TOTAL QUANTITY	UNITS	PERCENTAGE OF All DISTRESS
DEPRESSION	LOW	12	28	S.F.	1
LONG.& TRANS. CRACK	MED	378	886	L.F.	55.7
LONG.& TRANS. CRACK	LOW	587	1,376	L.F.	37.7
WEATHERING	LOW	2,000	4,689	S.F.	5.4

APPROXIMATE AMOUNT OF DISTRESS RELATED TO LOAD ON THE PAVEMENT IS:	0 %
APPROXIMATE AMOUNT OF DISTRESS RELATED TO MATERIALS PROBLEMS IN THE FEATURE IS:	65 %
APPROXIMATE AMOUNT OF DISTRESS RELATED TO AGE OF PAVEMENT AND TRAFFIC REPETITIONS IS:	35 %

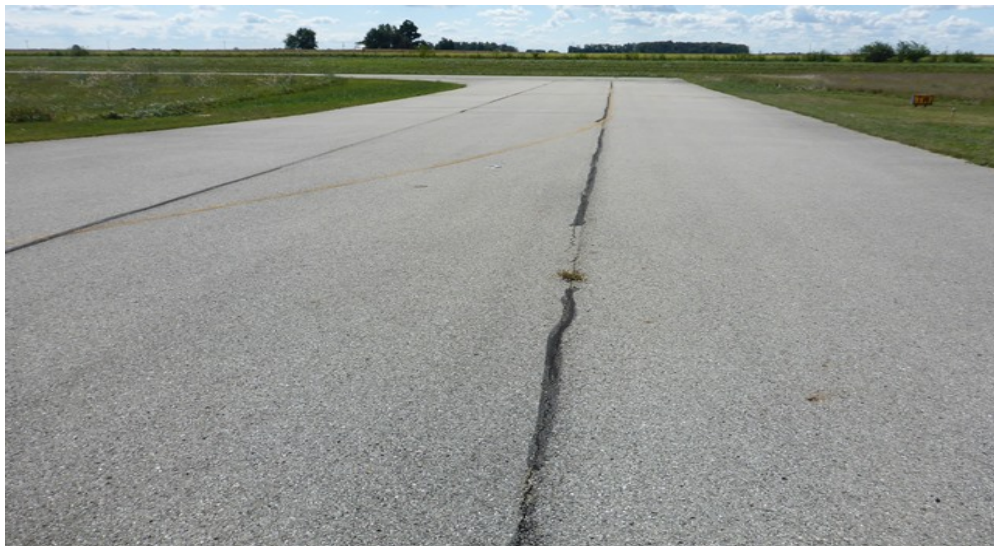
DISTRESS TYPE	SEVERITY	MEASURED QUANTITY	ESTIMATED TOTAL QUANTITY	UNITS	PERCENTAGE OF ALL DISTRESS
LONG.& TRANS. CRACK	MED	8	14	L.F.	13.7
LONG.& TRANS. CRACK	LOW	372	683	L.F.	76.3
SWELL	LOW	40	73	S.F.	9.8

APPROXIMATE AMOUNT OF DISTRESS RELATED TO LOAD ON THE PAVEMENT IS: 0 %
 APPROXIMATE AMOUNT OF DISTRESS RELATED TO MATERIALS PROBLEMS IN THE FEATURE IS: 70 %
 APPROXIMATE AMOUNT OF DISTRESS RELATED TO AGE OF PAVEMENT AND TRAFFIC REPETITIONS IS: 30 %

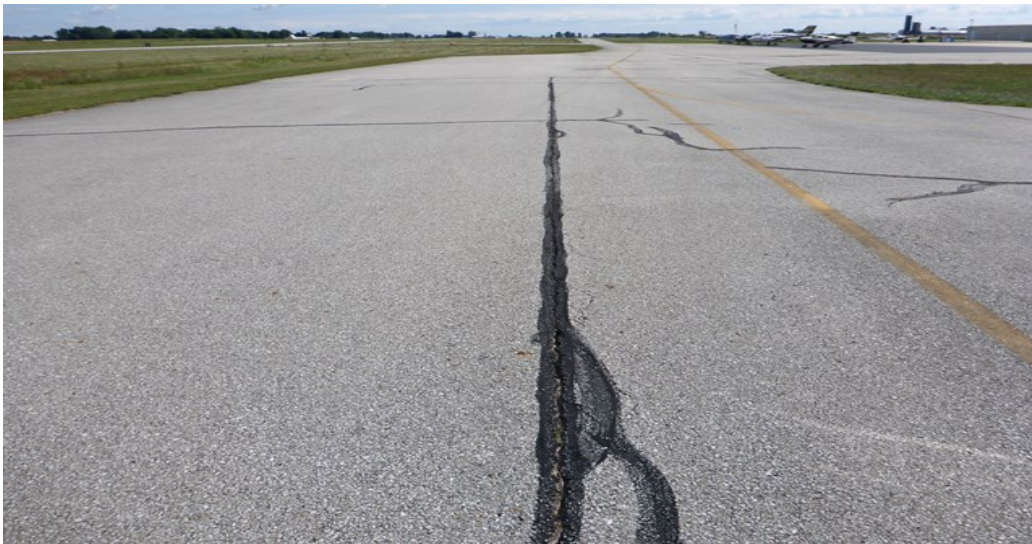
DISTRESS TYPE	SEVERITY	MEASURED QUANTITY	ESTIMATED TOTAL QUANTITY	UNITS	PERCENTAGE OF All DISTRESS
LONG.& TRANS. CRACK	MED	217	217	L.F.	41.8
LONG.& TRANS. CRACK	LOW	548	548	L.F.	46.5
WEATHERING	LOW	10,300	10,300	S.F.	11.5

APPROXIMATE AMOUNT OF DISTRESS RELATED TO LOAD ON THE PAVEMENT IS:	0 %
APPROXIMATE AMOUNT OF DISTRESS RELATED TO MATERIALS PROBLEMS IN THE FEATURE IS:	63 %
APPROXIMATE AMOUNT OF DISTRESS RELATED TO AGE OF PAVEMENT AND TRAFFIC REPETITIONS IS:	37 %

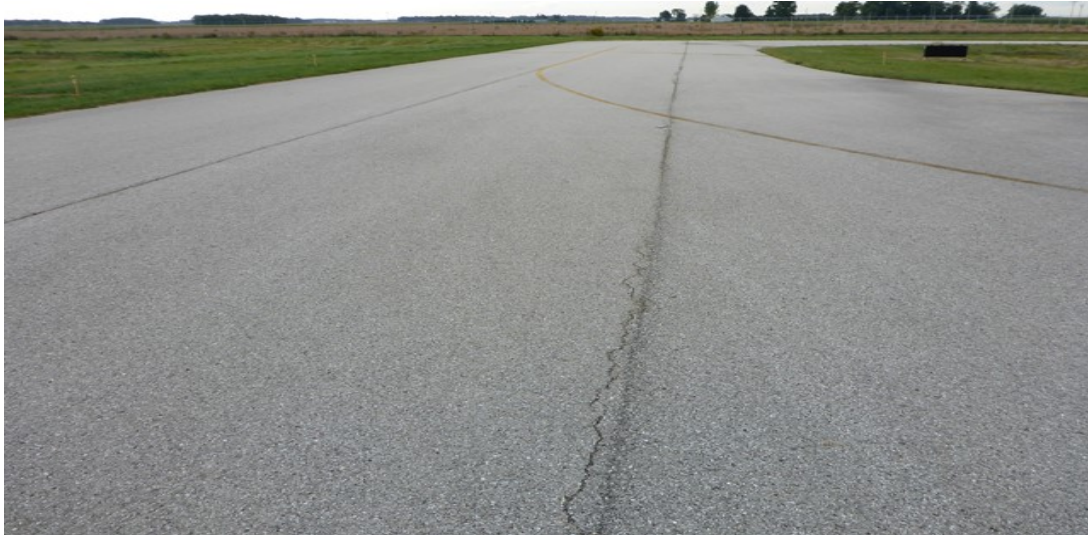
DISTRESS TYPE	SEVERITY	MEASURED QUANTITY	ESTIMATED TOTAL QUANTITY	UNITS	PERCENTAGE OF All DISTRESS
LONG.& TRANS. CRACK	LOW	308	763	L.F.	100

APPROXIMATE AMOUNT OF DISTRESS RELATED TO LOAD ON THE PAVEMENT IS:	0 %
APPROXIMATE AMOUNT OF DISTRESS RELATED TO MATERIALS PROBLEMS IN THE FEATURE IS:	67 %
APPROXIMATE AMOUNT OF DISTRESS RELATED TO AGE OF PAVEMENT AND TRAFFIC REPETITIONS IS:	33 %

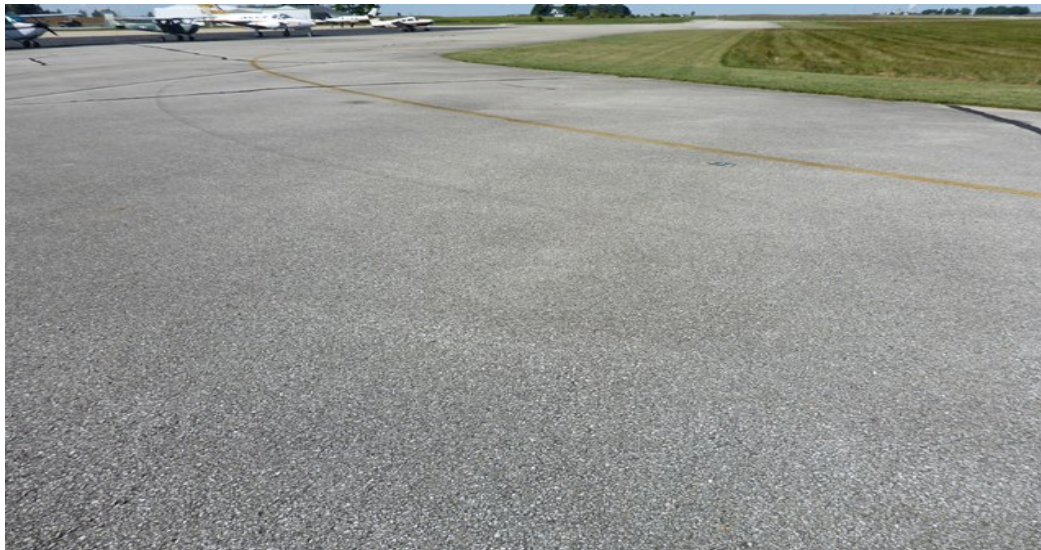
DISTRESS TYPE	SEVERITY	MEASURED QUANTITY	ESTIMATED TOTAL QUANTITY	UNITS	PERCENTAGE OF All DISTRESS
LONG.& TRANS. CRACK	MED	9	10	L.F.	26
LONG.& TRANS. CRACK	LOW	126	153	L.F.	57.8
WEATHERING	LOW	1,300	1,582	S.F.	16

APPROXIMATE AMOUNT OF DISTRESS RELATED TO LOAD ON THE PAVEMENT IS:	0 %
APPROXIMATE AMOUNT OF DISTRESS RELATED TO MATERIALS PROBLEMS IN THE FEATURE IS:	61 %
APPROXIMATE AMOUNT OF DISTRESS RELATED TO AGE OF PAVEMENT AND TRAFFIC REPETITIONS IS:	39 %

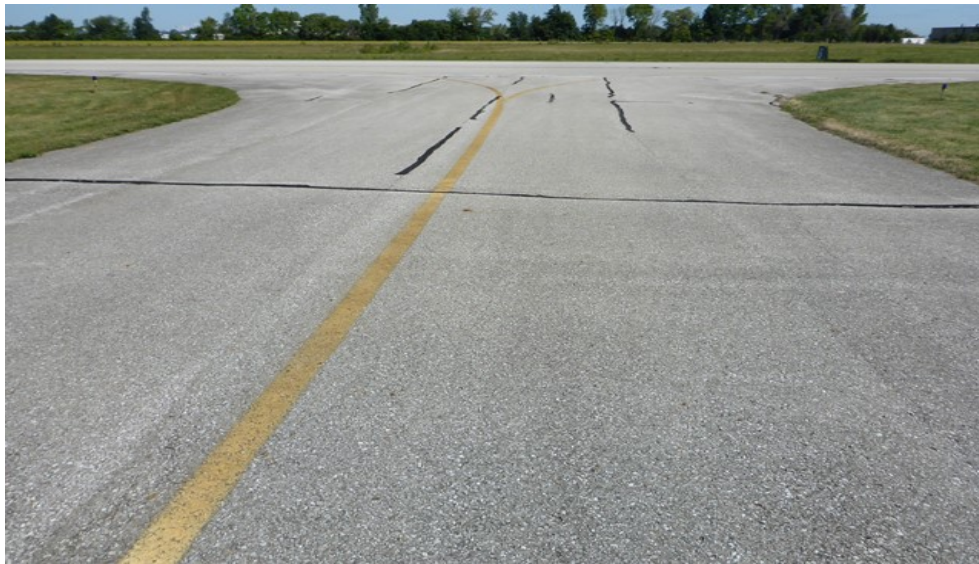
DISTRESS TYPE	SEVERITY	MEASURED QUANTITY	ESTIMATED TOTAL QUANTITY	UNITS	PERCENTAGE OF All DISTRESS
LONG.& TRANS. CRACK	HIGH	35	38	L.F.	31.3
LONG.& TRANS. CRACK	MED	83	90	L.F.	24.9
LONG.& TRANS. CRACK	LOW	434	475	L.F.	36.3
WEATHERING	LOW	2,800	3,066	S.F.	7.3

APPROXIMATE AMOUNT OF DISTRESS RELATED TO LOAD ON THE PAVEMENT IS:	0 %
APPROXIMATE AMOUNT OF DISTRESS RELATED TO MATERIALS PROBLEMS IN THE FEATURE IS:	64 %
APPROXIMATE AMOUNT OF DISTRESS RELATED TO AGE OF PAVEMENT AND TRAFFIC REPETITIONS IS:	36 %

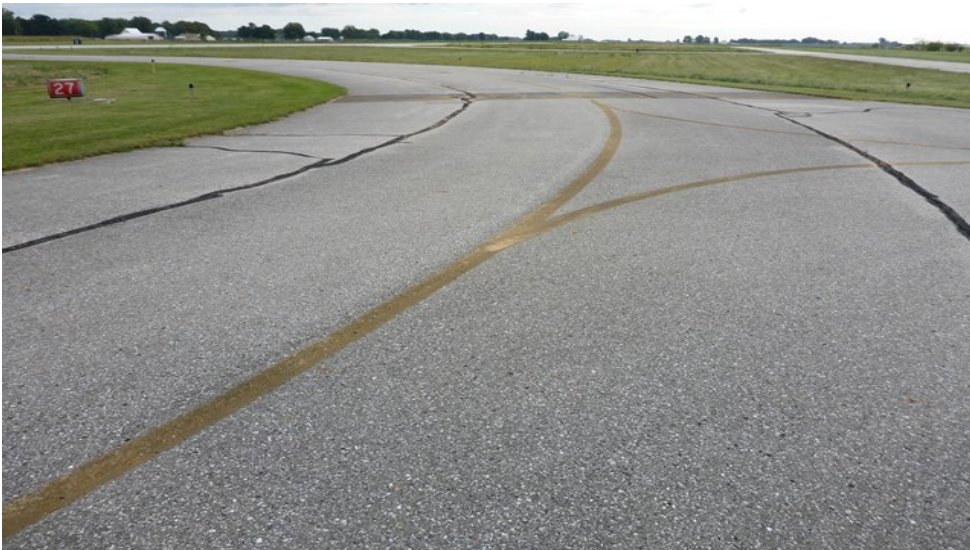
DISTRESS TYPE	SEVERITY	MEASURED QUANTITY	ESTIMATED TOTAL QUANTITY	UNITS	PERCENTAGE OF ALL DISTRESS
DEPRESSION	LOW	68	142	S.F.	6.5
LONG.& TRANS. CRACK	MED	156	326	L.F.	27.1
LONG.& TRANS. CRACK	LOW	1,109	2,319	L.F.	51.6
SWELL	LOW	80	167	S.F.	4
WEATHERING	LOW	8,000	16,732	S.F.	10.6

APPROXIMATE AMOUNT OF DISTRESS RELATED TO LOAD ON THE PAVEMENT IS:	0 %
APPROXIMATE AMOUNT OF DISTRESS RELATED TO MATERIALS PROBLEMS IN THE FEATURE IS:	67 %
APPROXIMATE AMOUNT OF DISTRESS RELATED TO AGE OF PAVEMENT AND TRAFFIC REPETITIONS IS:	33 %

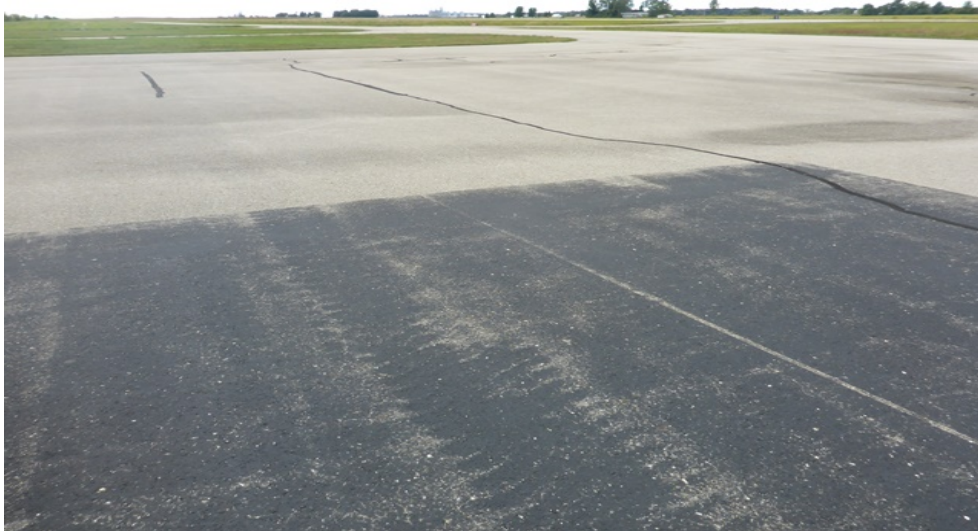
DISTRESS TYPE	SEVERITY	MEASURED QUANTITY	ESTIMATED TOTAL QUANTITY	UNITS	PERCENTAGE OF All DISTRESS
ALLIGATOR CRACKING	LOW	27	57	S.F.	9.5
DEPRESSION	LOW	75	158	S.F.	5
LONG.& TRANS. CRACK	HIGH	158	333	L.F.	26.4
LONG.& TRANS. CRACK	MED	253	534	L.F.	27.8
LONG.& TRANS. CRACK	LOW	625	1,319	L.F.	23.7
WEATHERING	LOW	6,500	13,721	S.F.	7.3

APPROXIMATE AMOUNT OF DISTRESS RELATED TO LOAD ON THE PAVEMENT IS: 10 %
 APPROXIMATE AMOUNT OF DISTRESS RELATED TO MATERIALS PROBLEMS IN THE FEATURE IS: 60 %
 APPROXIMATE AMOUNT OF DISTRESS RELATED TO AGE OF PAVEMENT AND TRAFFIC REPETITIONS IS: 31 %

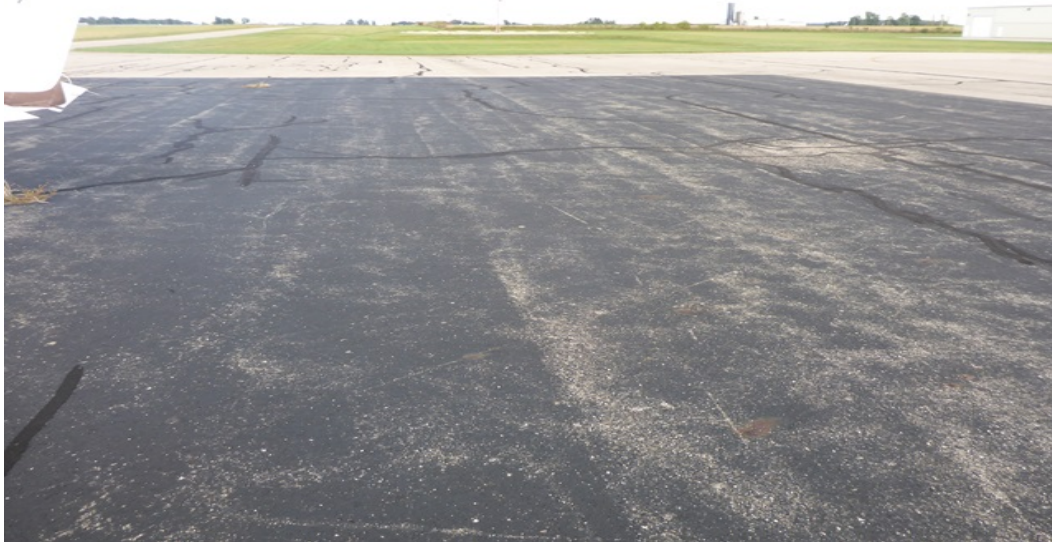
DISTRESS TYPE	SEVERITY	MEASURED QUANTITY	ESTIMATED TOTAL QUANTITY	UNITS	PERCENTAGE OF All DISTRESS
LONG.& TRANS. CRACK	HIGH	17	30	L.F.	16.6
LONG.& TRANS. CRACK	MED	42	74	L.F.	12.3
LONG.& TRANS. CRACK	LOW	1,631	2,876	L.F.	68.8
WEATHERING	LOW	1,150	2,028	S.F.	2.1

APPROXIMATE AMOUNT OF DISTRESS RELATED TO LOAD ON THE PAVEMENT IS:	0 %
APPROXIMATE AMOUNT OF DISTRESS RELATED TO MATERIALS PROBLEMS IN THE FEATURE IS:	66 %
APPROXIMATE AMOUNT OF DISTRESS RELATED TO AGE OF PAVEMENT AND TRAFFIC REPETITIONS IS:	34 %

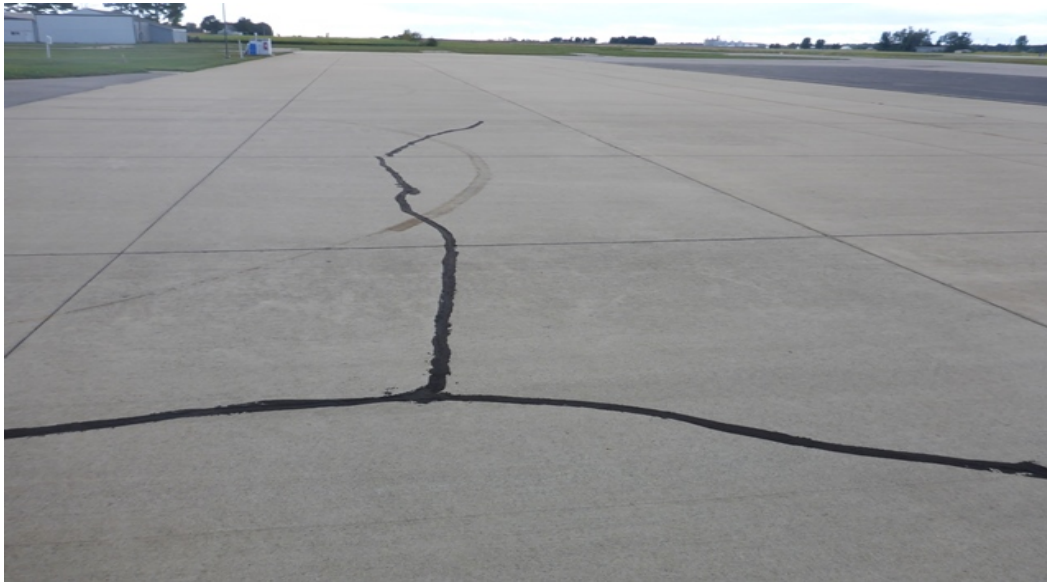
DISTRESS TYPE	SEVERITY	MEASURED QUANTITY	ESTIMATED TOTAL QUANTITY	UNITS	PERCENTAGE OF All DISTRESS
LONG/TRAN/DIAG CRK.	LOW	2	2	SLABS	57.9
SPALLING-CORNERS	MED	1	1	SLABS	26.2
SPALLING-CORNERS	LOW	1	1	SLABS	15.8

APPROXIMATE AMOUNT OF DISTRESS RELATED TO LOAD ON THE PAVEMENT IS:	33 %
APPROXIMATE AMOUNT OF DISTRESS RELATED TO MATERIALS PROBLEMS IN THE FEATURE IS:	14 %
APPROXIMATE AMOUNT OF DISTRESS RELATED TO AGE OF PAVEMENT AND TRAFFIC REPETITIONS IS:	53 %

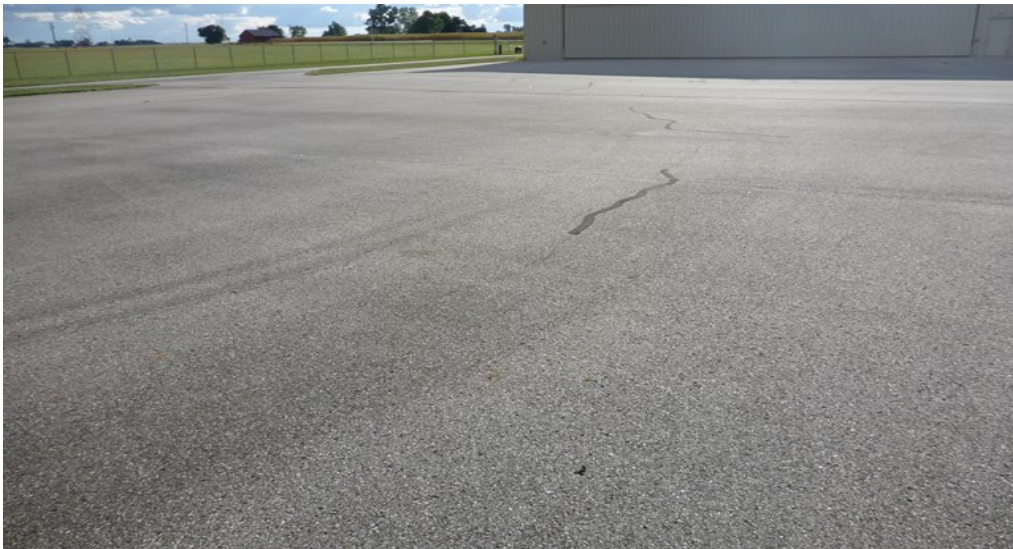
DISTRESS TYPE	SEVERITY	MEASURED QUANTITY	ESTIMATED TOTAL QUANTITY	UNITS	PERCENTAGE OF All DISTRESS
LONG.& TRANS. CRACK	LOW	700	1,330	L.F.	69.3
RUTTING	LOW	2	3	S.F.	13.5
WEATHERING	MED	30	57	S.F.	.8
WEATHERING	LOW	4,600	8,740	S.F.	16.2

APPROXIMATE AMOUNT OF DISTRESS RELATED TO LOAD ON THE PAVEMENT IS:	9 %
APPROXIMATE AMOUNT OF DISTRESS RELATED TO MATERIALS PROBLEMS IN THE FEATURE IS:	56 %
APPROXIMATE AMOUNT OF DISTRESS RELATED TO AGE OF PAVEMENT AND TRAFFIC REPETITIONS IS:	34 %

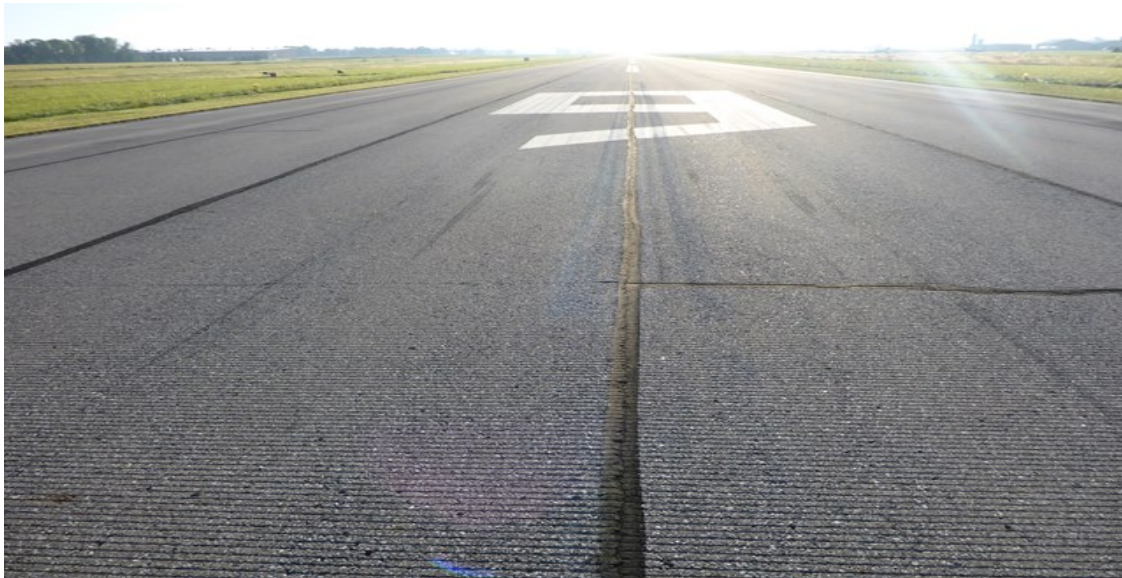
DISTRESS TYPE	SEVERITY	MEASURED QUANTITY	ESTIMATED TOTAL QUANTITY	UNITS	PERCENTAGE OF All DISTRESS
LONG.& TRANS. CRACK	MED	1,083	6,860	L.F.	39
LONG.& TRANS. CRACK	LOW	3,367	21,328	L.F.	46.9
SWELL	LOW	95	601	S.F.	1.6
WEATHERING	MED	1,900	12,035	S.F.	5.7
WEATHERING	LOW	12,460	78,930	S.F.	6.5

APPROXIMATE AMOUNT OF DISTRESS RELATED TO LOAD ON THE PAVEMENT IS:	0 %
APPROXIMATE AMOUNT OF DISTRESS RELATED TO MATERIALS PROBLEMS IN THE FEATURE IS:	63 %
APPROXIMATE AMOUNT OF DISTRESS RELATED TO AGE OF PAVEMENT AND TRAFFIC REPETITIONS IS:	37 %

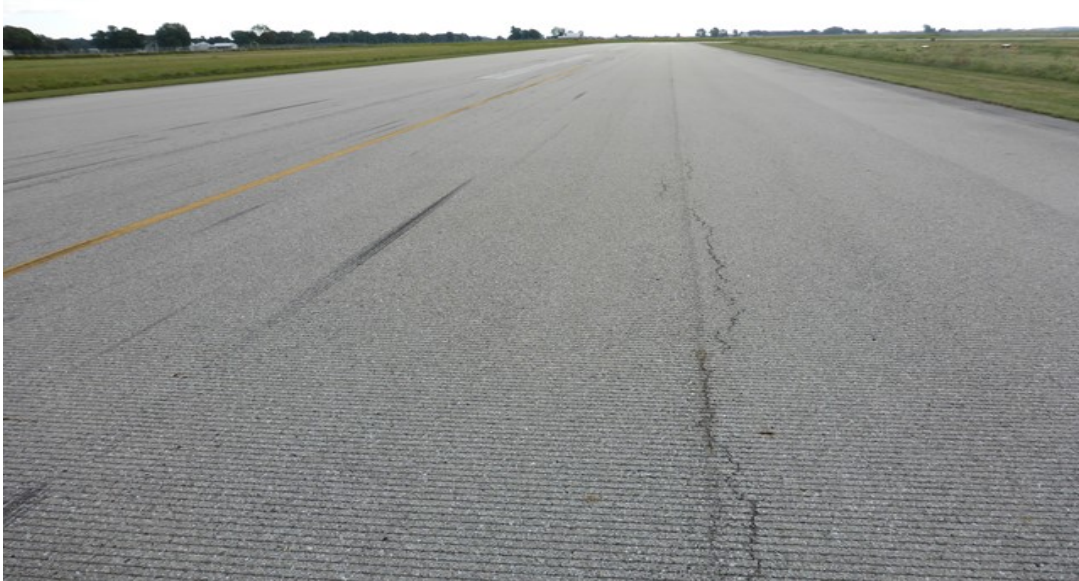
DISTRESS TYPE	SEVERITY	MEASURED QUANTITY	ESTIMATED TOTAL QUANTITY	UNITS	PERCENTAGE OF All DISTRESS
LONG.& TRANS. CRACK	MED	33	97	L.F.	22.2
LONG.& TRANS. CRACK	LOW	614	1,806	L.F.	77.7

APPROXIMATE AMOUNT OF DISTRESS RELATED TO LOAD ON THE PAVEMENT IS:	0 %
APPROXIMATE AMOUNT OF DISTRESS RELATED TO MATERIALS PROBLEMS IN THE FEATURE IS:	67 %
APPROXIMATE AMOUNT OF DISTRESS RELATED TO AGE OF PAVEMENT AND TRAFFIC REPETITIONS IS:	33 %
