Pavement Condition Report

Marion Municipal Airport

Project 16801839

January 2016

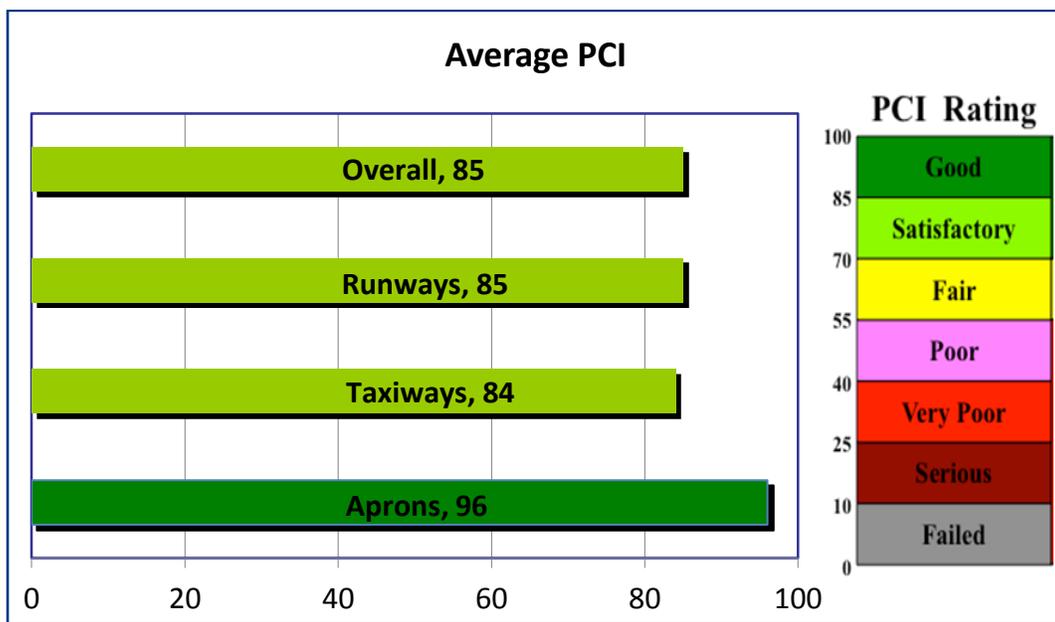
The average inspected Pavement Condition Index (PCI) for all the airfield pavements was 85. Runways had an average inspected PCI of 85 and were above the desired MSL of 60. Taxiways had an average inspected PCI of 84, and ramps had an average inspected PCI of 96.

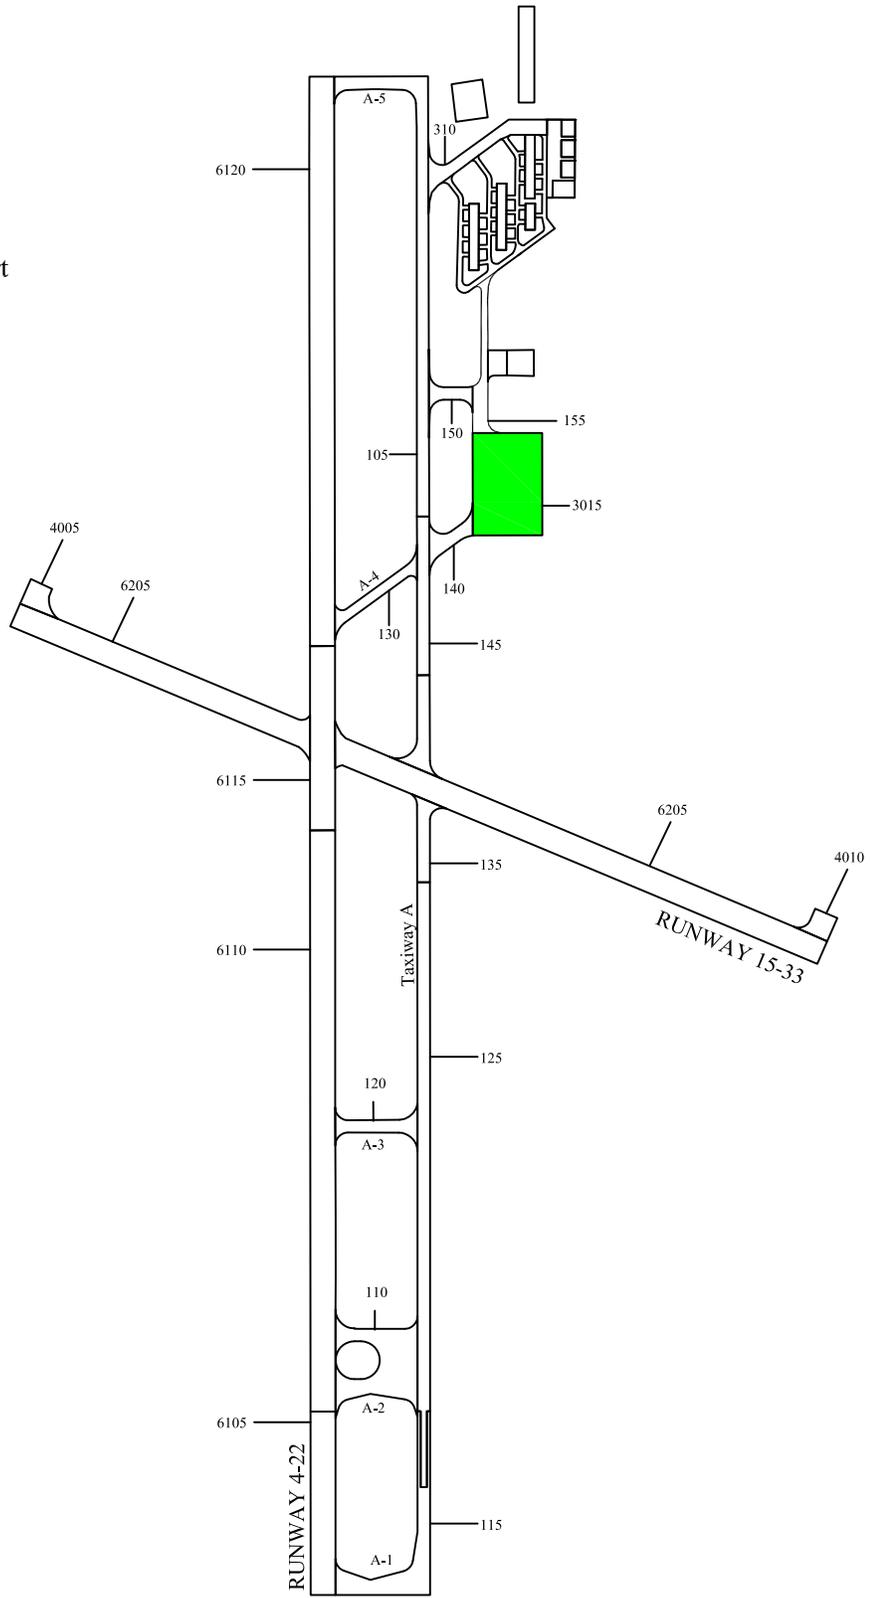
Marion Municipal Airport
2015 PCI Inspection

Analysis of potential maintenance projects identified approximately 100 square feet of patching needs, at an estimated total cost of approximately \$1,300. Specific recommendations to help prioritize airfield maintenance are found in chapter 4 of this report. A summary of all identified maintenance needs is shown in the table below and in the figure on the following page.

Work Item	Quantity	Unit	Cost
PCC PATCH	77	SF	\$1,296
Total:			\$1,296

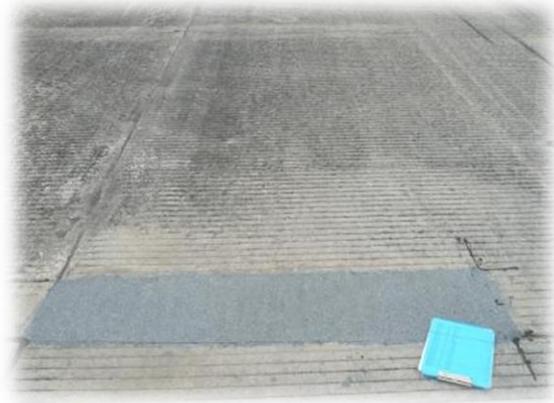
Patches, Large and Small

Large and small patches, by PCI inspection criteria, are distress conditions. Patches indicate deterioration and aging of pavement that contributes to shortened service life. However, patching also indicates that pavement is being maintained.

A patch that is performing well and shows no outward distress is recorded at low severity, and no corrective action is required. Medium-severity patches are serviceable but are beginning to deteriorate. Maintenance or replacement is indicated. At high severity, replacement is indicated.

By definition, small patches are smaller than 5 square feet in surface area, and they usually result from spall repair at slab joints and corners.

Large patches also may be the result of spall repair, but they often indicate more serious deficiencies, such as corner breaks or other full-depth failure smaller than panel size.

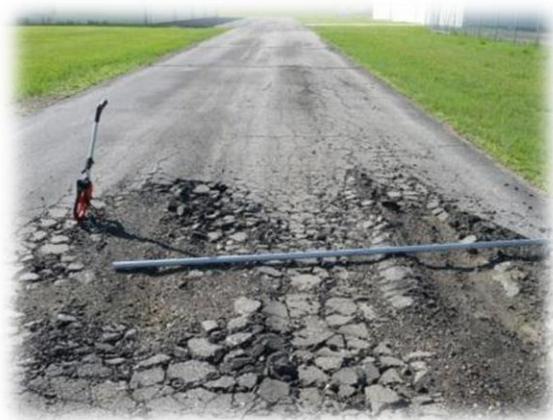
Alligator Cracking

Alligator cracks are a series of interconnected load-related cracks caused by fatigue of the asphalt surface. Alligator cracking is a significant structural distress and develops only in places subject to traffic loads. These cracks typically initiate at the bottom of the asphalt layer and propagate upward. Once a fatigue crack is visible at the surface, significant damage has already occurred.

At low severity, alligator cracks are evidenced by a series of parallel hairline cracks (usually in a wheel path). Medium-severity alligator cracking is a well-defined pattern of interconnected cracks, and some spalling may be present. High-severity alligator cracks have lost aggregate interlock between adjacent pieces, and the cracks may be severely spalled with FOD potential. Most likely, the pieces will move freely under traffic.

Alligator cracking is a serious structural failure that cannot be repaired with sealant. The proper repair is patching.

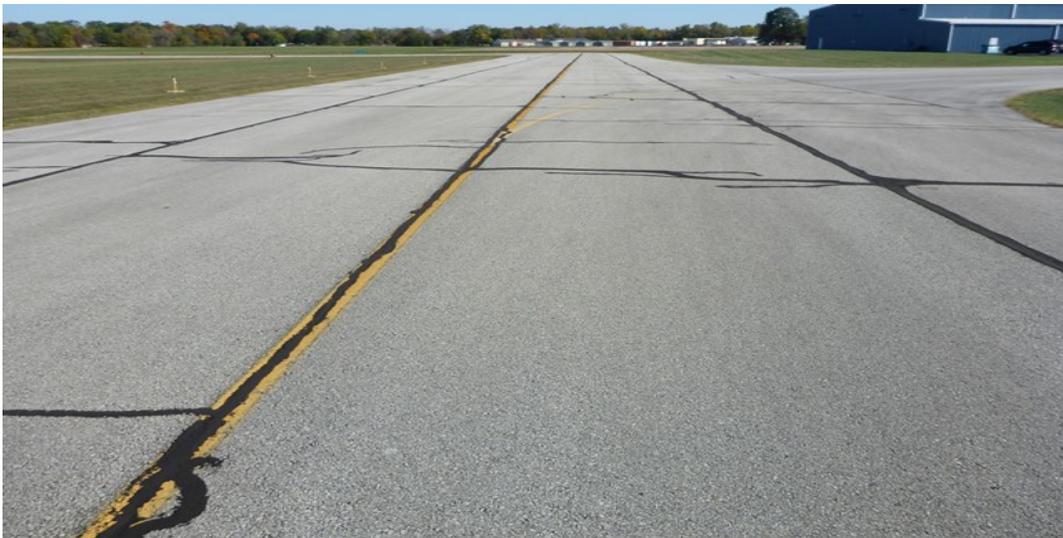
DISTRESS TYPE	SEVERITY	MEASURED QUANTITY	ESTIMATED TOTAL QUANTITY	UNITS	PERCENTAGE OF All DISTRESS
ALLIGATOR CRACKING	LOW	6	17	S.F.	3.5
LONG.& TRANS. CRACK	LOW	4,615	13,216	L.F.	83.5
RUTTING	LOW	75	214	S.F.	7.8
WEATHERING	MED	100	286	S.F.	.3
WEATHERING	LOW	4,200	12,027	S.F.	4.6

APPROXIMATE AMOUNT OF DISTRESS RELATED TO LOAD ON THE PAVEMENT IS:	9 %
APPROXIMATE AMOUNT OF DISTRESS RELATED TO MATERIALS PROBLEMS IN THE FEATURE IS:	60 %
APPROXIMATE AMOUNT OF DISTRESS RELATED TO AGE OF PAVEMENT AND TRAFFIC REPETITIONS IS:	31 %

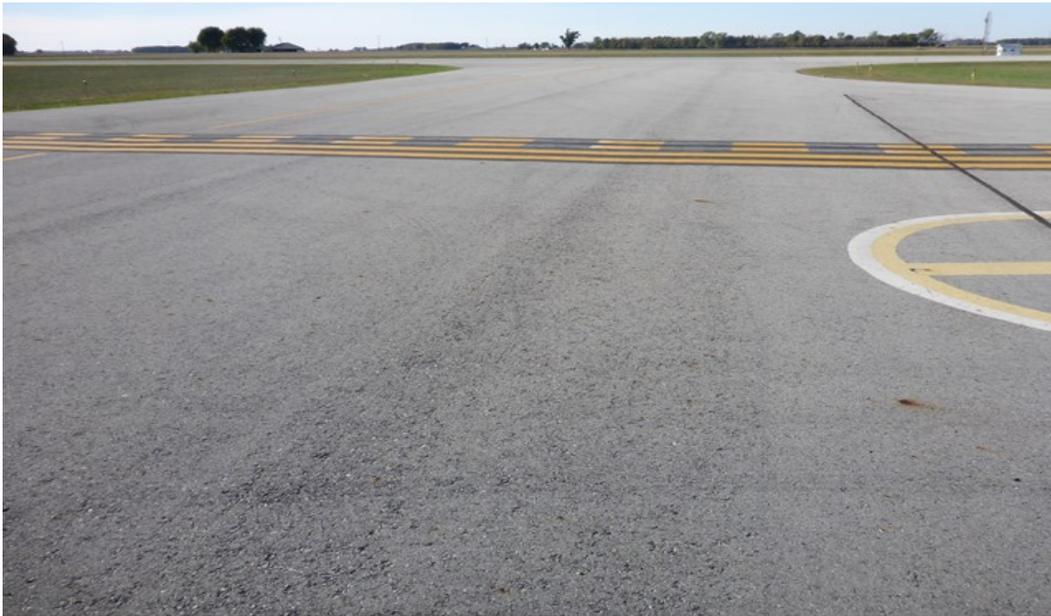
DISTRESS TYPE	SEVERITY	MEASURED QUANTITY	ESTIMATED TOTAL QUANTITY	UNITS	PERCENTAGE OF All DISTRESS
LONG.& TRANS. CRACK	LOW	162	538	L.F.	82.9
WEATHERING	LOW	600	1,992	S.F.	17

APPROXIMATE AMOUNT OF DISTRESS RELATED TO LOAD ON THE PAVEMENT IS:	0 %
APPROXIMATE AMOUNT OF DISTRESS RELATED TO MATERIALS PROBLEMS IN THE FEATURE IS:	61 %
APPROXIMATE AMOUNT OF DISTRESS RELATED TO AGE OF PAVEMENT AND TRAFFIC REPETITIONS IS:	39 %

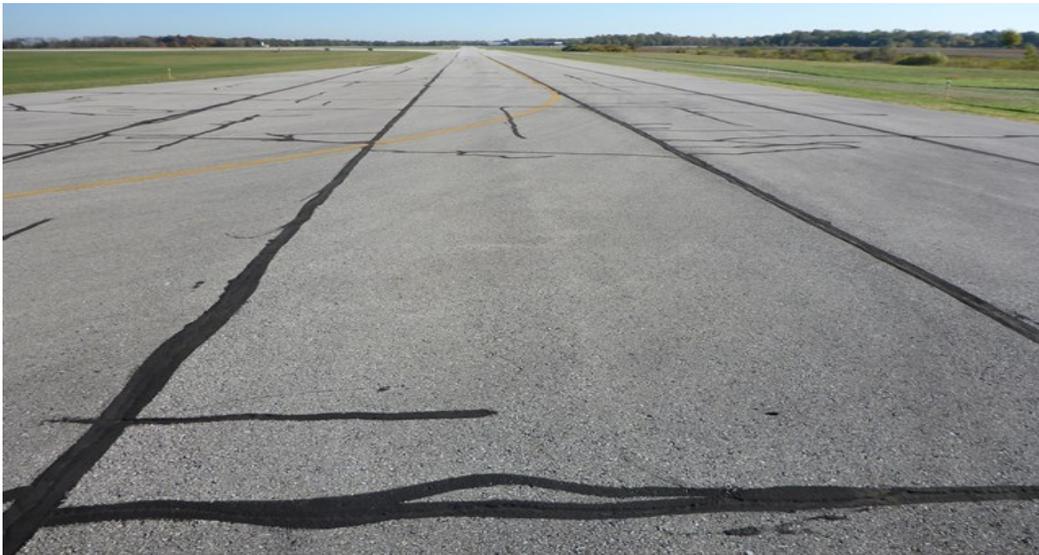
DISTRESS TYPE	SEVERITY	MEASURED QUANTITY	ESTIMATED TOTAL QUANTITY	UNITS	PERCENTAGE OF All DISTRESS
LONG.& TRANS. CRACK	LOW	3,620	7,967	L.F.	92
WEATHERING	HIGH	15	33	S.F.	2.8
WEATHERING	MED	60	132	S.F.	.2
WEATHERING	LOW	3,050	6,712	S.F.	4.8

APPROXIMATE AMOUNT OF DISTRESS RELATED TO LOAD ON THE PAVEMENT IS:	0 %
APPROXIMATE AMOUNT OF DISTRESS RELATED TO MATERIALS PROBLEMS IN THE FEATURE IS:	64 %
APPROXIMATE AMOUNT OF DISTRESS RELATED TO AGE OF PAVEMENT AND TRAFFIC REPETITIONS IS:	36 %

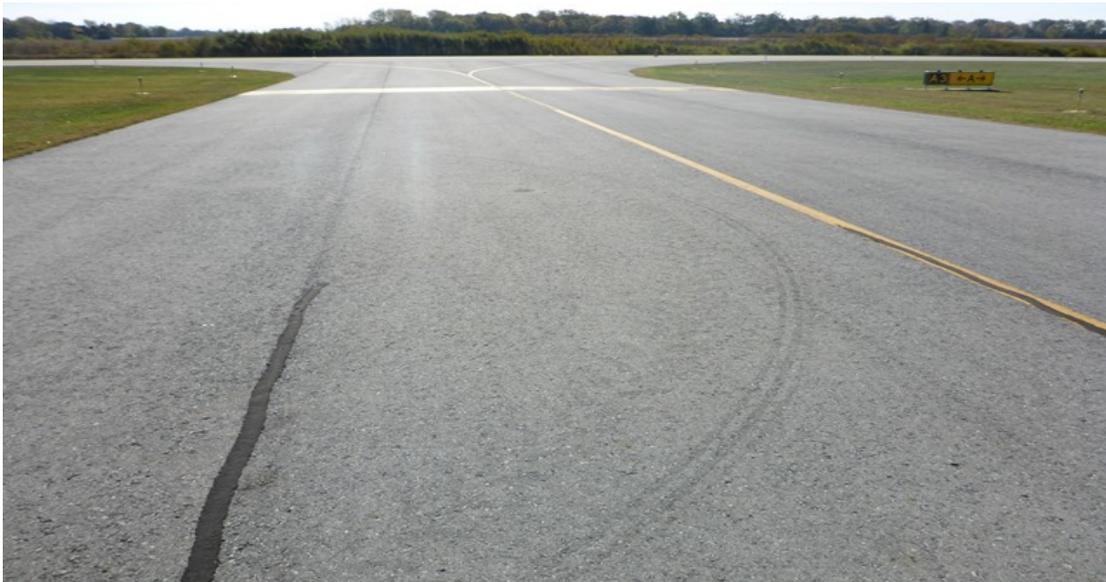
DISTRESS TYPE	SEVERITY	MEASURED QUANTITY	ESTIMATED TOTAL QUANTITY	UNITS	PERCENTAGE OF All DISTRESS
LONG.& TRANS. CRACK	LOW	553	726	L.F.	100

APPROXIMATE AMOUNT OF DISTRESS RELATED TO LOAD ON THE PAVEMENT IS:	0 %
APPROXIMATE AMOUNT OF DISTRESS RELATED TO MATERIALS PROBLEMS IN THE FEATURE IS:	67 %
APPROXIMATE AMOUNT OF DISTRESS RELATED TO AGE OF PAVEMENT AND TRAFFIC REPETITIONS IS:	33 %

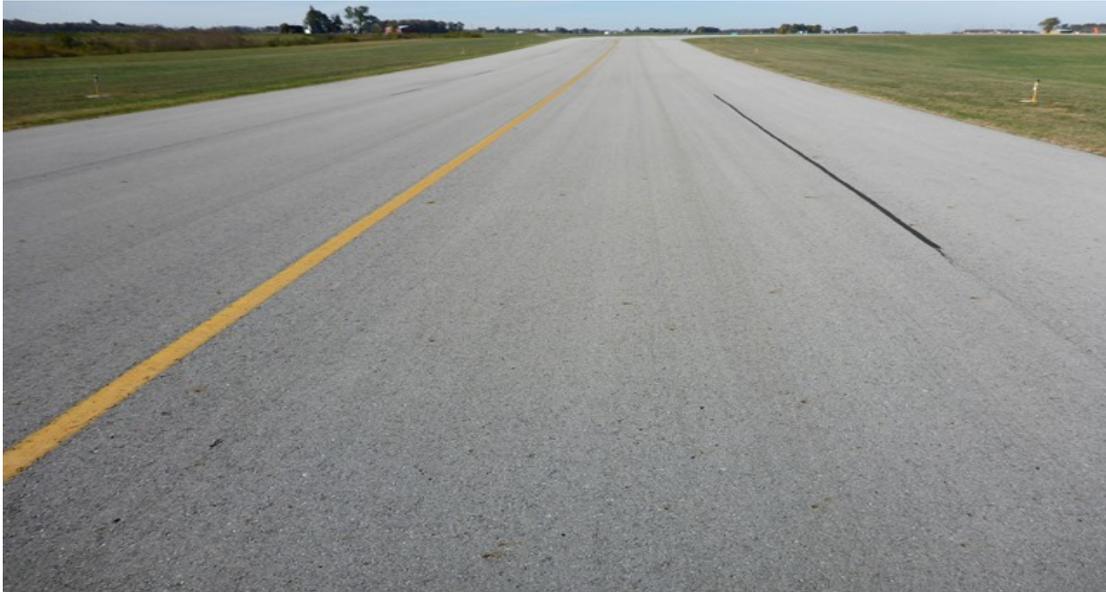
DISTRESS TYPE	SEVERITY	MEASURED QUANTITY	ESTIMATED TOTAL QUANTITY	UNITS	PERCENTAGE OF All DISTRESS
LONG.& TRANS. CRACK	LOW	882	3,601	L.F.	100

APPROXIMATE AMOUNT OF DISTRESS RELATED TO LOAD ON THE PAVEMENT IS:	0 %
APPROXIMATE AMOUNT OF DISTRESS RELATED TO MATERIALS PROBLEMS IN THE FEATURE IS:	67 %
APPROXIMATE AMOUNT OF DISTRESS RELATED TO AGE OF PAVEMENT AND TRAFFIC REPETITIONS IS:	33 %

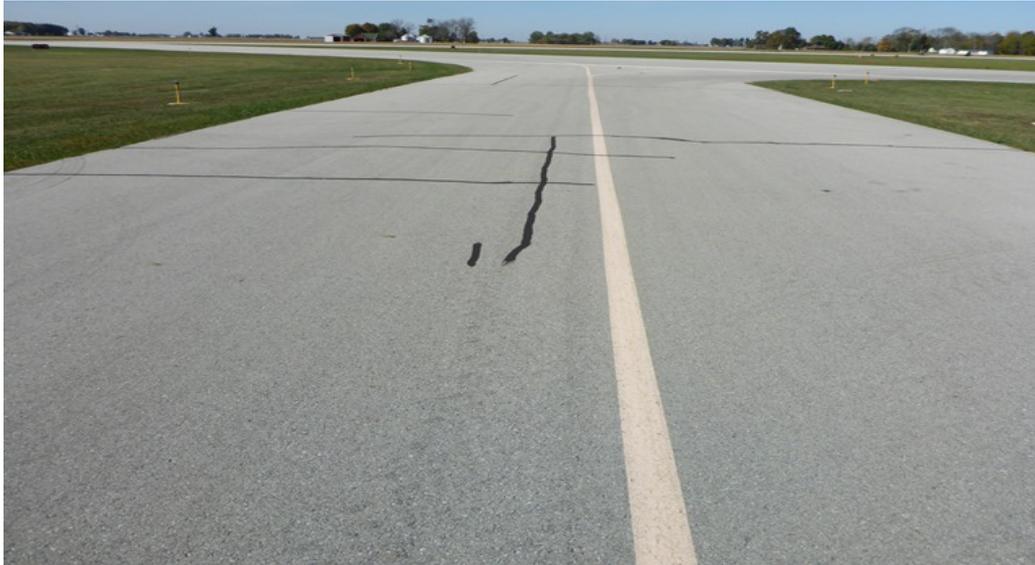
DISTRESS TYPE	SEVERITY	MEASURED QUANTITY	ESTIMATED TOTAL QUANTITY	UNITS	PERCENTAGE OF All DISTRESS
LONG.& TRANS. CRACK	LOW	320	716	L.F.	100

APPROXIMATE AMOUNT OF DISTRESS RELATED TO LOAD ON THE PAVEMENT IS:	0 %
APPROXIMATE AMOUNT OF DISTRESS RELATED TO MATERIALS PROBLEMS IN THE FEATURE IS:	67 %
APPROXIMATE AMOUNT OF DISTRESS RELATED TO AGE OF PAVEMENT AND TRAFFIC REPETITIONS IS:	33 %

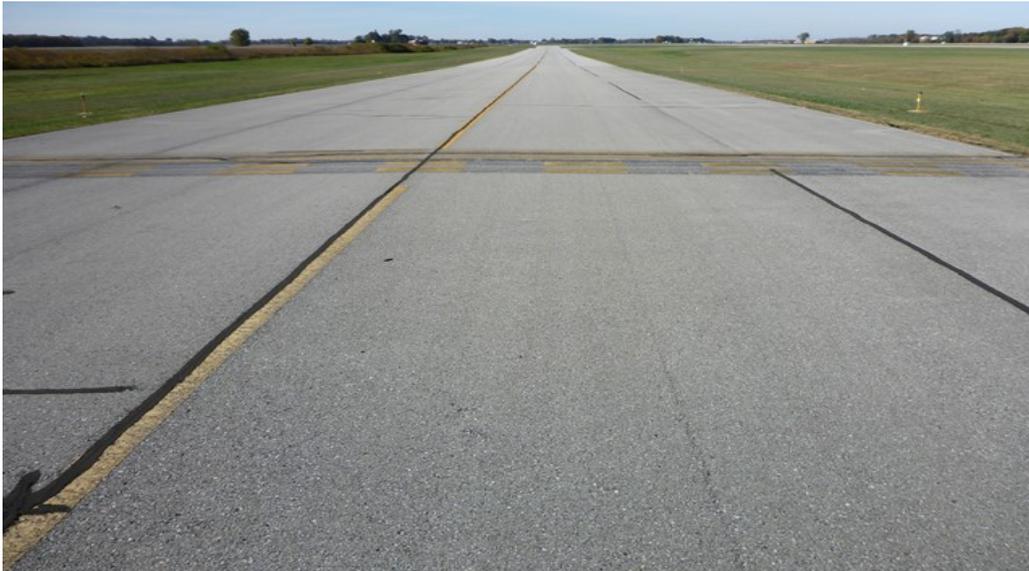
DISTRESS TYPE	SEVERITY	MEASURED QUANTITY	ESTIMATED TOTAL QUANTITY	UNITS	PERCENTAGE OF All DISTRESS
LONG.& TRANS. CRACK	LOW	1,490	3,031	L.F.	100

APPROXIMATE AMOUNT OF DISTRESS RELATED TO LOAD ON THE PAVEMENT IS:	0 %
APPROXIMATE AMOUNT OF DISTRESS RELATED TO MATERIALS PROBLEMS IN THE FEATURE IS:	67 %
APPROXIMATE AMOUNT OF DISTRESS RELATED TO AGE OF PAVEMENT AND TRAFFIC REPETITIONS IS:	33 %

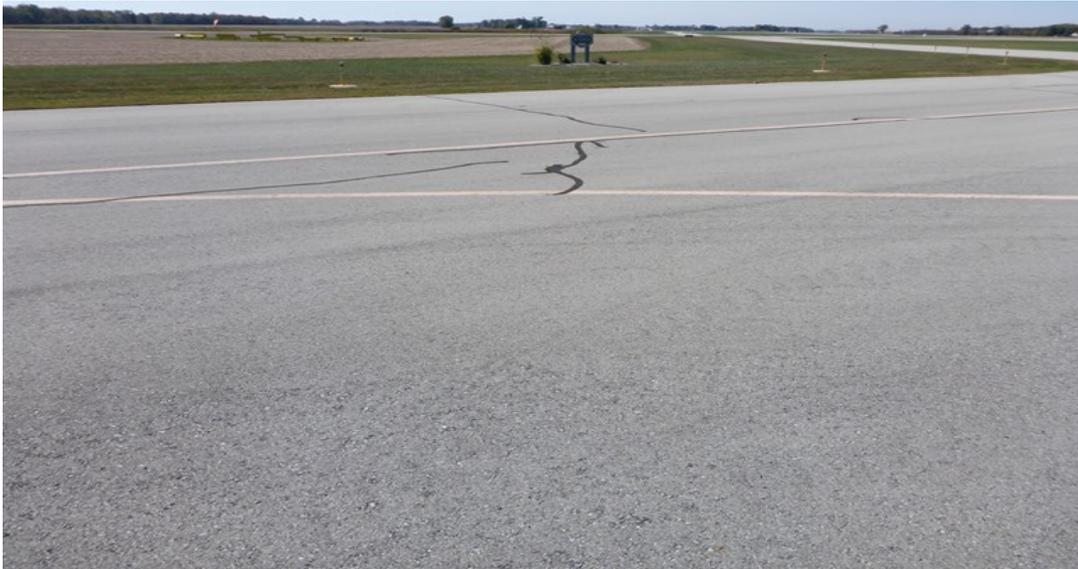
DISTRESS TYPE	SEVERITY	MEASURED QUANTITY	ESTIMATED TOTAL QUANTITY	UNITS	PERCENTAGE OF ALL DISTRESS
LONG.& TRANS. CRACK	LOW	458	654	L.F.	100

APPROXIMATE AMOUNT OF DISTRESS RELATED TO LOAD ON THE PAVEMENT IS:	0 %
APPROXIMATE AMOUNT OF DISTRESS RELATED TO MATERIALS PROBLEMS IN THE FEATURE IS:	67 %
APPROXIMATE AMOUNT OF DISTRESS RELATED TO AGE OF PAVEMENT AND TRAFFIC REPETITIONS IS:	33 %

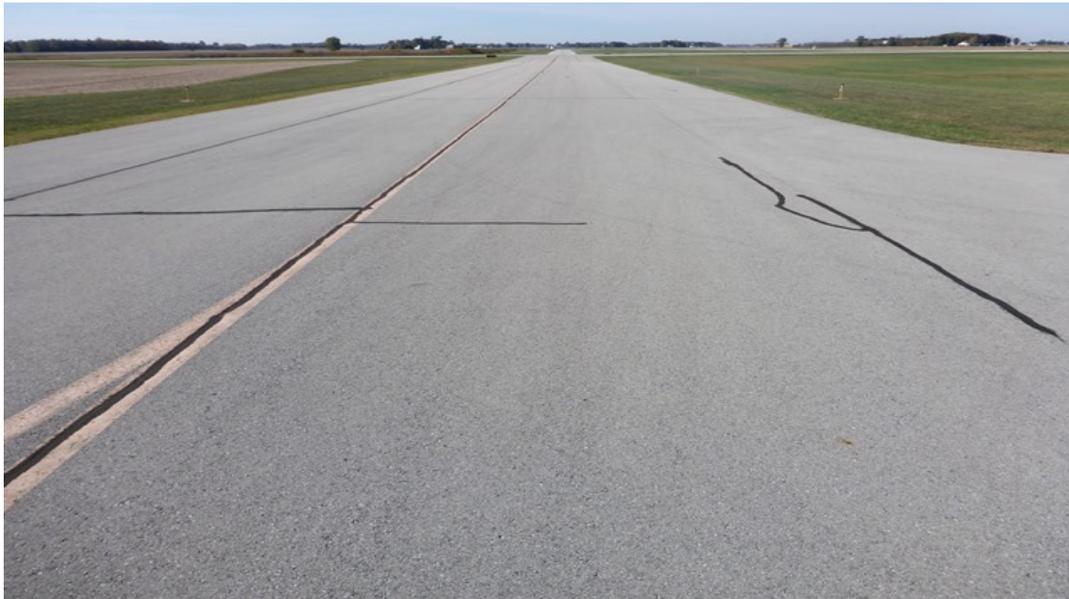
DISTRESS TYPE	SEVERITY	MEASURED QUANTITY	ESTIMATED TOTAL QUANTITY	UNITS	PERCENTAGE OF All DISTRESS
LONG.& TRANS. CRACK	LOW	1,062	2,190	L.F.	100

APPROXIMATE AMOUNT OF DISTRESS RELATED TO LOAD ON THE PAVEMENT IS:	0 %
APPROXIMATE AMOUNT OF DISTRESS RELATED TO MATERIALS PROBLEMS IN THE FEATURE IS:	67 %
APPROXIMATE AMOUNT OF DISTRESS RELATED TO AGE OF PAVEMENT AND TRAFFIC REPETITIONS IS:	33 %

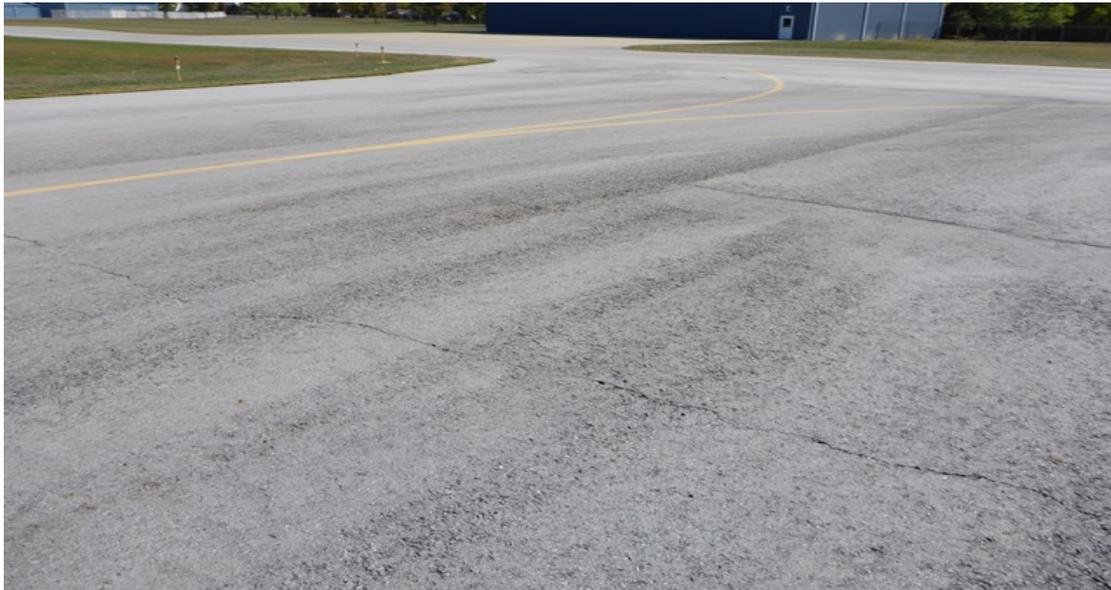
DISTRESS TYPE	SEVERITY	MEASURED QUANTITY	ESTIMATED TOTAL QUANTITY	UNITS	PERCENTAGE OF All DISTRESS
LONG.& TRANS. CRACK	LOW	207	271	L.F.	100

APPROXIMATE AMOUNT OF DISTRESS RELATED TO LOAD ON THE PAVEMENT IS:	0 %
APPROXIMATE AMOUNT OF DISTRESS RELATED TO MATERIALS PROBLEMS IN THE FEATURE IS:	67 %
APPROXIMATE AMOUNT OF DISTRESS RELATED TO AGE OF PAVEMENT AND TRAFFIC REPETITIONS IS:	33 %

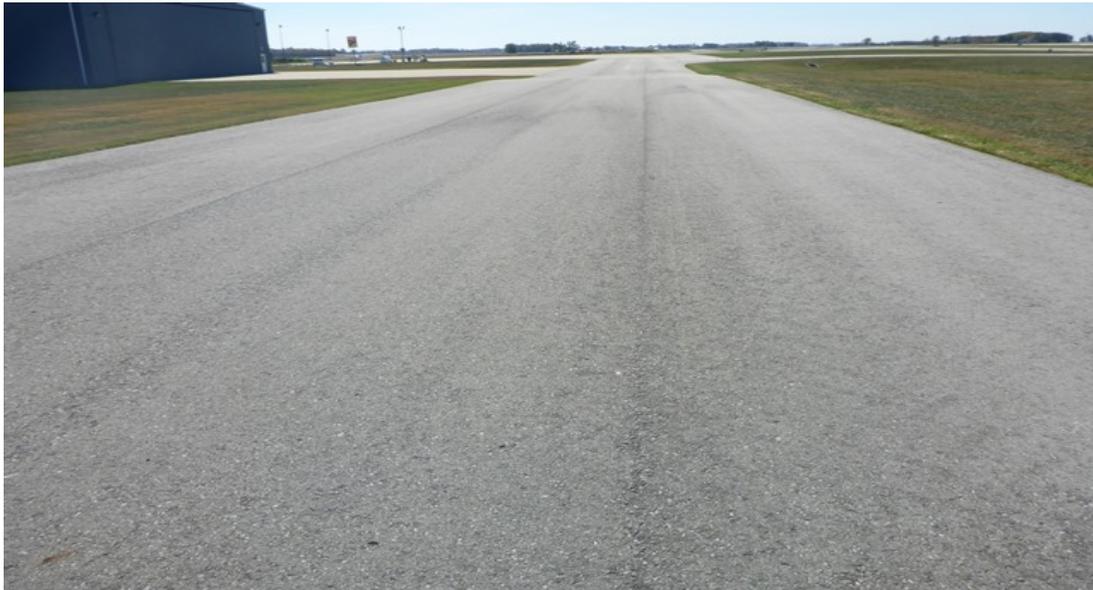
DISTRESS TYPE	SEVERITY	MEASURED QUANTITY	ESTIMATED TOTAL QUANTITY	UNITS	PERCENTAGE OF All DISTRESS
LONG.& TRANS. CRACK	LOW	71	136	L.F.	100

APPROXIMATE AMOUNT OF DISTRESS RELATED TO LOAD ON THE PAVEMENT IS:	0 %
APPROXIMATE AMOUNT OF DISTRESS RELATED TO MATERIALS PROBLEMS IN THE FEATURE IS:	67 %
APPROXIMATE AMOUNT OF DISTRESS RELATED TO AGE OF PAVEMENT AND TRAFFIC REPETITIONS IS:	33 %

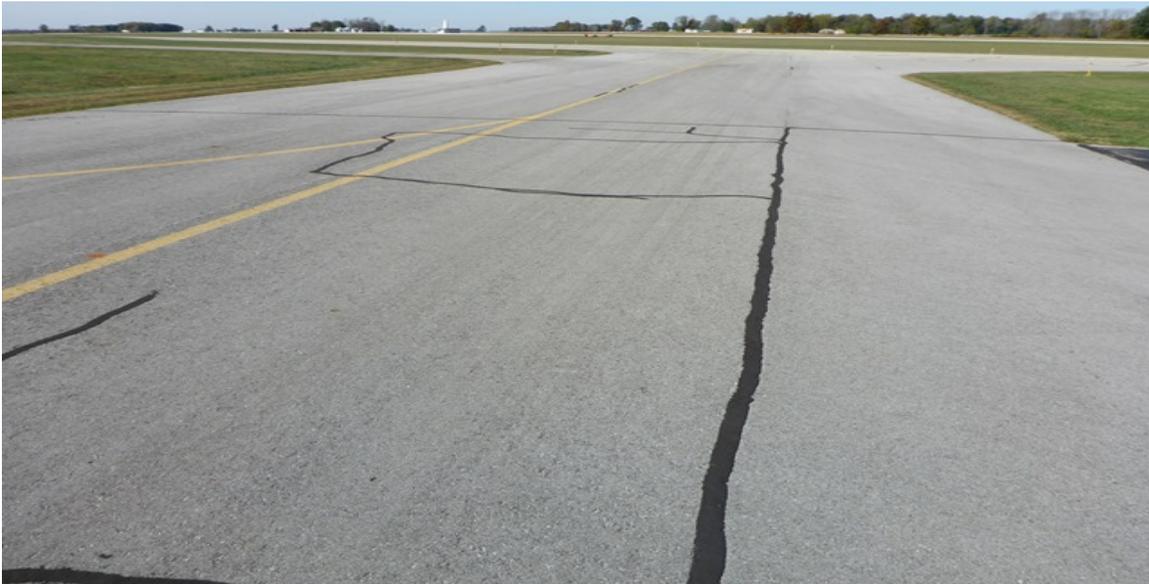
DISTRESS TYPE	SEVERITY	MEASURED QUANTITY	ESTIMATED TOTAL QUANTITY	UNITS	PERCENTAGE OF All DISTRESS
LONG.& TRANS. CRACK	LOW	318	719	L.F.	97.5
WEATHERING	LOW	200	452	S.F.	2.4

APPROXIMATE AMOUNT OF DISTRESS RELATED TO LOAD ON THE PAVEMENT IS:	0 %
APPROXIMATE AMOUNT OF DISTRESS RELATED TO MATERIALS PROBLEMS IN THE FEATURE IS:	66 %
APPROXIMATE AMOUNT OF DISTRESS RELATED TO AGE OF PAVEMENT AND TRAFFIC REPETITIONS IS:	34 %

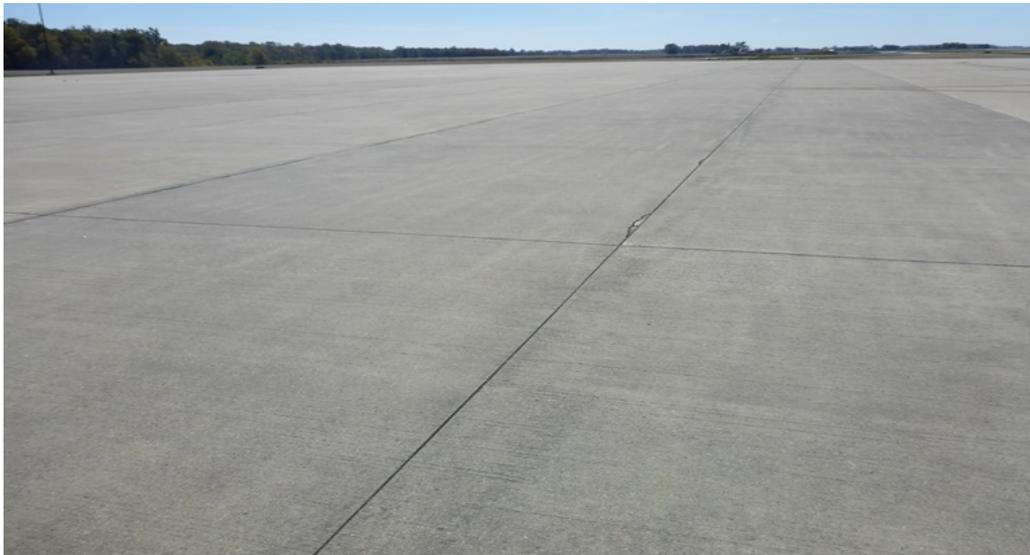
DISTRESS TYPE	SEVERITY	MEASURED QUANTITY	ESTIMATED TOTAL QUANTITY	UNITS	PERCENTAGE OF All DISTRESS
JOINT SEAL DAMAGE	LOW	20	74	SLABS	7.2
SETTLEMENT/FAULT	LOW	2	7	SLABS	29.3
SPALLING-JOINTS	MED	3	11	SLABS	39.5
SPALLING-CORNERS	LOW	3	11	SLABS	23.9

APPROXIMATE AMOUNT OF DISTRESS RELATED TO LOAD ON THE PAVEMENT IS:	54 %
APPROXIMATE AMOUNT OF DISTRESS RELATED TO MATERIALS PROBLEMS IN THE FEATURE IS:	20 %
APPROXIMATE AMOUNT OF DISTRESS RELATED TO AGE OF PAVEMENT AND TRAFFIC REPETITIONS IS:	26 %

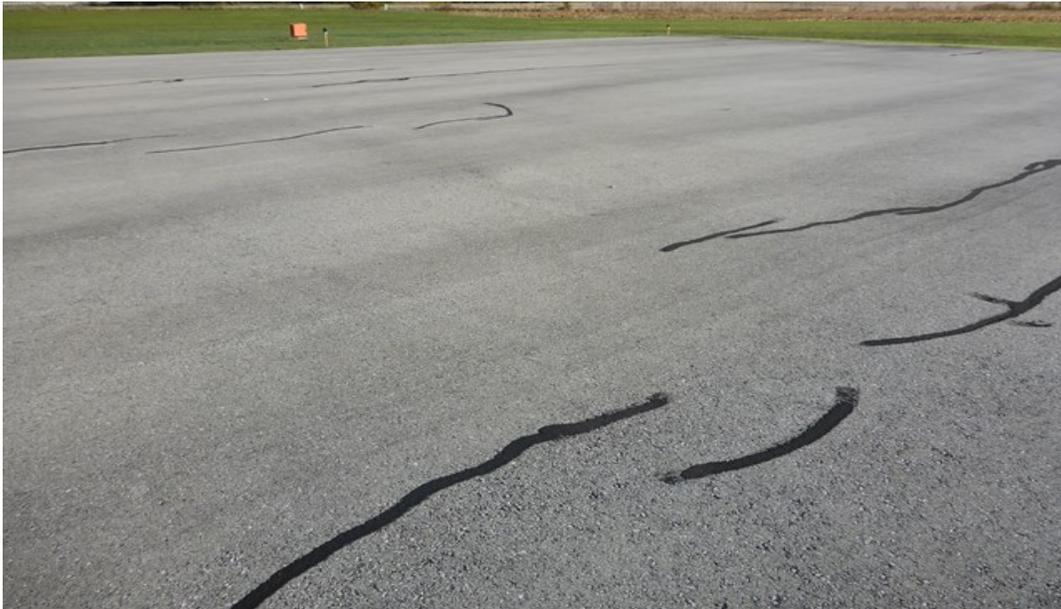
DISTRESS TYPE	SEVERITY	MEASURED QUANTITY	ESTIMATED TOTAL QUANTITY	UNITS	PERCENTAGE OF All DISTRESS
LONG.& TRANS. CRACK	LOW	255	299	L.F.	100

APPROXIMATE AMOUNT OF DISTRESS RELATED TO LOAD ON THE PAVEMENT IS:	0 %
APPROXIMATE AMOUNT OF DISTRESS RELATED TO MATERIALS PROBLEMS IN THE FEATURE IS:	67 %
APPROXIMATE AMOUNT OF DISTRESS RELATED TO AGE OF PAVEMENT AND TRAFFIC REPETITIONS IS:	33 %

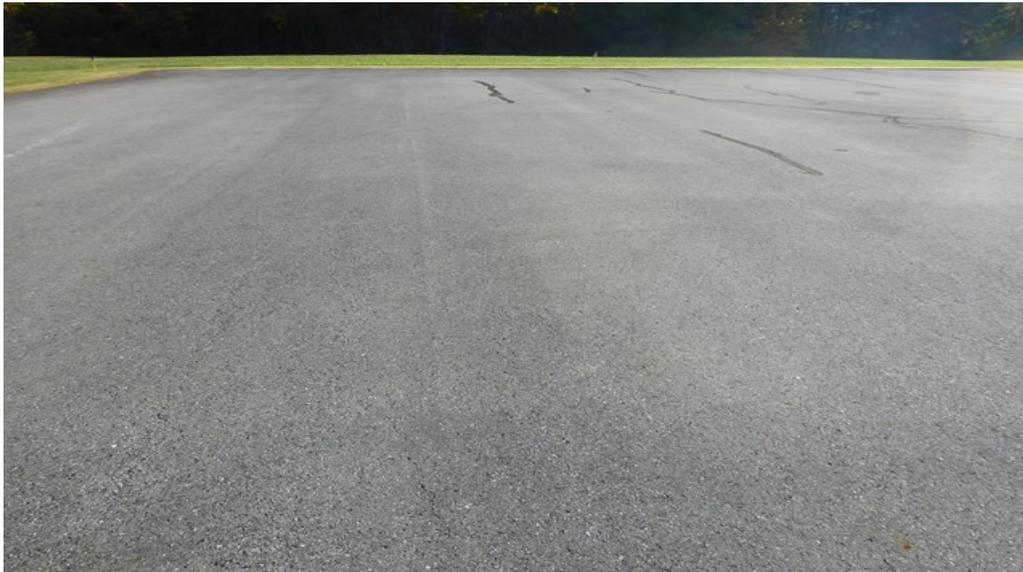
DISTRESS TYPE	SEVERITY	MEASURED QUANTITY	ESTIMATED TOTAL QUANTITY	UNITS	PERCENTAGE OF All DISTRESS
LONG.& TRANS. CRACK	LOW	289	294	L.F.	89.2
WEATHERING	LOW	800	815	S.F.	10.7

APPROXIMATE AMOUNT OF DISTRESS RELATED TO LOAD ON THE PAVEMENT IS:	0 %
APPROXIMATE AMOUNT OF DISTRESS RELATED TO MATERIALS PROBLEMS IN THE FEATURE IS:	63 %
APPROXIMATE AMOUNT OF DISTRESS RELATED TO AGE OF PAVEMENT AND TRAFFIC REPETITIONS IS:	37 %

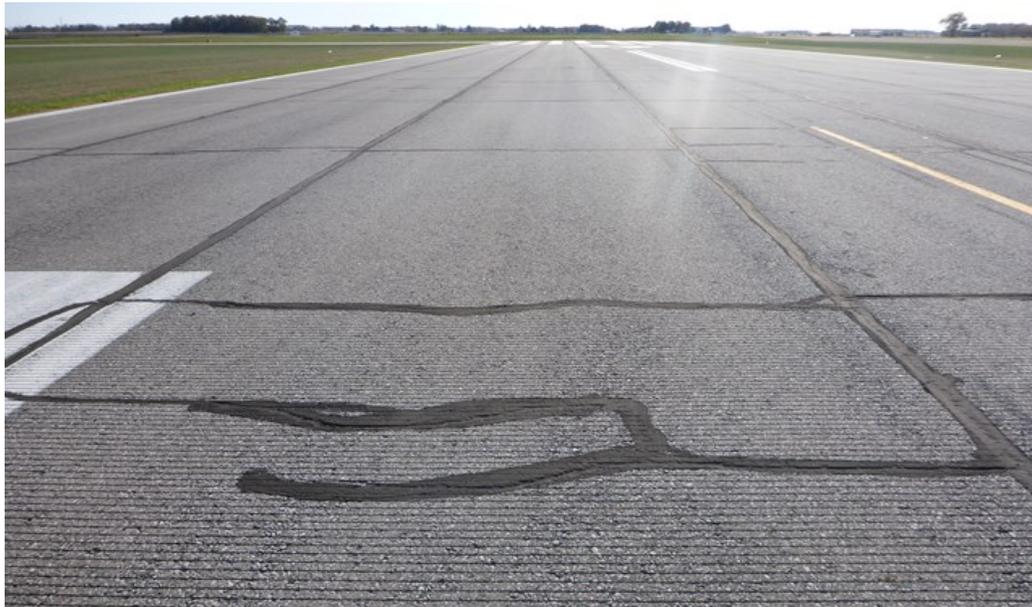
DISTRESS TYPE	SEVERITY	MEASURED QUANTITY	ESTIMATED TOTAL QUANTITY	UNITS	PERCENTAGE OF All DISTRESS
LONG.& TRANS. CRACK	MED	61	145	L.F.	9
LONG.& TRANS. CRACK	LOW	3,416	8,149	L.F.	78.9
WEATHERING	MED	50	119	S.F.	.2
WEATHERING	LOW	13,750	32,802	S.F.	11.8

APPROXIMATE AMOUNT OF DISTRESS RELATED TO LOAD ON THE PAVEMENT IS:	0 %
APPROXIMATE AMOUNT OF DISTRESS RELATED TO MATERIALS PROBLEMS IN THE FEATURE IS:	63 %
APPROXIMATE AMOUNT OF DISTRESS RELATED TO AGE OF PAVEMENT AND TRAFFIC REPETITIONS IS:	37 %

LEGEND	DESCRIPTION	COST	LIFE EXTENSION
▲	RESURFACING	\$103,060	20 YEARS
▼	SURFACE TREATMENT	\$28,092	9 YEARS
◆	CRACK REPAIR	\$10,284	1 YEAR
●	NO ACTION	N/A	N/A
-	MINIMUM SERVICE LEVEL, CURRENTLY 60

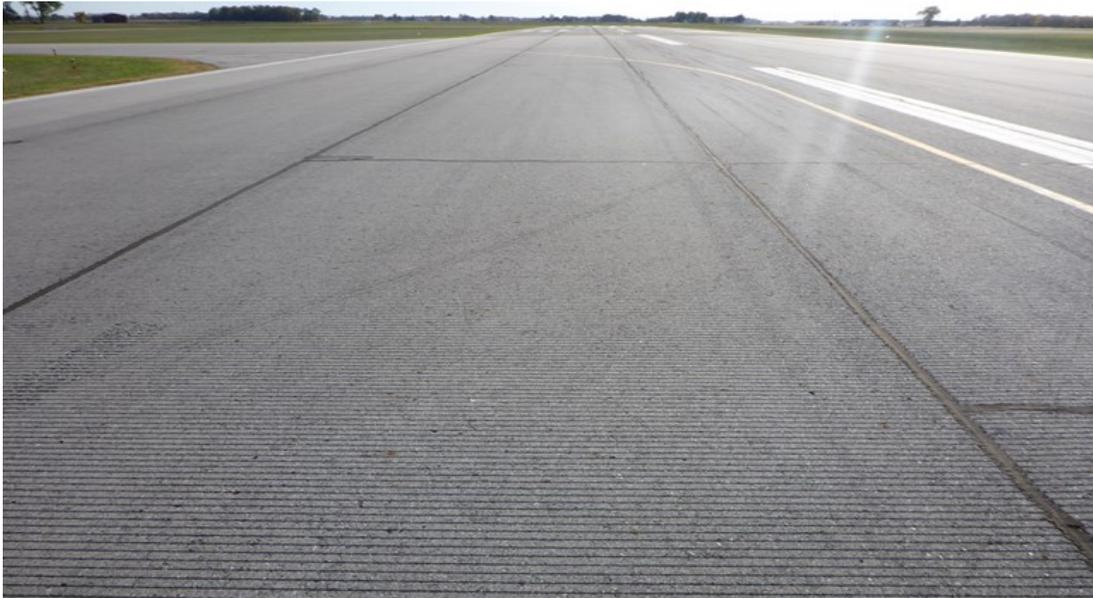
DISTRESS TYPE	SEVERITY	MEASURED QUANTITY	ESTIMATED TOTAL QUANTITY	UNITS	PERCENTAGE OF All DISTRESS
LONG.& TRANS. CRACK	MED	60	248	L.F.	11.2
LONG.& TRANS. CRACK	LOW	3,523	14,570	L.F.	88.7

APPROXIMATE AMOUNT OF DISTRESS RELATED TO LOAD ON THE PAVEMENT IS:	0 %
APPROXIMATE AMOUNT OF DISTRESS RELATED TO MATERIALS PROBLEMS IN THE FEATURE IS:	67 %
APPROXIMATE AMOUNT OF DISTRESS RELATED TO AGE OF PAVEMENT AND TRAFFIC REPETITIONS IS:	33 %

LEGEND	DESCRIPTION	COST	LIFE EXTENSION
▲	RESURFACING	\$327,564	20 YEARS
▼	CRACK REPAIR	\$18,374	1 YEAR
●	NO ACTION	N/A	N/A
-	MINIMUM SERVICE LEVEL, CURRENTLY 60

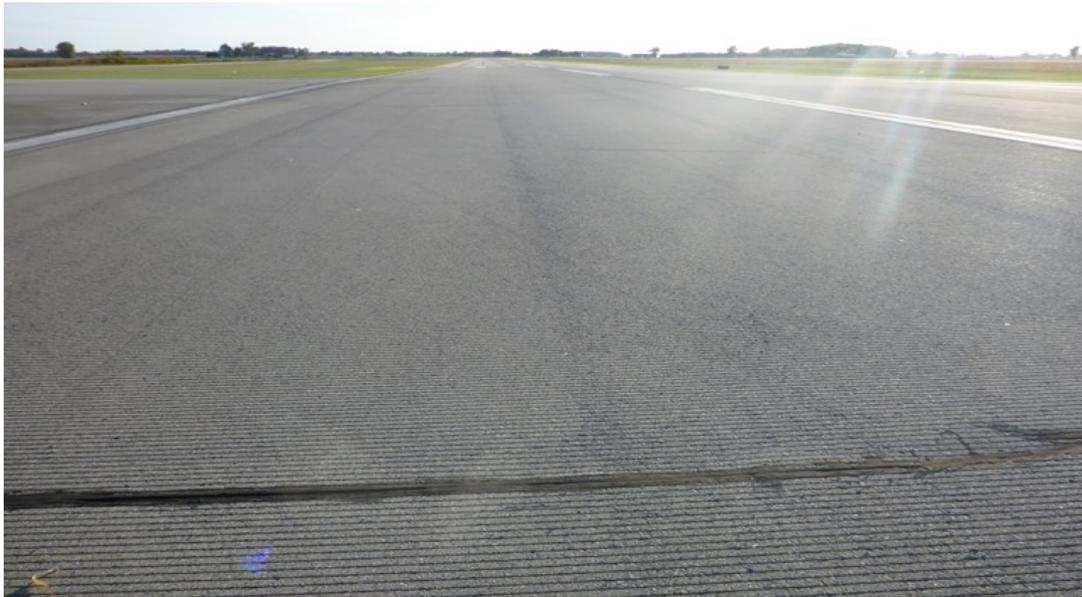
DISTRESS TYPE	SEVERITY	MEASURED QUANTITY	ESTIMATED TOTAL QUANTITY	UNITS	PERCENTAGE OF All DISTRESS
LONG.& TRANS. CRACK	LOW	1,529	3,675	L.F.	92
WEATHERING	MED	225	540	S.F.	3
WEATHERING	LOW	1,750	4,206	S.F.	4.9

APPROXIMATE AMOUNT OF DISTRESS RELATED TO LOAD ON THE PAVEMENT IS:	0 %
APPROXIMATE AMOUNT OF DISTRESS RELATED TO MATERIALS PROBLEMS IN THE FEATURE IS:	64 %
APPROXIMATE AMOUNT OF DISTRESS RELATED TO AGE OF PAVEMENT AND TRAFFIC REPETITIONS IS:	36 %

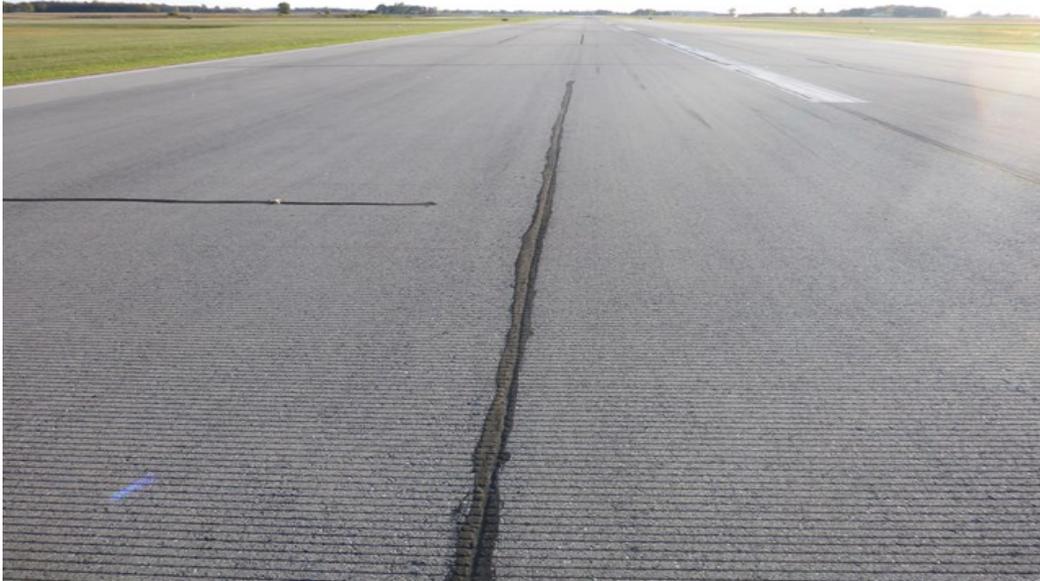
DISTRESS TYPE	SEVERITY	MEASURED QUANTITY	ESTIMATED TOTAL QUANTITY	UNITS	PERCENTAGE OF All DISTRESS
LONG.& TRANS. CRACK	LOW	2,084	8,440	L.F.	100

APPROXIMATE AMOUNT OF DISTRESS RELATED TO LOAD ON THE PAVEMENT IS:	0 %
APPROXIMATE AMOUNT OF DISTRESS RELATED TO MATERIALS PROBLEMS IN THE FEATURE IS:	67 %
APPROXIMATE AMOUNT OF DISTRESS RELATED TO AGE OF PAVEMENT AND TRAFFIC REPETITIONS IS:	33 %

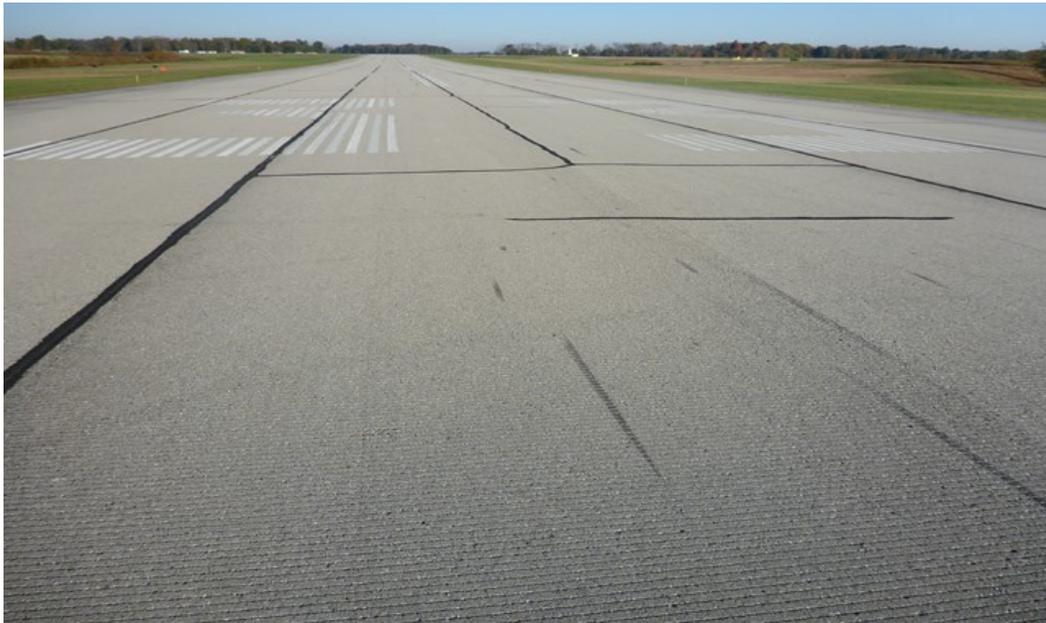
DISTRESS TYPE	SEVERITY	MEASURED QUANTITY	ESTIMATED TOTAL QUANTITY	UNITS	PERCENTAGE OF All DISTRESS
LONG.& TRANS. CRACK	LOW	2,672	15,104	L.F.	100

APPROXIMATE AMOUNT OF DISTRESS RELATED TO LOAD ON THE PAVEMENT IS:	0 %
APPROXIMATE AMOUNT OF DISTRESS RELATED TO MATERIALS PROBLEMS IN THE FEATURE IS:	67 %
APPROXIMATE AMOUNT OF DISTRESS RELATED TO AGE OF PAVEMENT AND TRAFFIC REPETITIONS IS:	33 %
