# Pavement Condition Report

## Michigan City Municipal Airport

Project 16801839

## 2015 PCI Inspection

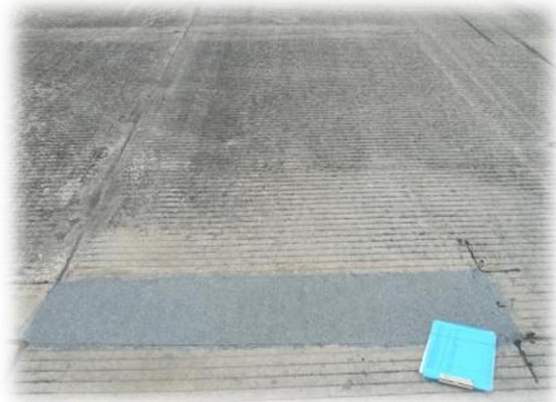
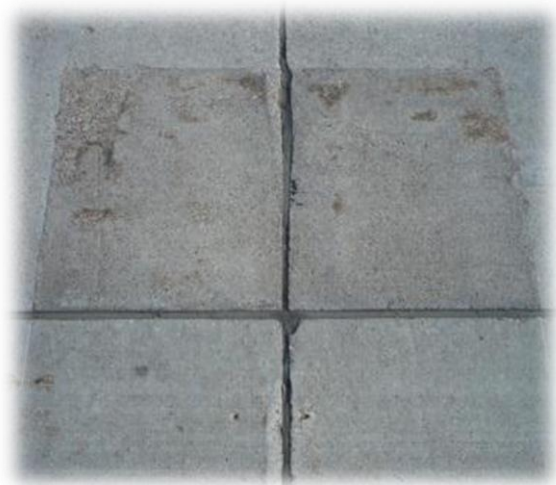
### *Patches, Large and Small*

Large and small patches, by PCI inspection criteria, are distress conditions. Patches indicate deterioration and aging of pavement that contributes to shortened service life. However, patching also indicates that pavement is being maintained.

A patch that is performing well and shows no outward distress is recorded at low severity, and no corrective action is required. Medium-severity patches are serviceable but are beginning to deteriorate. Maintenance or replacement is indicated. At high severity, replacement is indicated.

By definition, small patches are smaller than 5 square feet in surface area, and they usually result from spall repair at slab joints and corners.

Large patches also may be the result of spall repair, but they often indicate more serious deficiencies, such as corner breaks or other full-depth failure smaller than panel size.

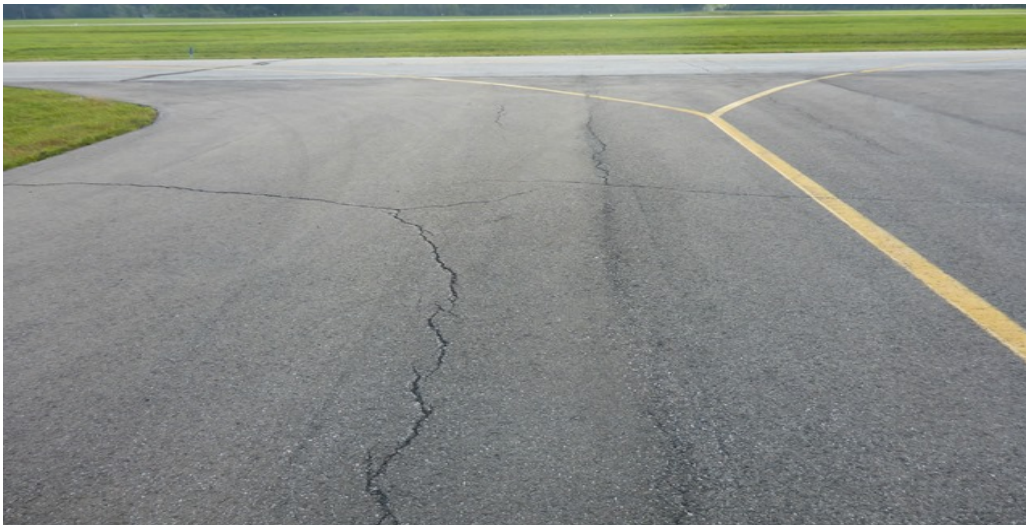
DISTRESS TYPE	SEVERITY	MEASURED QUANTITY	ESTIMATED TOTAL QUANTITY	UNITS	PERCENTAGE OF All DISTRESS
LONG.& TRANS. CRACK	MED	29	29	L.F.	37
LONG.& TRANS. CRACK	LOW	219	219	L.F.	62.9

APPROXIMATE AMOUNT OF DISTRESS RELATED TO LOAD ON THE PAVEMENT IS:	0 %
APPROXIMATE AMOUNT OF DISTRESS RELATED TO MATERIALS PROBLEMS IN THE FEATURE IS:	67 %
APPROXIMATE AMOUNT OF DISTRESS RELATED TO AGE OF PAVEMENT AND TRAFFIC REPETITIONS IS:	33 %

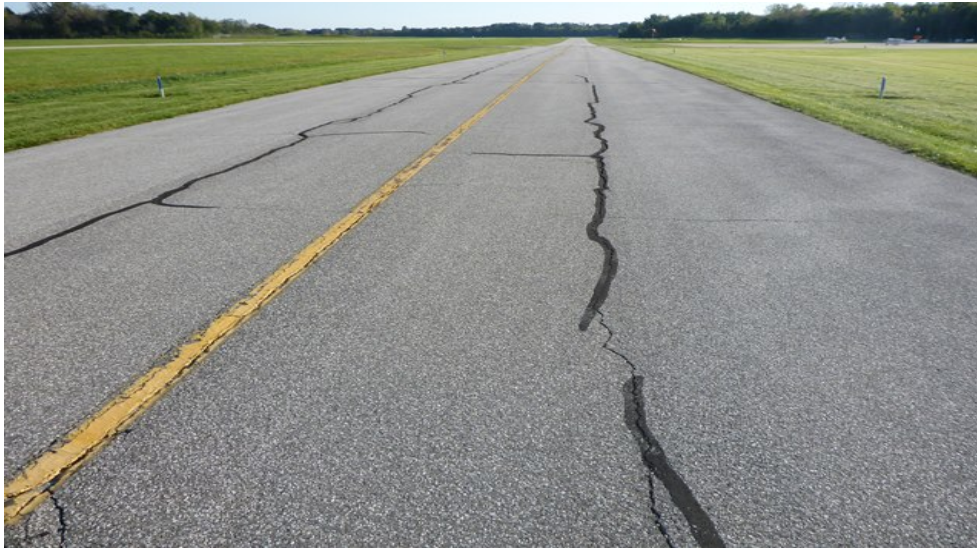
DISTRESS TYPE	SEVERITY	MEASURED QUANTITY	ESTIMATED TOTAL QUANTITY	UNITS	PERCENTAGE OF All DISTRESS
ALLIGATOR CRACKING	LOW	4	10	S.F.	3.3
LONG.& TRANS. CRACK	MED	294	785	L.F.	30.8
LONG.& TRANS. CRACK	LOW	1,861	4,973	L.F.	54.8
WEATHERING	MED	100	267	S.F.	.6
WEATHERING	LOW	10,750	28,728	S.F.	10.2

APPROXIMATE AMOUNT OF DISTRESS RELATED TO LOAD ON THE PAVEMENT IS:	3 %
APPROXIMATE AMOUNT OF DISTRESS RELATED TO MATERIALS PROBLEMS IN THE FEATURE IS:	61 %
APPROXIMATE AMOUNT OF DISTRESS RELATED TO AGE OF PAVEMENT AND TRAFFIC REPETITIONS IS:	36 %

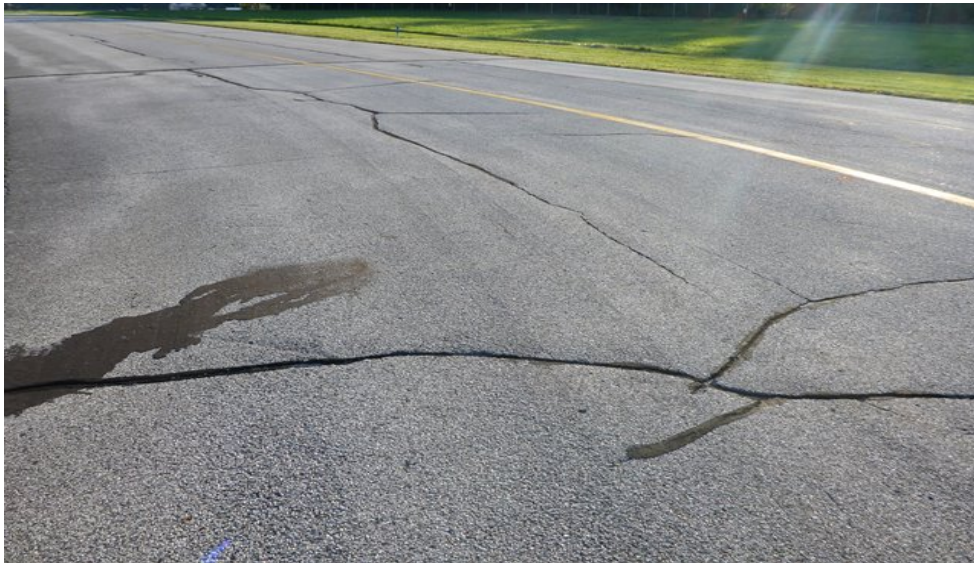
DISTRESS TYPE	SEVERITY	MEASURED QUANTITY	ESTIMATED TOTAL QUANTITY	UNITS	PERCENTAGE OF ALL DISTRESS
ALLIGATOR CRACKING	LOW	6	6	S.F.	5.2
BLOCK CRACKING	LOW	560	560	S.F.	11.1
LONG.& TRANS. CRACK	MED	34	34	L.F.	10.8
LONG.& TRANS. CRACK	LOW	522	522	L.F.	27.7
RAVELING	HIGH	15	15	S.F.	9.7
WEATHERING	HIGH	410	410	S.F.	22.5
WEATHERING	MED	900	900	S.F.	10.5
WEATHERING	LOW	2,000	2,000	S.F.	2.2

APPROXIMATE AMOUNT OF DISTRESS RELATED TO LOAD ON THE PAVEMENT IS:	5 %
APPROXIMATE AMOUNT OF DISTRESS RELATED TO MATERIALS PROBLEMS IN THE FEATURE IS:	41 %
APPROXIMATE AMOUNT OF DISTRESS RELATED TO AGE OF PAVEMENT AND TRAFFIC REPETITIONS IS:	54 %

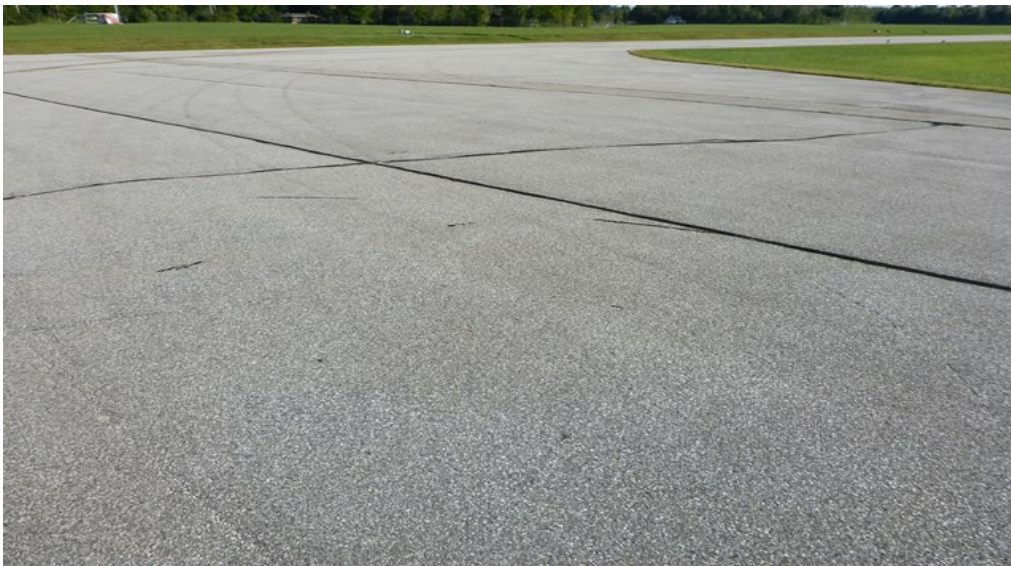
DISTRESS TYPE	SEVERITY	MEASURED QUANTITY	ESTIMATED TOTAL QUANTITY	UNITS	PERCENTAGE OF All DISTRESS
ALLIGATOR CRACKING	LOW	18	18	S.F.	22.8
LONG.& TRANS. CRACK	MED	78	78	L.F.	22.1
LONG.& TRANS. CRACK	LOW	805	805	L.F.	45.5
SWELL	LOW	24	24	S.F.	2.9
WEATHERING	LOW	3,000	3,000	S.F.	6.5

APPROXIMATE AMOUNT OF DISTRESS RELATED TO LOAD ON THE PAVEMENT IS:	23 %
APPROXIMATE AMOUNT OF DISTRESS RELATED TO MATERIALS PROBLEMS IN THE FEATURE IS:	50 %
APPROXIMATE AMOUNT OF DISTRESS RELATED TO AGE OF PAVEMENT AND TRAFFIC REPETITIONS IS:	27 %
