Pavement Condition Report

Paoli Municipal Airport

Project 16801839

January 2016

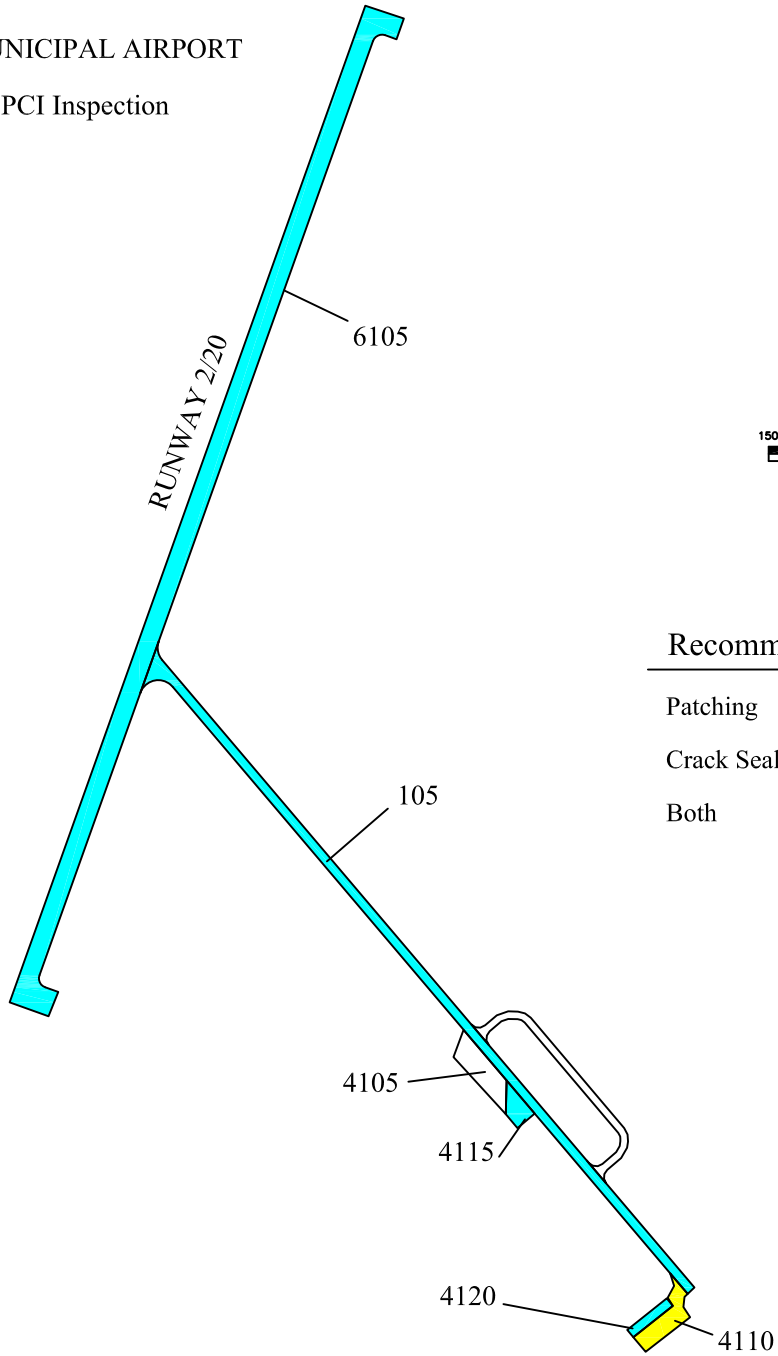
2015 PCI Inspection

Analysis of potential maintenance projects identified approximately 4,800 linear feet of crack sealing and crack repair needs, at an estimated total cost of approximately \$5,000 and approximately 100 square feet of patching, at an estimated cost of approximately \$1,000.

Recommended Maintenance

- Patching

- Crack Sealing

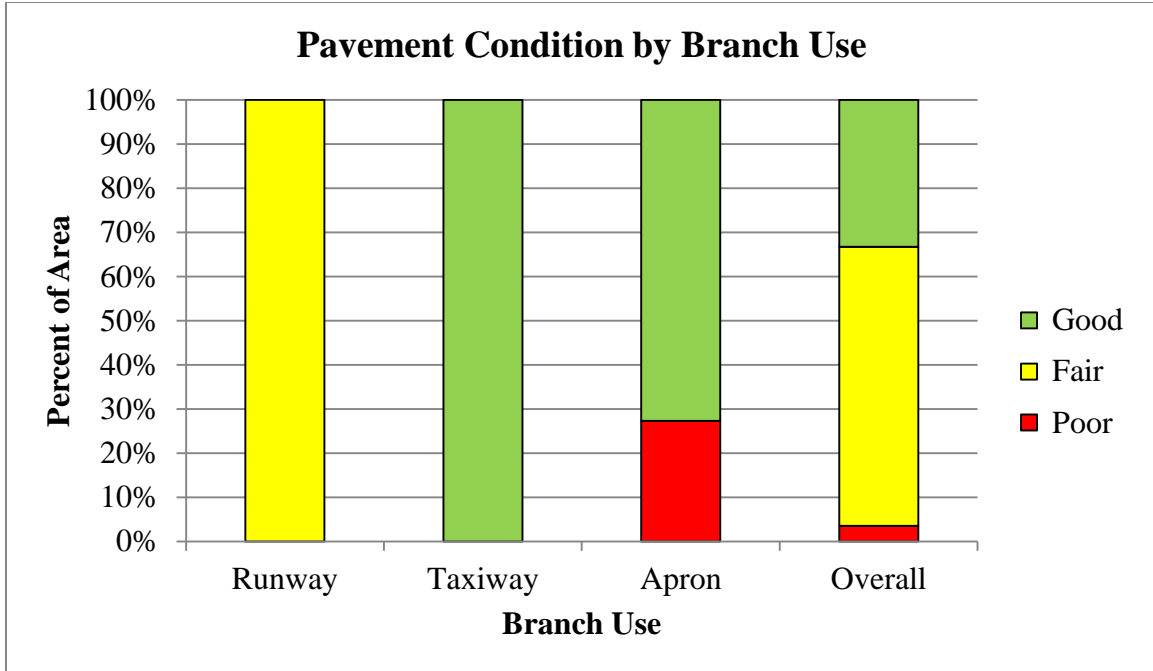
Figure 2-2. Pavement Condition by Branch Use

The runway consisted of 1 sections of AC pavement. The runway has a total area of 146,337 ft² with an area-weighted average PCI of 63 (Fair). L&T cracking and raveling were the dominate distress types. The distribution of runway pavement by PCI range is shown in Table 2-5.

The taxiway consisted of one section of AC pavement. The total area of the taxiways was 55,288 ft². The AC taxiway pavement was in Good condition with age related distresses (L&T cracking) being the main cause of deterioration. Taxiway pavement distribution by PCI range is shown in Table 2-6.

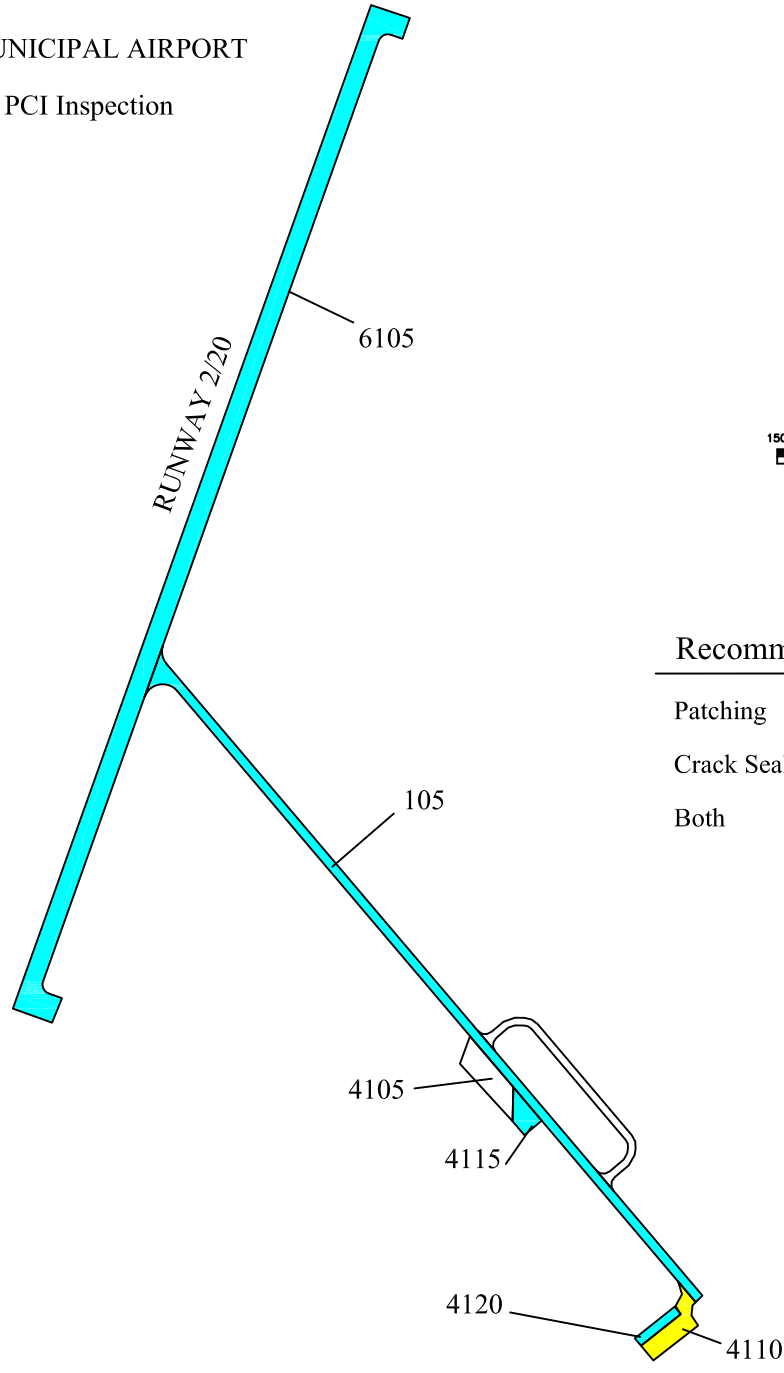
PAOLI MUNICIPAL AIRPORT
2015 PCI Inspection

Feature	Work Item	Amount	Insp. PCI	Change	Est. PCI
4115	PCC PATCHING	5	41	10	51
	TOTAL:	5	S.F.		
EQUIPMENT: SAW, AIR COMPRESSOR, JACK HAMMER, MIXER, HAND TOOLS					
EST. MATERIALS: 0 CUBIC YARDS CONCRETE MIX					
EST. MATERIAL COST: \$15					
EST. CREW HOURS: .6					
EST. CREW COST: \$80					
EST. PROJECT COST: \$95

Recommended Maintenance

- Patching
- Crack Sealing
- Both

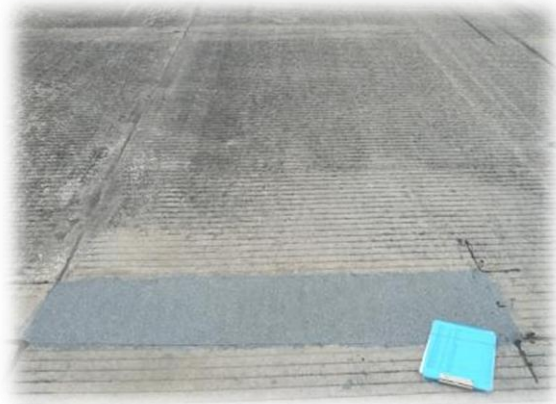
Patches, Large and Small

Large and small patches, by PCI inspection criteria, are distress conditions. Patches indicate deterioration and aging of pavement that contributes to shortened service life. However, patching also indicates that pavement is being maintained.

A patch that is performing well and shows no outward distress is recorded at low severity, and no corrective action is required. Medium-severity patches are serviceable but are beginning to deteriorate. Maintenance or replacement is indicated. At high severity, replacement is indicated.

By definition, small patches are smaller than 5 square feet in surface area, and they usually result from spall repair at slab joints and corners.

Large patches also may be the result of spall repair, but they often indicate more serious deficiencies, such as corner breaks or other full-depth failure smaller than panel size.

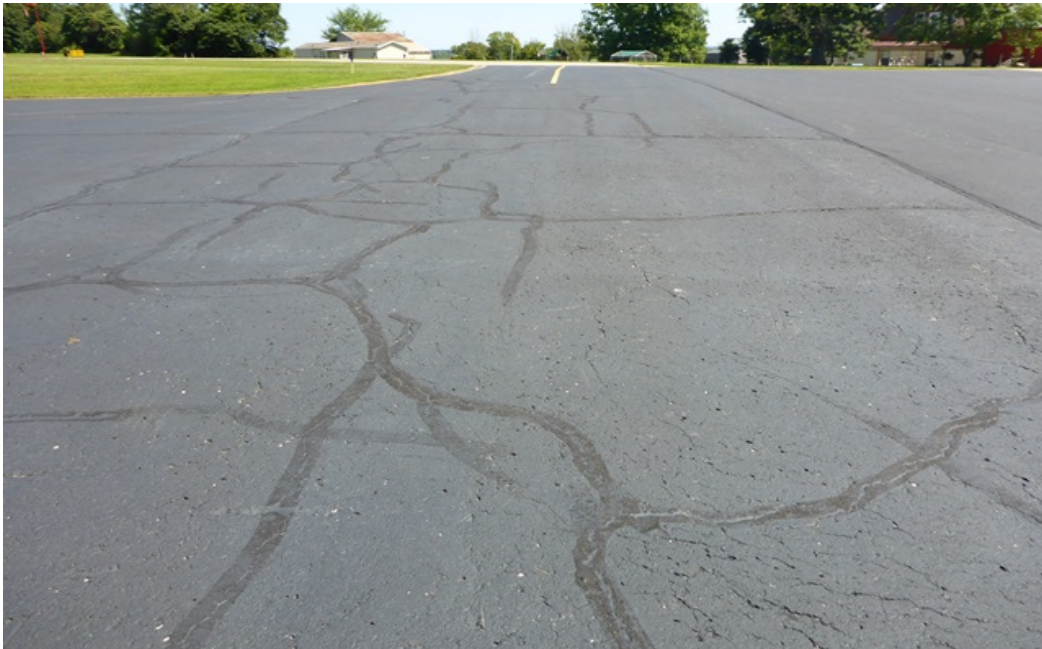
DISTRESS TYPE	SEVERITY	MEASURED QUANTITY	ESTIMATED TOTAL QUANTITY	UNITS	PERCENTAGE OF All DISTRESS
ALLIGATOR CRACKING	MED	35	35	S.F.	31.6
ALLIGATOR CRACKING	LOW	32	32	S.F.	21.6
BLOCK CRACKING	LOW	600	600	S.F.	13.8
LONG.& TRANS. CRACK	MED	49	49	L.F.	14.7
LONG.& TRANS. CRACK	LOW	192	192	L.F.	18.1

APPROXIMATE AMOUNT OF DISTRESS RELATED TO LOAD ON THE PAVEMENT IS:	53 %
APPROXIMATE AMOUNT OF DISTRESS RELATED TO MATERIALS PROBLEMS IN THE FEATURE IS:	22 %
APPROXIMATE AMOUNT OF DISTRESS RELATED TO AGE OF PAVEMENT AND TRAFFIC REPETITIONS IS:	25 %

LEGEND	DESCRIPTION	COST	LIFE EXTENSION
▲	STRUCTURAL OVERLAY	\$6,243	25 YEARS
▼	CRACK REPAIR	\$745	1 YEAR
●	NO ACTION	N/A	N/A
-	MINIMUM SERVICE LEVEL, CURRENTLY 50

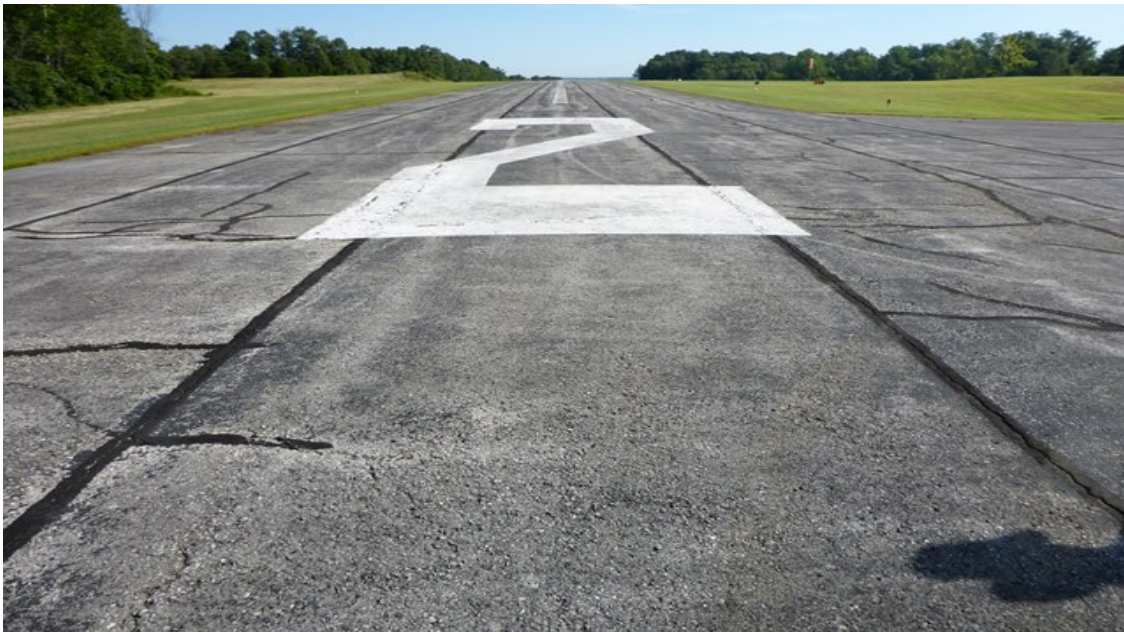
DISTRESS TYPE	SEVERITY	MEASURED QUANTITY	ESTIMATED TOTAL QUANTITY	UNITS	PERCENTAGE OF All DISTRESS
LONG.& TRANS. CRACK	HIGH	2	7	L.F.	1.8
LONG.& TRANS. CRACK	MED	911	3,332	L.F.	31.1
LONG.& TRANS. CRACK	LOW	5,119	18,727	L.F.	53.9
RAVELING	MED	8	29	S.F.	1.4
RAVELING	LOW	1,255	4,591	S.F.	11.2
SWELL	LOW	7	25	S.F.	.3

APPROXIMATE AMOUNT OF DISTRESS RELATED TO LOAD ON THE PAVEMENT IS:	0 %
APPROXIMATE AMOUNT OF DISTRESS RELATED TO MATERIALS PROBLEMS IN THE FEATURE IS:	63 %
APPROXIMATE AMOUNT OF DISTRESS RELATED TO AGE OF PAVEMENT AND TRAFFIC REPETITIONS IS:	37 %

LEGEND	DESCRIPTION	COST	LIFE EXTENSION
▲	RESURFACING	\$210,725	23 YEARS
▼	SURFACE TREATMENT	\$61,211	7 YEARS
●	NO ACTION	N/A	N/A
-	MINIMUM SERVICE LEVEL, CURRENTLY 55
