Pavement Condition Report

Peru Municipal Airport

Project 16801839

January 2016

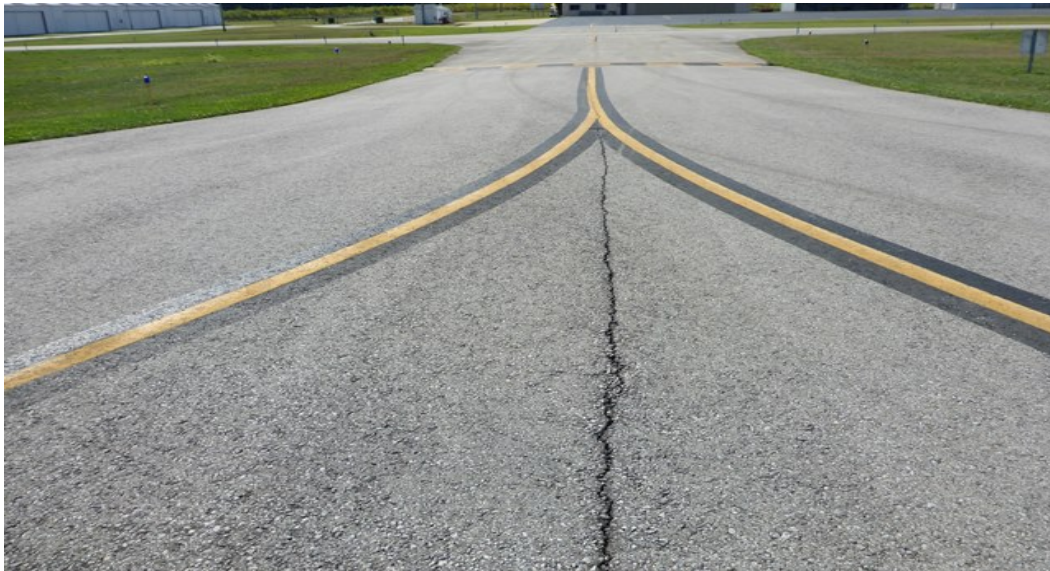
DISTRESS TYPE	SEVERITY	MEASURED QUANTITY	ESTIMATED TOTAL QUANTITY	UNITS	PERCENTAGE OF All DISTRESS
LONG.& TRANS. CRACK	MED	54	54	L.F.	72.2
LONG.& TRANS. CRACK	LOW	44	44	L.F.	27.7

APPROXIMATE AMOUNT OF DISTRESS RELATED TO LOAD ON THE PAVEMENT IS:	0 %
APPROXIMATE AMOUNT OF DISTRESS RELATED TO MATERIALS PROBLEMS IN THE FEATURE IS:	67 %
APPROXIMATE AMOUNT OF DISTRESS RELATED TO AGE OF PAVEMENT AND TRAFFIC REPETITIONS IS:	33 %

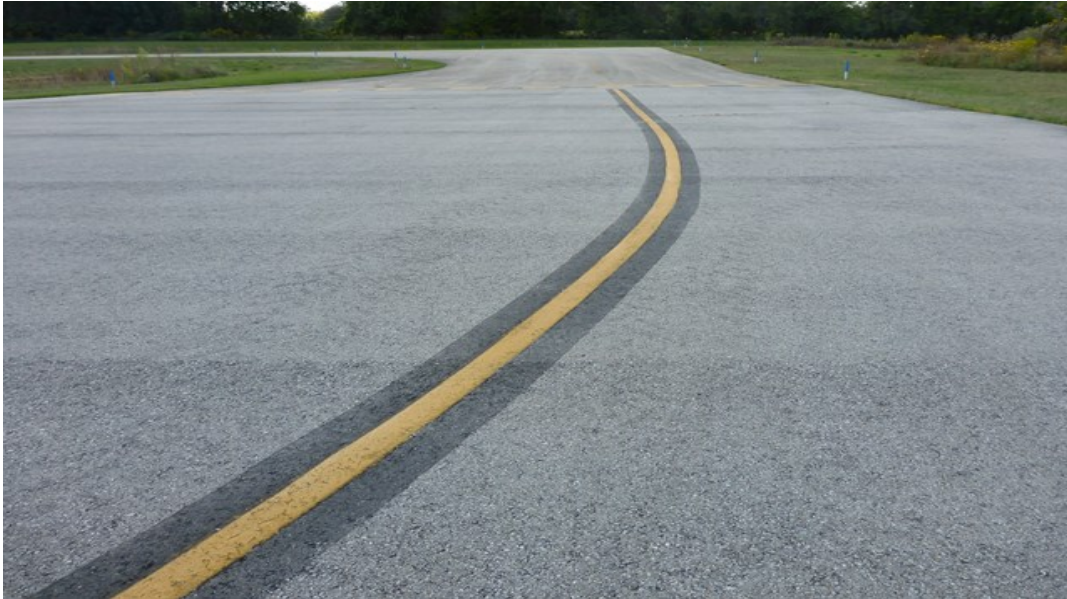
DISTRESS TYPE	SEVERITY	MEASURED QUANTITY	ESTIMATED TOTAL QUANTITY	UNITS	PERCENTAGE OF All DISTRESS
LONG.& TRANS. CRACK	LOW	219	313	L.F.	84.7
WEATHERING	LOW	950	1,358	S.F.	15.2

APPROXIMATE AMOUNT OF DISTRESS RELATED TO LOAD ON THE PAVEMENT IS:	0 %
APPROXIMATE AMOUNT OF DISTRESS RELATED TO MATERIALS PROBLEMS IN THE FEATURE IS:	62 %
APPROXIMATE AMOUNT OF DISTRESS RELATED TO AGE OF PAVEMENT AND TRAFFIC REPETITIONS IS:	38 %

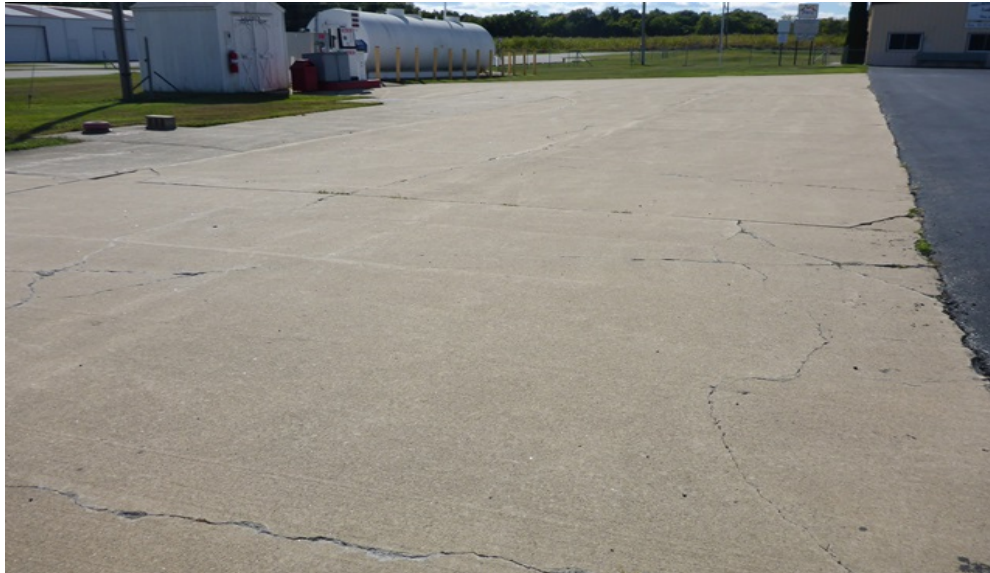
AVERAGE PCI: 4 FAILED

DISTRESS TYPE	SEVERITY	MEASURED QUANTITY	ESTIMATED TOTAL QUANTITY	UNITS	PERCENTAGE OF All DISTRESS
CORNER BREAK	HIGH	1	1	SLABS	7.5
CORNER BREAK	LOW	1	1	SLABS	3.2
LONG/TRAN/DIAG CRK.	MED	3	3	SLABS	15.7
LONG/TRAN/DIAG CRK.	LOW	2	2	SLABS	5.6
JOINT SEAL DAMAGE	HIGH	15	17	SLABS	6.7
DIVIDED SLAB	HIGH	5	5	SLABS	36.6
DIVIDED SLAB	MED	3	3	SLABS	21.5
SPALLING-JOINTS	MED	1	1	SLABS	2.7

APPROXIMATE AMOUNT OF DISTRESS RELATED TO LOAD ON THE PAVEMENT IS:	55 %
APPROXIMATE AMOUNT OF DISTRESS RELATED TO MATERIALS PROBLEMS IN THE FEATURE IS:	25 %
APPROXIMATE AMOUNT OF DISTRESS RELATED TO AGE OF PAVEMENT AND TRAFFIC REPETITIONS IS:	20 %

LEGEND	DESCRIPTION	COST	LIFE EXTENSION
▲	RECONSTRUCTION	\$53,276	31 YEARS
▼	REPAIR AND/OR OVERLAY	\$22,756	18 YEARS
●	NO ACTION	N/A	N/A
-	MINIMUM SERVICE LEVEL, CURRENTLY 55

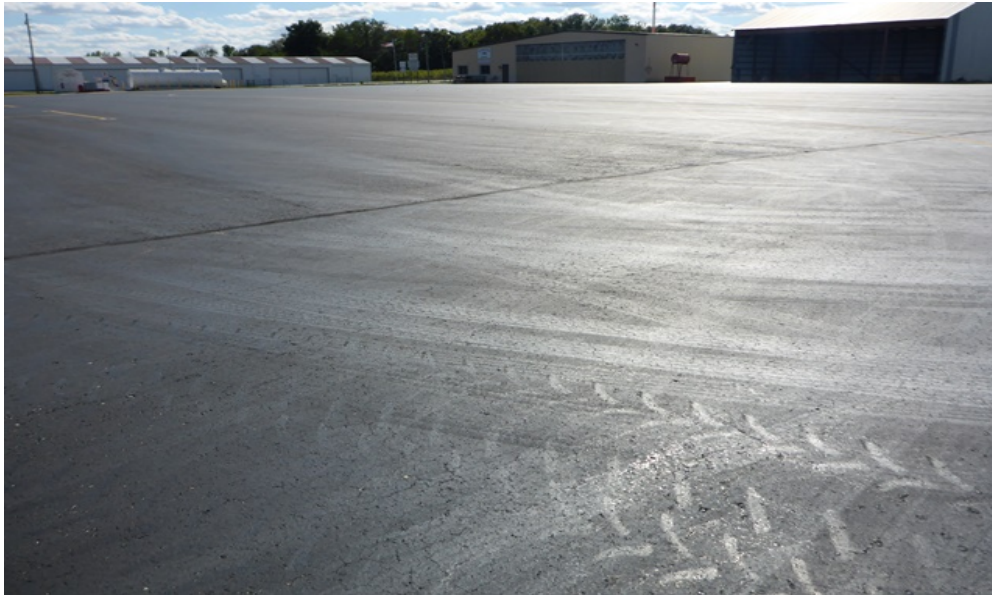
DISTRESS TYPE	SEVERITY	MEASURED QUANTITY	ESTIMATED TOTAL QUANTITY	UNITS	PERCENTAGE OF All DISTRESS
LONG.& TRANS. CRACK	MED	59	147	L.F.	21.2
LONG.& TRANS. CRACK	LOW	1,607	4,005	L.F.	78.7

APPROXIMATE AMOUNT OF DISTRESS RELATED TO LOAD ON THE PAVEMENT IS: 0 %
 APPROXIMATE AMOUNT OF DISTRESS RELATED TO MATERIALS PROBLEMS IN THE FEATURE IS: 67 %
 APPROXIMATE AMOUNT OF DISTRESS RELATED TO AGE OF PAVEMENT AND TRAFFIC REPETITIONS IS: 33 %

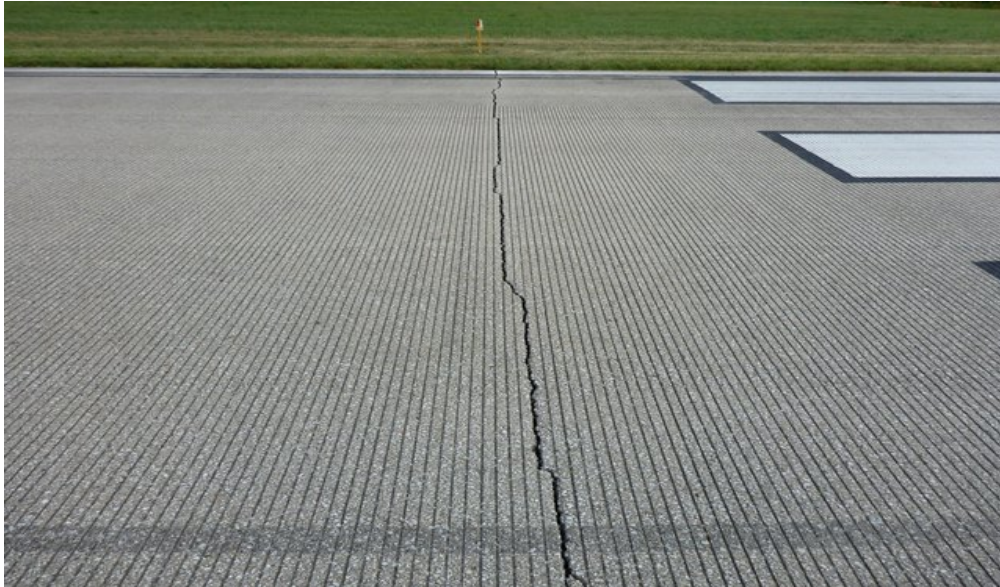
DISTRESS TYPE	SEVERITY	MEASURED QUANTITY	ESTIMATED TOTAL QUANTITY	UNITS	PERCENTAGE OF All DISTRESS
LONG.& TRANS. CRACK	MED	325	649	L.F.	77.7
LONG.& TRANS. CRACK	LOW	174	347	L.F.	22.2

APPROXIMATE AMOUNT OF DISTRESS RELATED TO LOAD ON THE PAVEMENT IS:	0 %
APPROXIMATE AMOUNT OF DISTRESS RELATED TO MATERIALS PROBLEMS IN THE FEATURE IS:	67 %
APPROXIMATE AMOUNT OF DISTRESS RELATED TO AGE OF PAVEMENT AND TRAFFIC REPETITIONS IS:	33 %

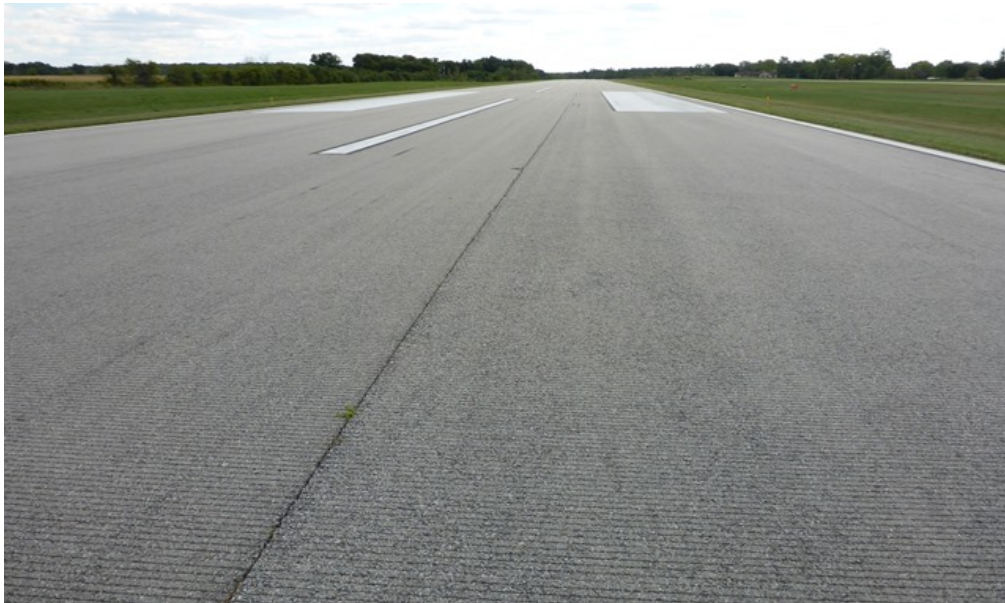
DISTRESS TYPE	SEVERITY	MEASURED QUANTITY	ESTIMATED TOTAL QUANTITY	UNITS	PERCENTAGE OF All DISTRESS
LONG.& TRANS. CRACK	MED	598	3,973	L.F.	62.7
LONG.& TRANS. CRACK	LOW	741	4,923	L.F.	37.2

APPROXIMATE AMOUNT OF DISTRESS RELATED TO LOAD ON THE PAVEMENT IS:	0 %
APPROXIMATE AMOUNT OF DISTRESS RELATED TO MATERIALS PROBLEMS IN THE FEATURE IS:	67 %
APPROXIMATE AMOUNT OF DISTRESS RELATED TO AGE OF PAVEMENT AND TRAFFIC REPETITIONS IS:	33 %
