# Pavement Condition Report

## Sullivan County Airport

Project 16801839

**January 2016**

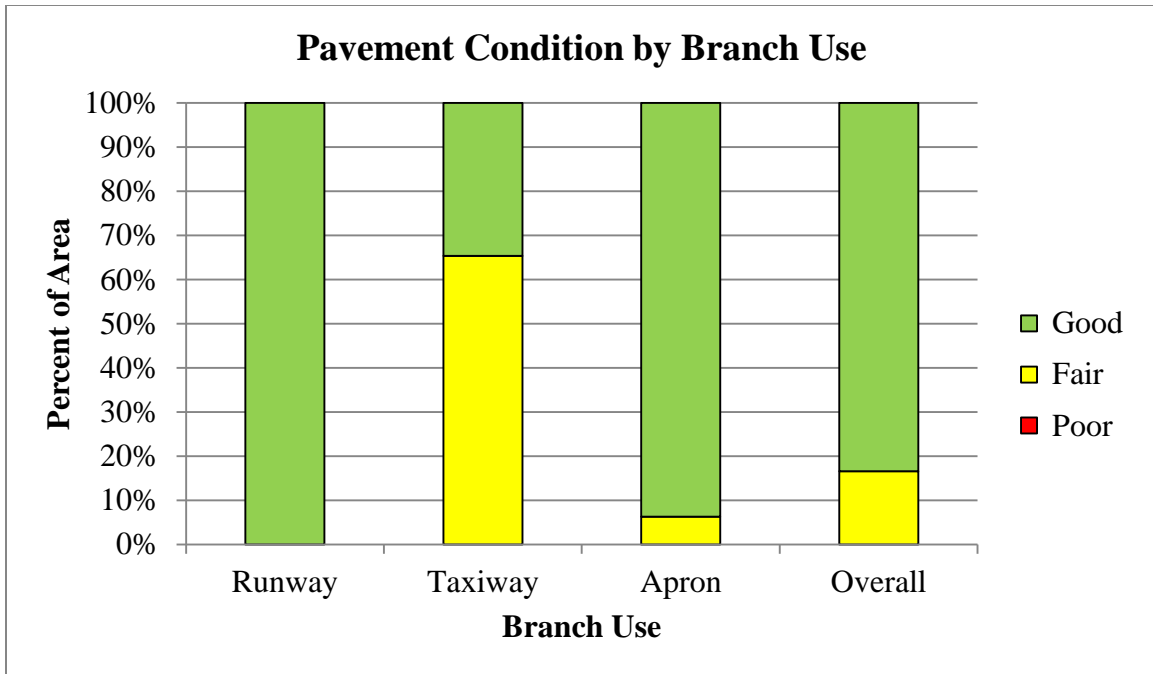
Figure 2-2. Pavement Condition by Branch Use

The runway consisted of two sections of AC pavement. The runway had a total area of 327,000 ft<sup>2</sup> with an area-weighted average PCI of 79 (Good). L&T cracking and patching were the most common recorded distress. The distribution of runway pavement by PCI range is shown in Table 2-5.

The taxiways consisted of six sections of AC pavement. The total area of the taxiways was 164,865 ft<sup>2</sup> with an area weighted average PCI of 73 (Good). L&T cracking and weathering were the main distresses for the taxiway in (Good) condition. The taxiway pavement in (Fair) condition had some added depression. Taxiway pavement distribution by PCI range is shown in Table 2-6.

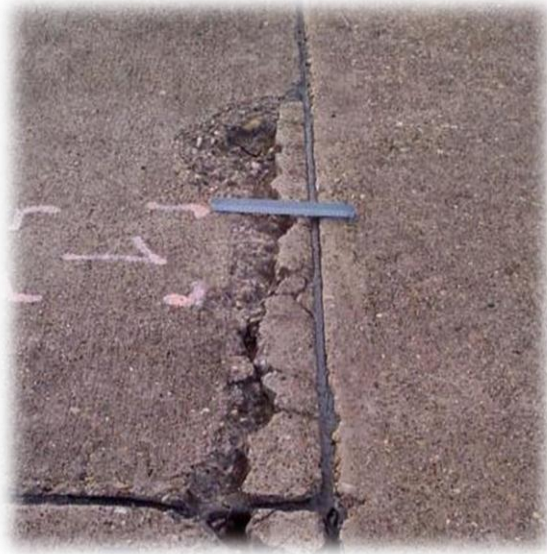
Spalls at slab joints and corners are caused by excessive internal stress in the pavement. Spalls occur when these stresses exceed the shear strength of the concrete.

Spalling usually results from thermal expansion during hot weather when slabs push and expand against one another. If the joints are filled with incompressible material, such as sand, stresses can become severe, causing spalls. Spalling can be reduced significantly by maintenance of joint sealant.

Spall repair requires patching. The extent and severity of spalling suggests the appropriate action. At low severity, spalled concrete remains securely in place in the slab. A low-severity spall should be monitored closely for further deterioration and should be patched when spalled particles become loose, or during the next scheduled patching activity. Medium- and high-severity spalls should be repaired immediately to prevent FOD. If the pavement can be restored to serviceable condition, spalls should be patched for long-term service. If the pavement is beyond repair, temporary patching should be considered to control FOD.

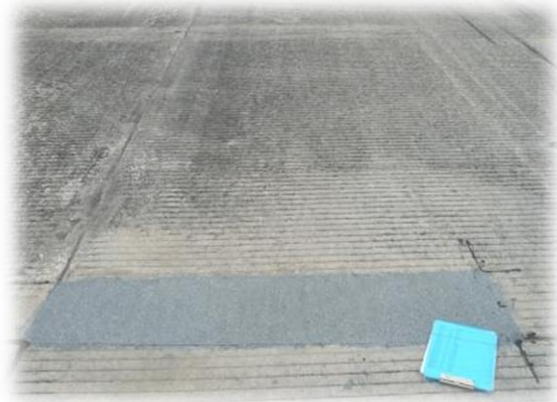
A patch that is performing well and shows no outward distress is recorded at low severity, and no corrective action is required. Medium-severity patches are serviceable but are beginning to deteriorate. Maintenance or replacement is indicated. At high severity, replacement is indicated.

By definition, small patches are smaller than 5 square feet in surface area, and they usually result from spall repair at slab joints and corners.

Large patches also may be the result of spall repair, but they often indicate more serious deficiencies, such as corner breaks or other full-depth failure smaller than panel size.

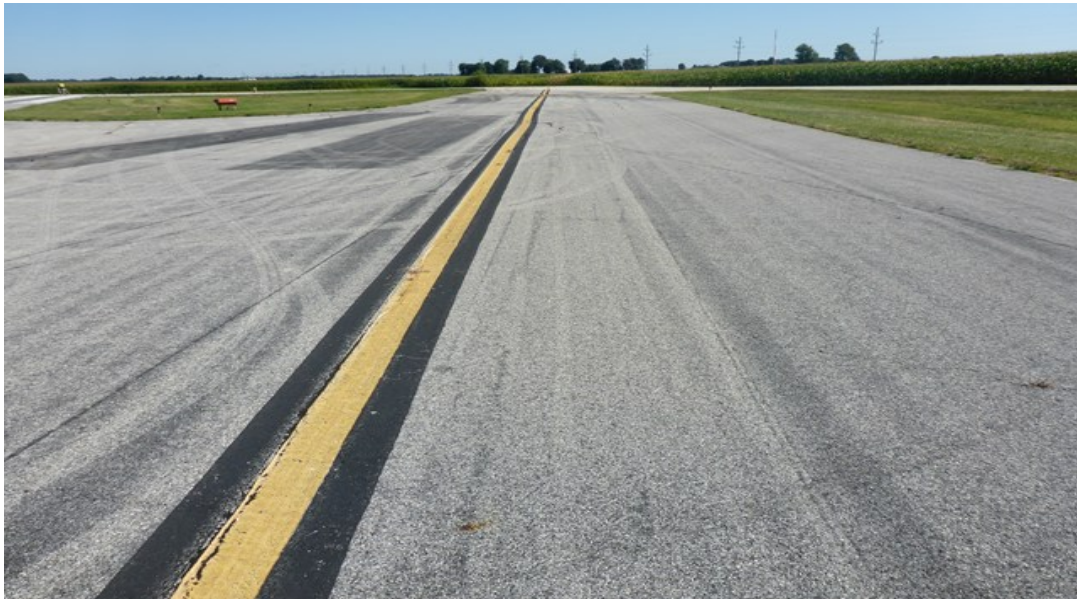
DISTRESS TYPE	SEVERITY	MEASURED QUANTITY	ESTIMATED TOTAL QUANTITY	UNITS	PERCENTAGE OF All DISTRESS
LONG.& TRANS. CRACK	MED	37	56	L.F.	21.6
LONG.& TRANS. CRACK	LOW	920	1,416	L.F.	74.6
WEATHERING	LOW	810	1,247	S.F.	3.7

APPROXIMATE AMOUNT OF DISTRESS RELATED TO LOAD ON THE PAVEMENT IS:	0 %
APPROXIMATE AMOUNT OF DISTRESS RELATED TO MATERIALS PROBLEMS IN THE FEATURE IS:	65 %
APPROXIMATE AMOUNT OF DISTRESS RELATED TO AGE OF PAVEMENT AND TRAFFIC REPETITIONS IS:	35 %

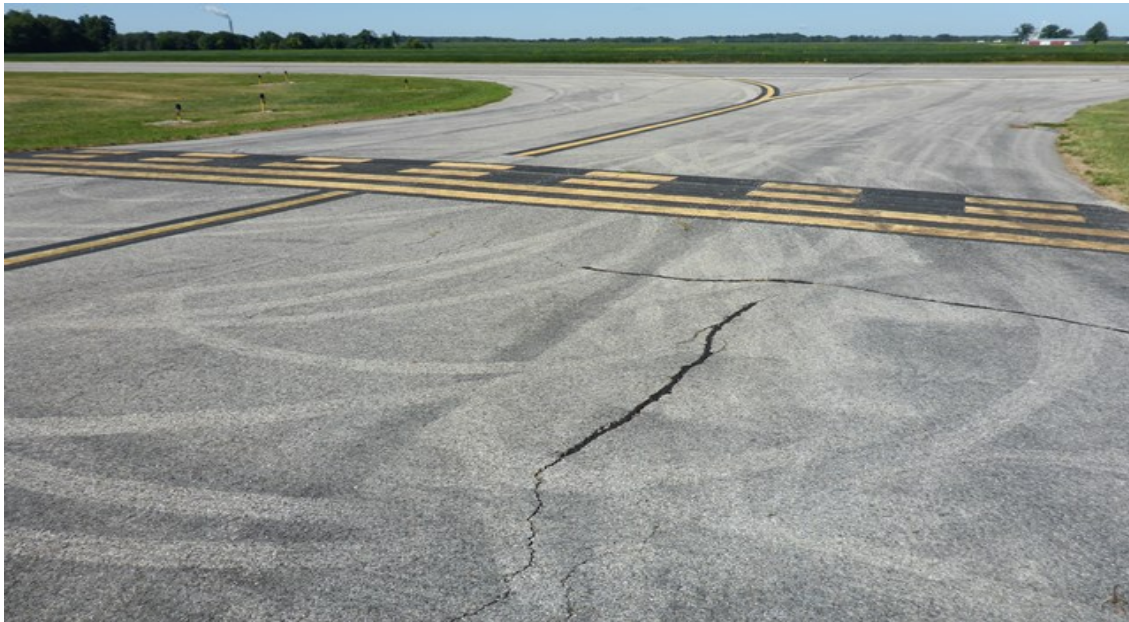
DISTRESS TYPE	SEVERITY	MEASURED QUANTITY	ESTIMATED TOTAL QUANTITY	UNITS	PERCENTAGE OF All DISTRESS
LONG.& TRANS. CRACK	MED	25	25	L.F.	20.8
LONG.& TRANS. CRACK	LOW	718	718	L.F.	77.1
WEATHERING	LOW	300	300	S.F.	2

APPROXIMATE AMOUNT OF DISTRESS RELATED TO LOAD ON THE PAVEMENT IS: 0 %  
 APPROXIMATE AMOUNT OF DISTRESS RELATED TO MATERIALS PROBLEMS IN THE FEATURE IS: 66 %  
 APPROXIMATE AMOUNT OF DISTRESS RELATED TO AGE OF PAVEMENT AND TRAFFIC REPETITIONS IS: 34 %

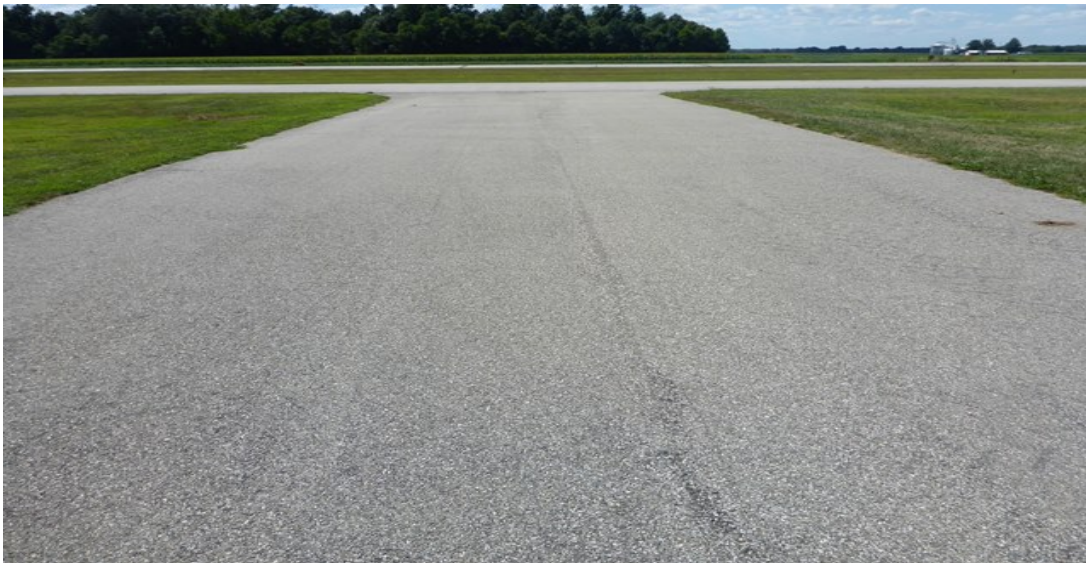
DISTRESS TYPE	SEVERITY	MEASURED QUANTITY	ESTIMATED TOTAL QUANTITY	UNITS	PERCENTAGE OF All DISTRESS
DEPRESSION	MED	58	58	S.F.	51.4
DEPRESSION	LOW	58	58	S.F.	26.9
LONG.& TRANS. CRACK	LOW	85	85	L.F.	21.5

APPROXIMATE AMOUNT OF DISTRESS RELATED TO LOAD ON THE PAVEMENT IS:	0 %
APPROXIMATE AMOUNT OF DISTRESS RELATED TO MATERIALS PROBLEMS IN THE FEATURE IS:	93 %
APPROXIMATE AMOUNT OF DISTRESS RELATED TO AGE OF PAVEMENT AND TRAFFIC REPETITIONS IS:	7 %

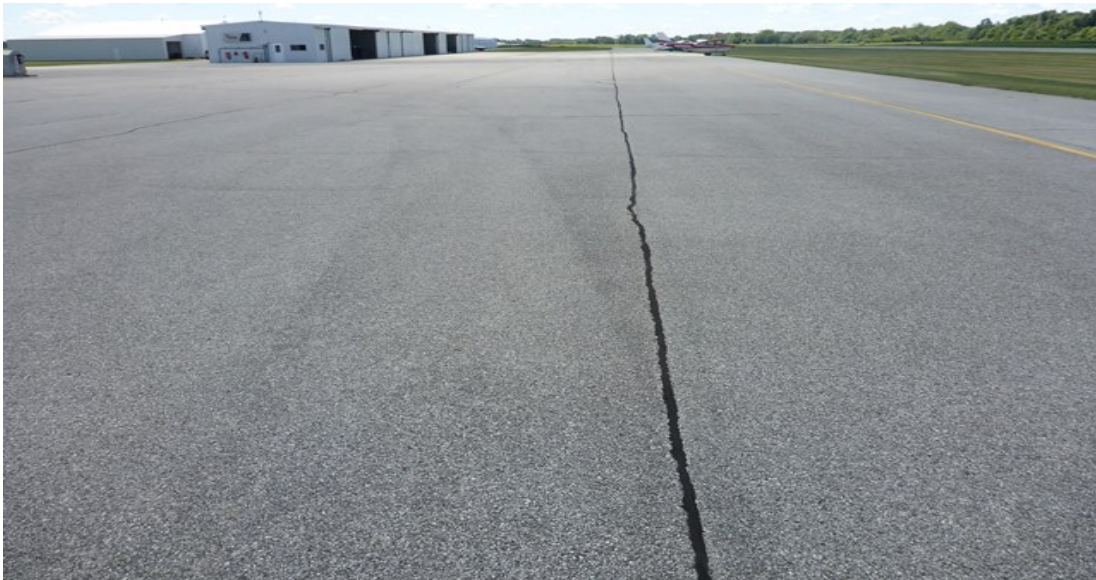
DISTRESS TYPE	SEVERITY	MEASURED QUANTITY	ESTIMATED TOTAL QUANTITY	UNITS	PERCENTAGE OF All DISTRESS
LONG.& TRANS. CRACK	MED	33	70	L.F.	13.8
LONG.& TRANS. CRACK	LOW	1,514	3,239	L.F.	86.1

APPROXIMATE AMOUNT OF DISTRESS RELATED TO LOAD ON THE PAVEMENT IS: 0 %  
 APPROXIMATE AMOUNT OF DISTRESS RELATED TO MATERIALS PROBLEMS IN THE FEATURE IS: 67 %  
 APPROXIMATE AMOUNT OF DISTRESS RELATED TO AGE OF PAVEMENT AND TRAFFIC REPETITIONS IS: 33 %

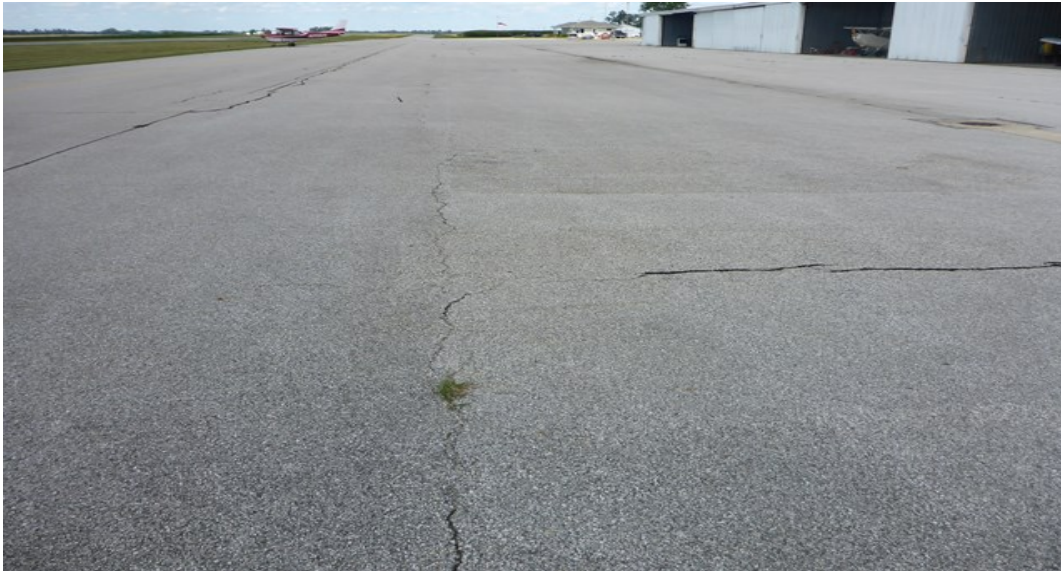
DISTRESS TYPE	SEVERITY	MEASURED QUANTITY	ESTIMATED TOTAL QUANTITY	UNITS	PERCENTAGE OF All DISTRESS
DEPRESSION	LOW	40	103	S.F.	4.8
LONG.& TRANS. CRACK	MED	33	85	L.F.	17.1
LONG.& TRANS. CRACK	LOW	1,043	2,696	L.F.	54.9
PATCH & UTILITY CUT	LOW	125	323	S.F.	6.4
RAVELING	LOW	50	129	S.F.	2.7
SWELL	MED	4	10	S.F.	8.4
SWELL	LOW	1	2	S.F.	1.2
WEATHERING	LOW	1,600	4,136	S.F.	4

APPROXIMATE AMOUNT OF DISTRESS RELATED TO LOAD ON THE PAVEMENT IS: 4 %  
 APPROXIMATE AMOUNT OF DISTRESS RELATED TO MATERIALS PROBLEMS IN THE FEATURE IS: 67 %  
 APPROXIMATE AMOUNT OF DISTRESS RELATED TO AGE OF PAVEMENT AND TRAFFIC REPETITIONS IS: 29 %

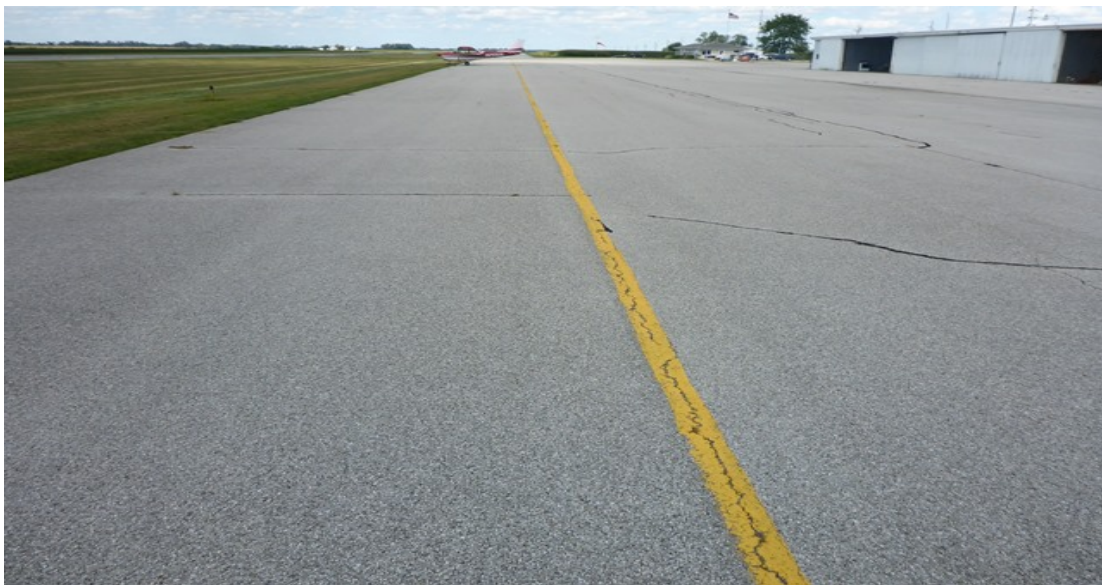
DISTRESS TYPE	SEVERITY	MEASURED QUANTITY	ESTIMATED TOTAL QUANTITY	UNITS	PERCENTAGE OF All DISTRESS
LONG.& TRANS. CRACK	MED	13	19	L.F.	6.8
LONG.& TRANS. CRACK	LOW	1,148	1,736	L.F.	75.9
SWELL	MED	4	6	S.F.	10.5
SWELL	LOW	10	15	S.F.	1.3
WEATHERING	LOW	1,800	2,723	S.F.	5.3

APPROXIMATE AMOUNT OF DISTRESS RELATED TO LOAD ON THE PAVEMENT IS:	0 %
APPROXIMATE AMOUNT OF DISTRESS RELATED TO MATERIALS PROBLEMS IN THE FEATURE IS:	69 %
APPROXIMATE AMOUNT OF DISTRESS RELATED TO AGE OF PAVEMENT AND TRAFFIC REPETITIONS IS:	31 %

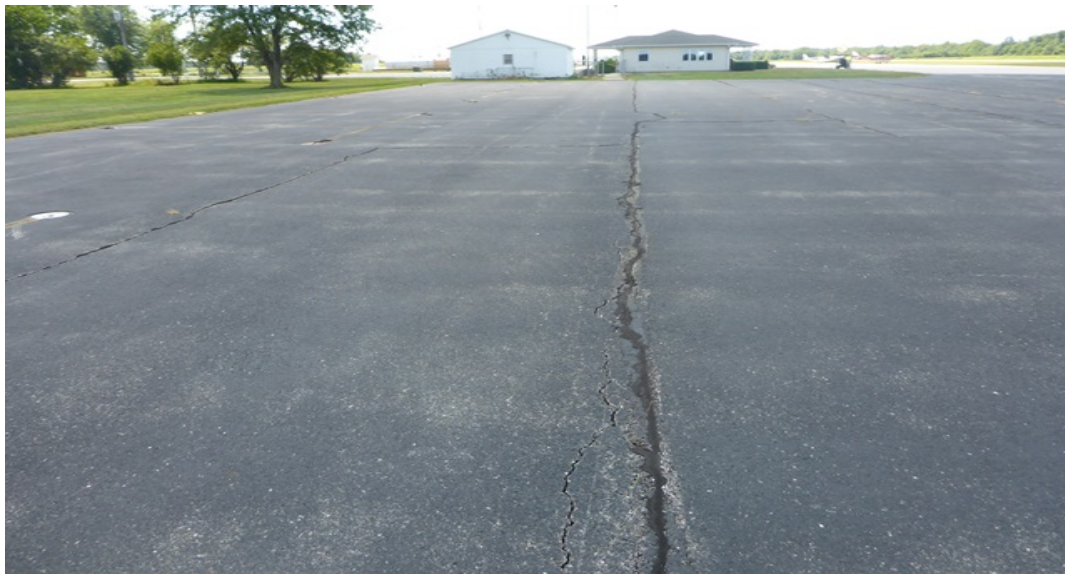
DISTRESS TYPE	SEVERITY	MEASURED QUANTITY	ESTIMATED TOTAL QUANTITY	UNITS	PERCENTAGE OF All DISTRESS
LONG.& TRANS. CRACK	MED	407	834	L.F.	36.2
LONG.& TRANS. CRACK	LOW	1,573	3,224	L.F.	50.7
RAVELING	HIGH	5	10	S.F.	4.5
RAVELING	MED	35	71	S.F.	8.4

APPROXIMATE AMOUNT OF DISTRESS RELATED TO LOAD ON THE PAVEMENT IS:	0 %
APPROXIMATE AMOUNT OF DISTRESS RELATED TO MATERIALS PROBLEMS IN THE FEATURE IS:	62 %
APPROXIMATE AMOUNT OF DISTRESS RELATED TO AGE OF PAVEMENT AND TRAFFIC REPETITIONS IS:	38 %

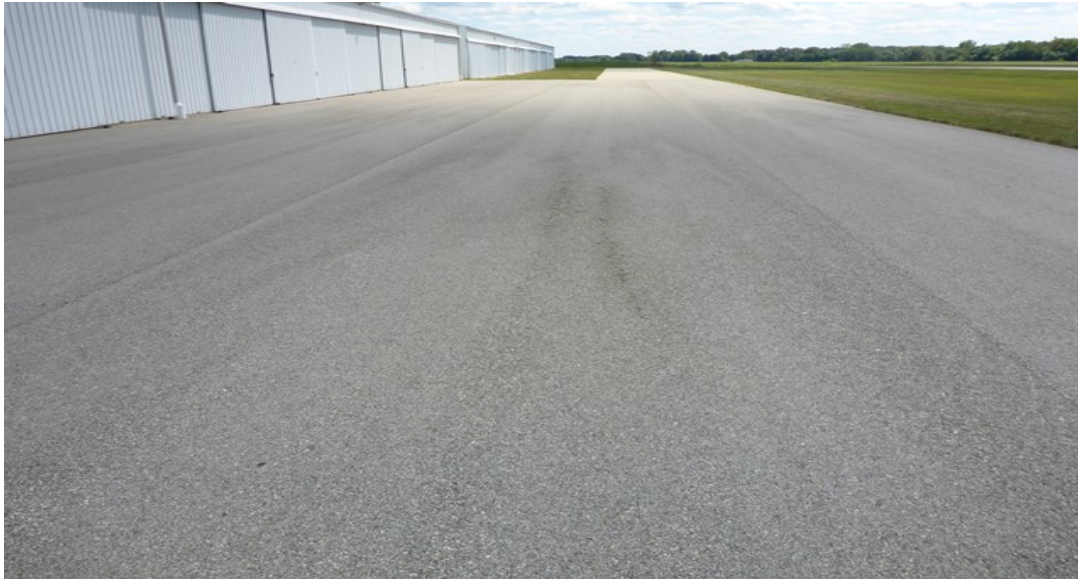
DISTRESS TYPE	SEVERITY	MEASURED QUANTITY	ESTIMATED TOTAL QUANTITY	UNITS	PERCENTAGE OF All DISTRESS
LONG.& TRANS. CRACK	LOW	130	488	L.F.	100

APPROXIMATE AMOUNT OF DISTRESS RELATED TO LOAD ON THE PAVEMENT IS:	0 %
APPROXIMATE AMOUNT OF DISTRESS RELATED TO MATERIALS PROBLEMS IN THE FEATURE IS:	67 %
APPROXIMATE AMOUNT OF DISTRESS RELATED TO AGE OF PAVEMENT AND TRAFFIC REPETITIONS IS:	33 %

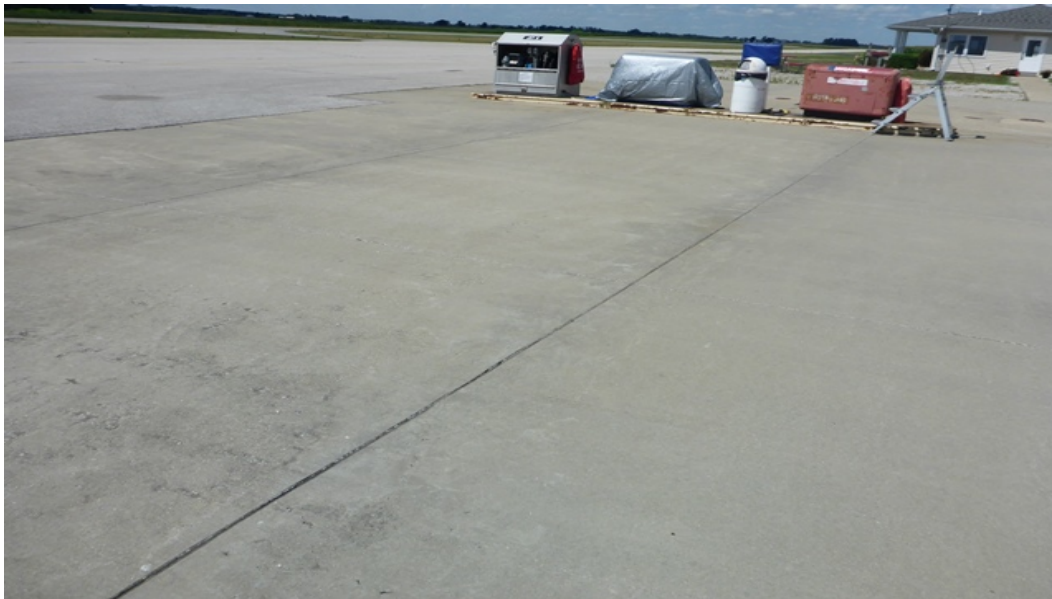
DISTRESS TYPE	SEVERITY	MEASURED QUANTITY	ESTIMATED TOTAL QUANTITY	UNITS	PERCENTAGE OF All DISTRESS
CORNER BREAK	LOW	3	3	SLABS	49.4
LONG/TRAN/DIAG CRK.	LOW	3	3	SLABS	47
SHRINKAGE CRACKS	N/A	1	1	SLABS	3.5

APPROXIMATE AMOUNT OF DISTRESS RELATED TO LOAD ON THE PAVEMENT IS:	49 %
APPROXIMATE AMOUNT OF DISTRESS RELATED TO MATERIALS PROBLEMS IN THE FEATURE IS:	18 %
APPROXIMATE AMOUNT OF DISTRESS RELATED TO AGE OF PAVEMENT AND TRAFFIC REPETITIONS IS:	33 %

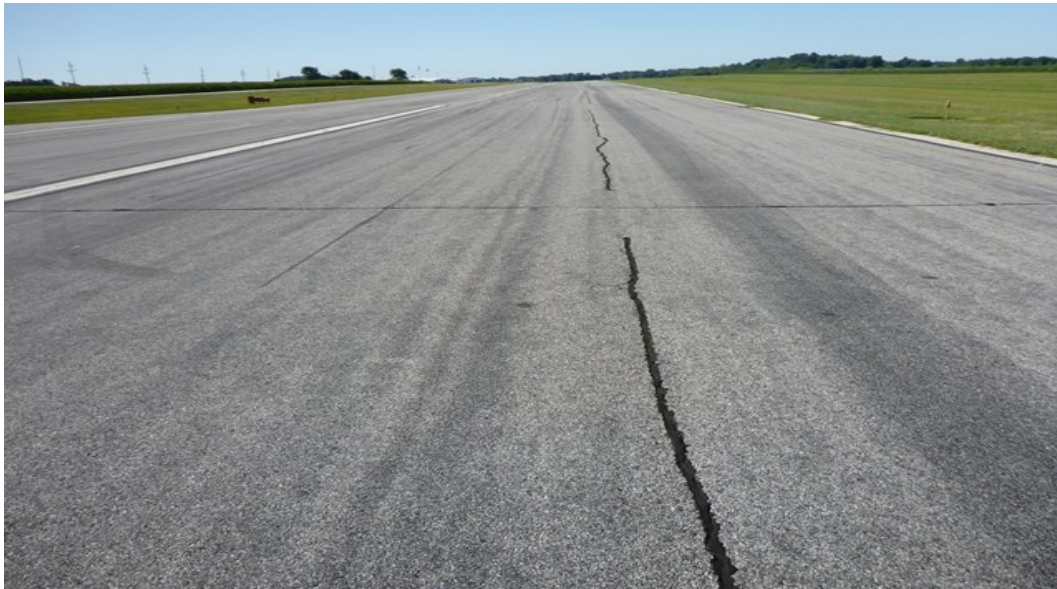
DISTRESS TYPE	SEVERITY	MEASURED QUANTITY	ESTIMATED TOTAL QUANTITY	UNITS	PERCENTAGE OF All DISTRESS
DEPRESSION	HIGH	32	32	S.F.	.2
LONG.& TRANS. CRACK	LOW	3,129	16,827	L.F.	66.8
LONG.& TRANS. CRACK	MED	330	1,837	L.F.	30.2
PATCH & UTILITY CUT	LOW	1,000	1,000	S.F.	.2
SWELL	LOW	15	94	S.F.	.5

APPROXIMATE AMOUNT OF DISTRESS RELATED TO LOAD ON THE PAVEMENT IS:	0 %
APPROXIMATE AMOUNT OF DISTRESS RELATED TO MATERIALS PROBLEMS IN THE FEATURE IS:	67 %
APPROXIMATE AMOUNT OF DISTRESS RELATED TO AGE OF PAVEMENT AND TRAFFIC REPETITIONS IS:	33 %

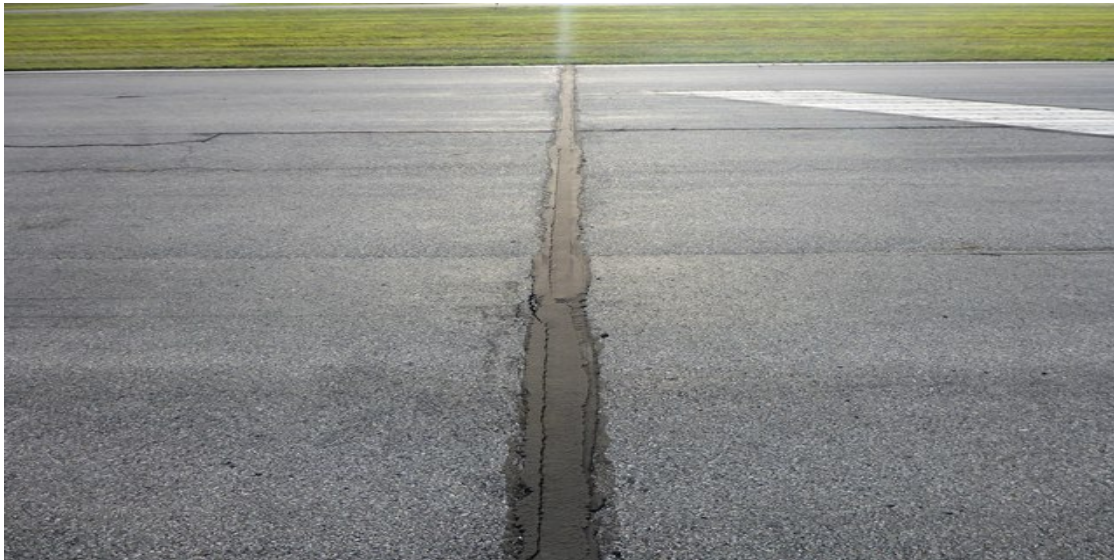
DISTRESS TYPE	SEVERITY	MEASURED QUANTITY	ESTIMATED TOTAL QUANTITY	UNITS	PERCENTAGE OF All DISTRESS
DEPRESSION	LOW	3	8	S.F.	0
LONG.& TRANS. CRACK	MED	144	384	L.F.	34.6
LONG.& TRANS. CRACK	LOW	768	2,048	L.F.	43.3
PATCH & UTILITY CUT	LOW	95	253	S.F.	9.4
SWELL	MED	35	93	S.F.	10.2
WEATHERING	MED	190	506	S.F.	1.8
WEATHERING	LOW	200	533	S.F.	.5

APPROXIMATE AMOUNT OF DISTRESS RELATED TO LOAD ON THE PAVEMENT IS:	6 %
APPROXIMATE AMOUNT OF DISTRESS RELATED TO MATERIALS PROBLEMS IN THE FEATURE IS:	66 %
APPROXIMATE AMOUNT OF DISTRESS RELATED TO AGE OF PAVEMENT AND TRAFFIC REPETITIONS IS:	28 %
