# Pavement Condition Report

## Terre Haute International Airport

Project 16801839

**January 2016**

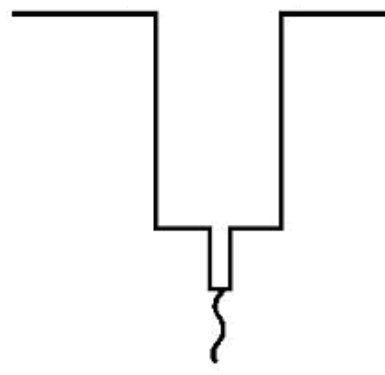
Clean joints exposing fresh,  
clean concrete and stone.  
Retain existing resevoir shape.

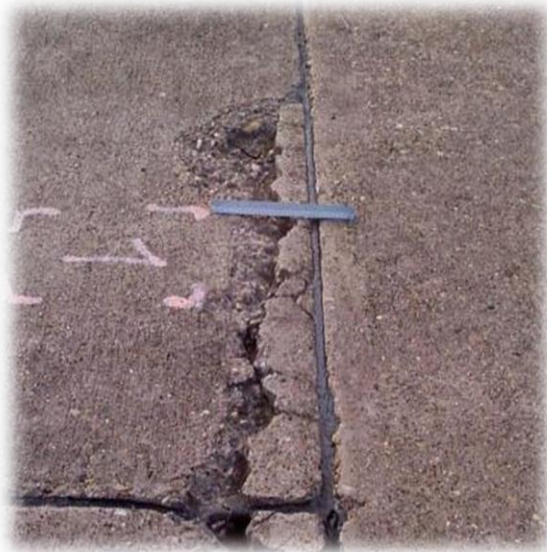
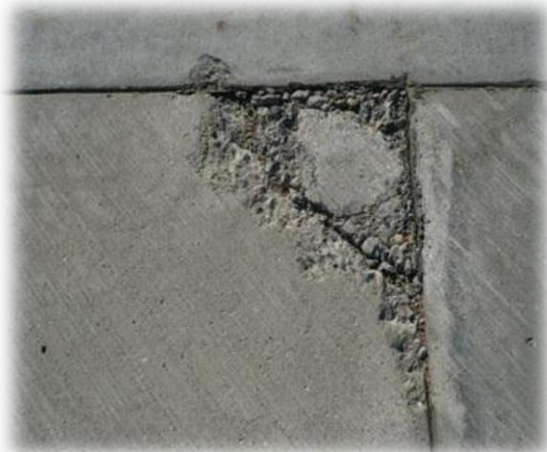
### *Joint Spall and Corner Spall*

Spalls at slab joints and corners are caused by excessive internal stress in the pavement. Spalls occur when these stresses exceed the shear strength of the concrete.

Spalling usually results from thermal expansion during hot weather when slabs push and expand against one another. If the joints are filled with incompressible material, such as sand, stresses can become severe, causing spalls. Spalling can be reduced significantly by maintenance of joint sealant.

Spall repair requires patching. The extent and severity of spalling suggests the appropriate action. At low severity, spalled concrete remains securely in place in the slab. A low-severity spall should be monitored closely for further deterioration and should be patched when spalled particles become loose, or during the next scheduled patching activity. Medium- and high-severity spalls should be repaired immediately to prevent FOD. If the pavement can be restored to serviceable condition, spalls should be patched for long-term service. If the pavement is beyond repair, temporary patching should be considered to control FOD.

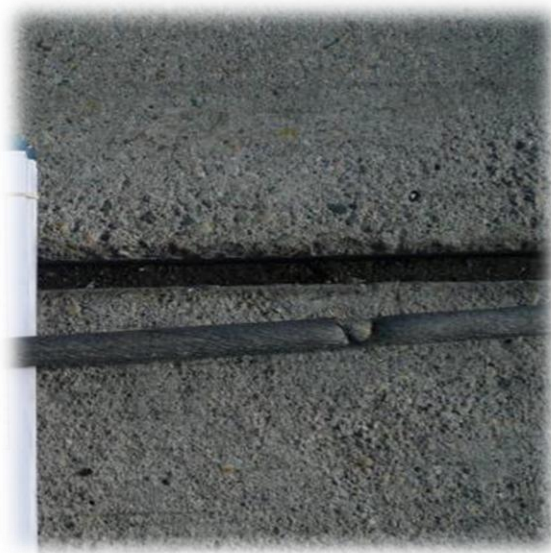
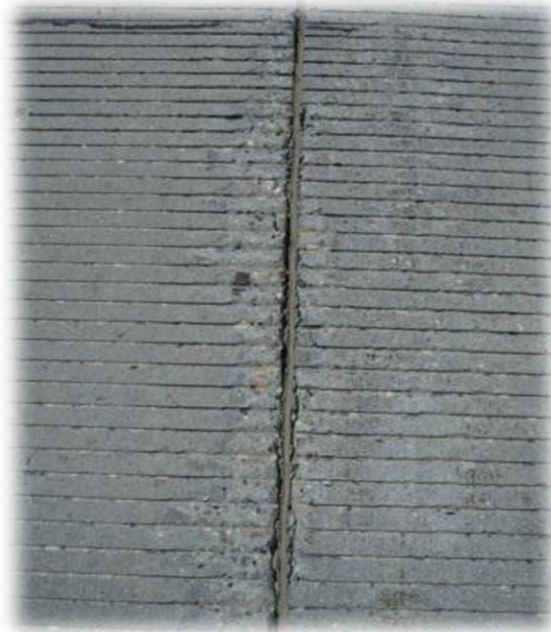
## Joint Seal Damage

When joint sealant is in perfect condition (no damage), there is no distress.

At low severity, at least 10 percent of the sealant is debonded but still in contact with the joint edges. Medium-severity joint seal damage is recorded when at least 10 percent of the sealant has visible gaps smaller than 1/8 inch and is an indicator that replacement should be programmed as soon as is practical. In the meantime, aggressive inspection and sustaining maintenance is recommended to minimize subsurface damage from moisture penetration. At high severity, visible gaps exceed 1/8 inch, and the amount and degree of joint seal damage typically requires complete removal and replacement of the existing sealant.

On serviceable pavement, deteriorated joint sealant should be repaired or replaced to preserve pavement and subgrade integrity and prolong service life. The issue is not so clear-cut with unserviceable pavement. Pavement that can be restored to serviceable condition by maintenance activities such as patching and joint seal repair, or by slab replacement, should be so maintained as long as the process is cost-effective. However, when age and condition preclude economical return to serviceable condition by such means, joint seal repair would no longer be cost-effective and should be suspended except for an interim maintenance program to control FOD potential.

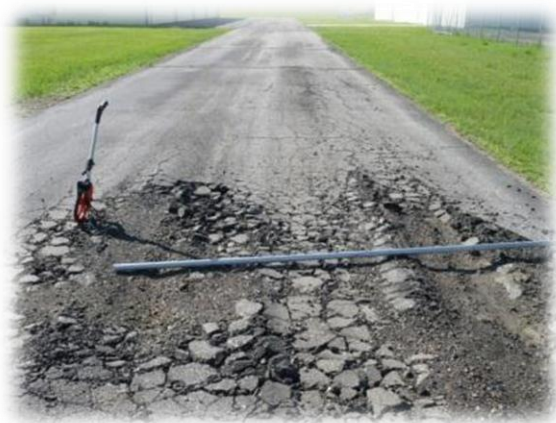
## Alligator Cracking

Alligator cracks are a series of interconnected load-related cracks caused by fatigue of the asphalt surface. Alligator cracking is a significant structural distress and develops only in places subject to traffic loads. These cracks typically initiate at the bottom of the asphalt layer and propagate upward. Once a fatigue crack is visible at the surface, significant damage has already occurred.

At low severity, alligator cracks are evidenced by a series of parallel hairline cracks (usually in a wheel path). Medium-severity alligator cracking is a well-defined pattern of interconnected cracks, and some spalling may be present. High-severity alligator cracks have lost aggregate interlock between adjacent pieces, and the cracks may be severely spalled with FOD potential. Most likely, the pieces will move freely under traffic.

Alligator cracking is a serious structural failure that cannot be repaired with sealant. The proper repair is patching.

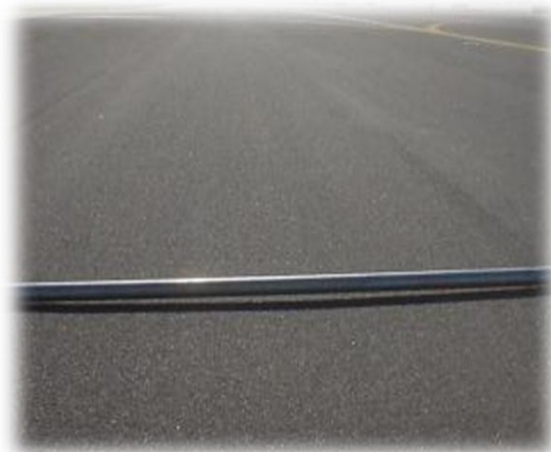
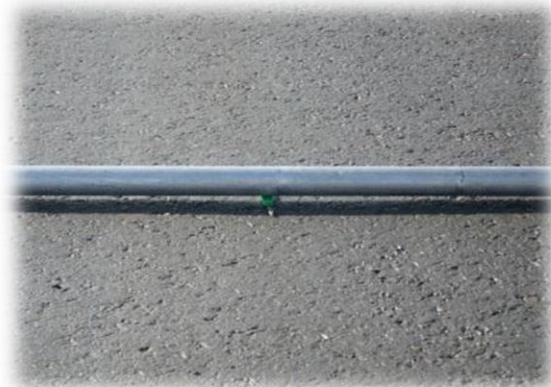
### Rutting

Ruts are localized areas of pavement having elevations lower than the surrounding sections.

Rutting is due to base and subgrade consolidation caused by excessive wheel loads or poor compaction. Ruts indicate structural failure and can cause hydroplaning.

At low severity, ruts have an average depth of ¼ to ½ inches. At medium severity, ruts have an average depth of ½ to 1 inch. At high severity, ruts have an average depth greater than 1 inch. Patching is the appropriate repair for ruts.

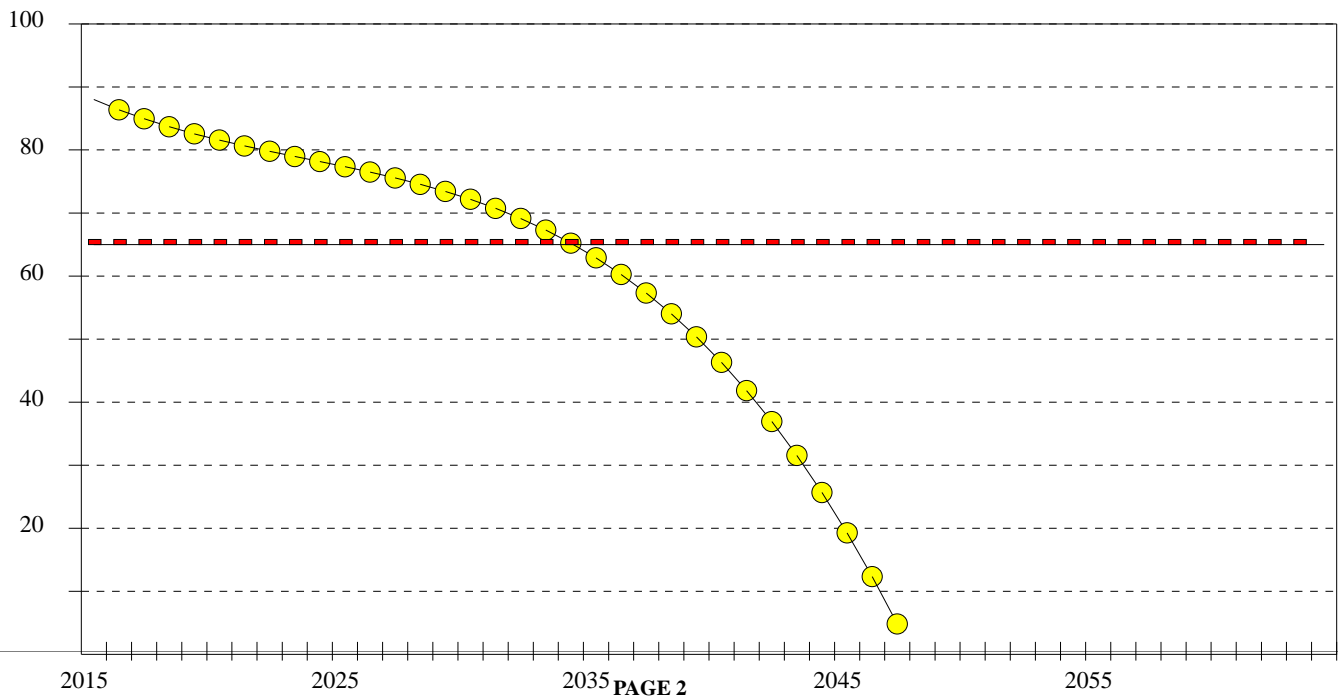
PROJECTED PERFORMANCE

DISTRESS TYPE	SEVERITY	MEASURED QUANTITY	ESTIMATED TOTAL QUANTITY	UNITS	PERCENTAGE OF All DISTRESS
LONG.& TRANS. CRACK	MED	18	120	L.F.	5.8
LONG.& TRANS. CRACK	LOW	2,598	17,368	L.F.	91.6
PATCH & UTILITY CUT	LOW	2	13	S.F.	2.4

LEGEND	DESCRIPTION	COST	LIFE EXTENSION
●	NO ACTION	N/A	N/A
-	MINIMUM SERVICE LEVEL, CURRENTLY 65

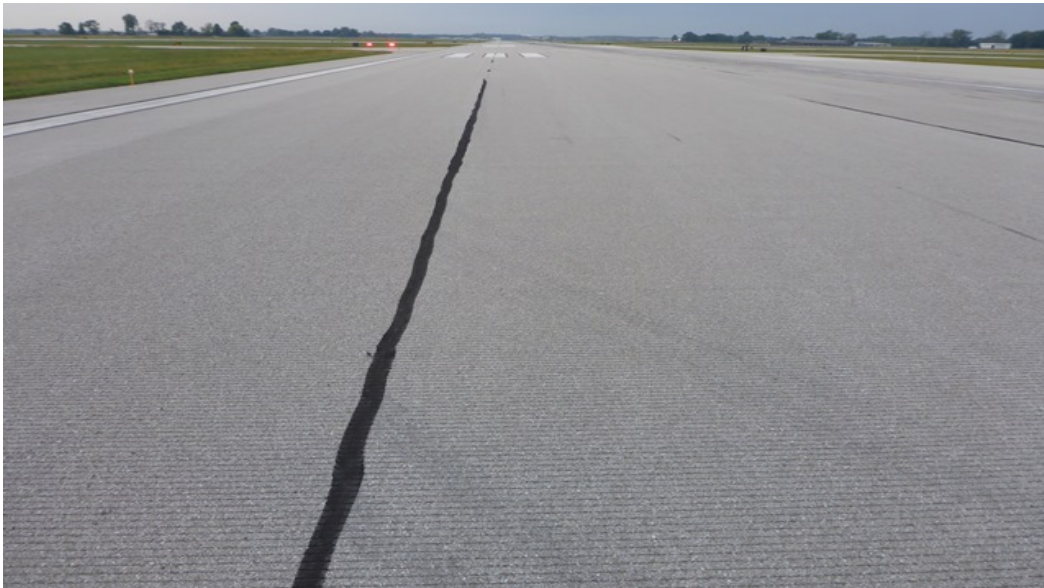
DISTRESS TYPE	SEVERITY	MEASURED QUANTITY	ESTIMATED TOTAL QUANTITY	UNITS	PERCENTAGE OF All DISTRESS
LONG.& TRANS. CRACK	LOW	4,518	28,020	L.F.	100

APPROXIMATE AMOUNT OF DISTRESS RELATED TO LOAD ON THE PAVEMENT IS:	0 %
APPROXIMATE AMOUNT OF DISTRESS RELATED TO MATERIALS PROBLEMS IN THE FEATURE IS:	67 %
APPROXIMATE AMOUNT OF DISTRESS RELATED TO AGE OF PAVEMENT AND TRAFFIC REPETITIONS IS:	33 %
