Pavement Condition Report

Wabash Municipal Airport

Project 16801839

January 2016

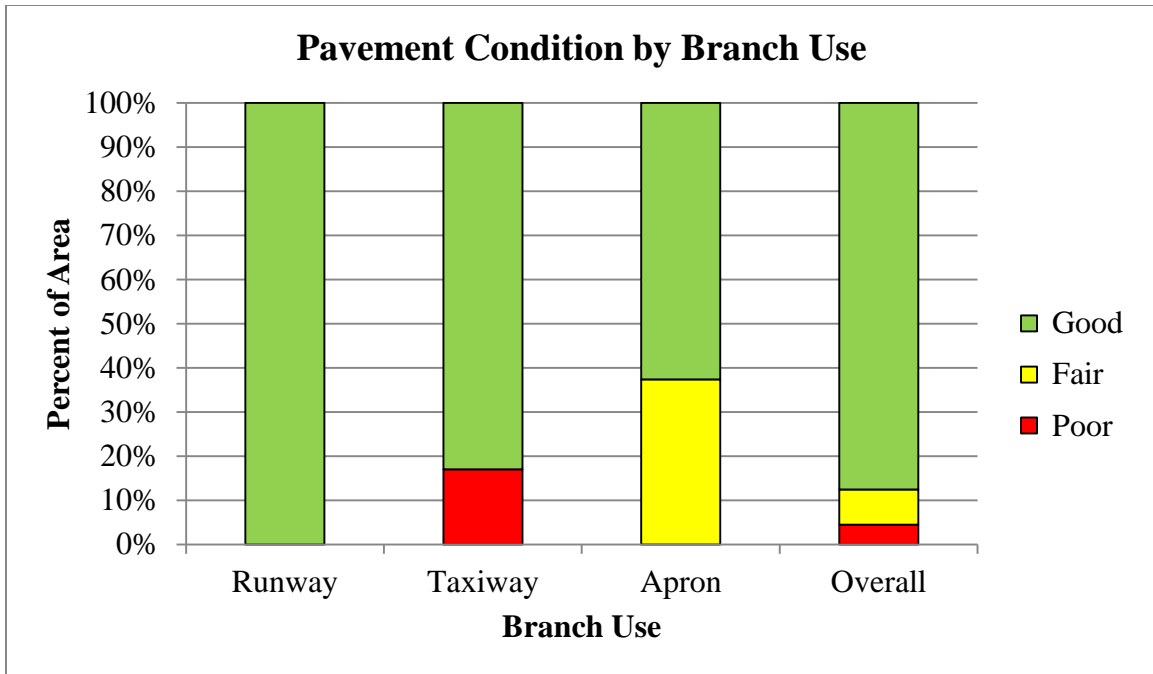
Figure 2-2. Pavement Condition by Branch Use

The pavement within each of the PCI condition categories is shown in Figure 2-1. The inspected PCI is summarized by branch use in Figure 2-2, and the photographs in Figure 2-3 through Figure 2-6 provide examples of the condition categories.

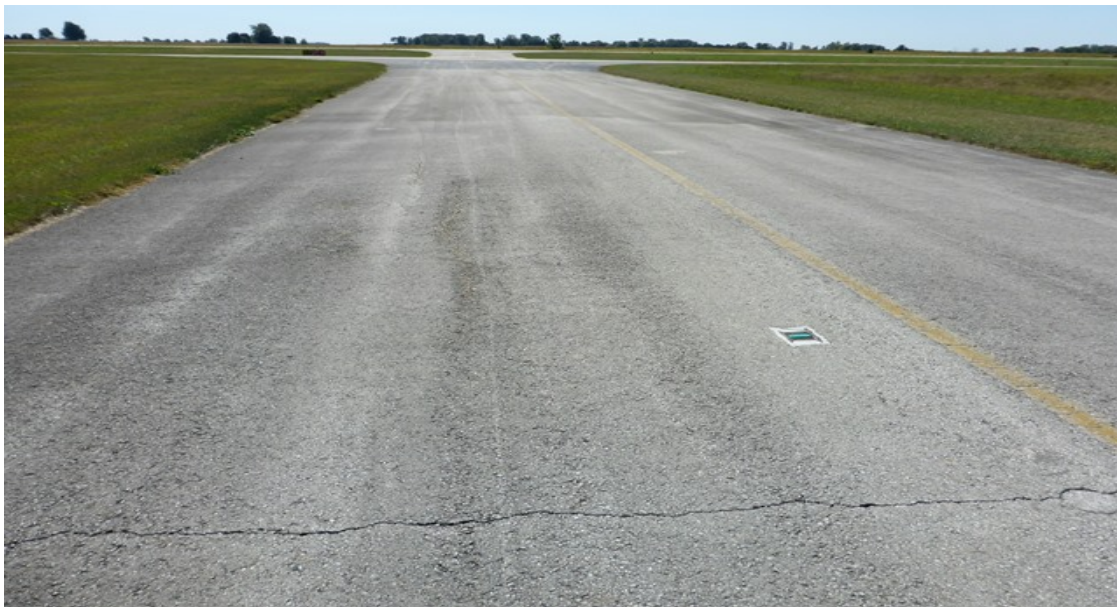
DISTRESS TYPE	SEVERITY	MEASURED QUANTITY	ESTIMATED TOTAL QUANTITY	UNITS	PERCENTAGE OF All DISTRESS
LONG.& TRANS. CRACK	MED	84	179	L.F.	49.7
LONG.& TRANS. CRACK	LOW	140	299	L.F.	29.1
WEATHERING	MED	300	642	S.F.	11.2
WEATHERING	LOW	1,500	3,211	S.F.	9.8

APPROXIMATE AMOUNT OF DISTRESS RELATED TO LOAD ON THE PAVEMENT IS:	0 %
APPROXIMATE AMOUNT OF DISTRESS RELATED TO MATERIALS PROBLEMS IN THE FEATURE IS:	60 %
APPROXIMATE AMOUNT OF DISTRESS RELATED TO AGE OF PAVEMENT AND TRAFFIC REPETITIONS IS:	40 %

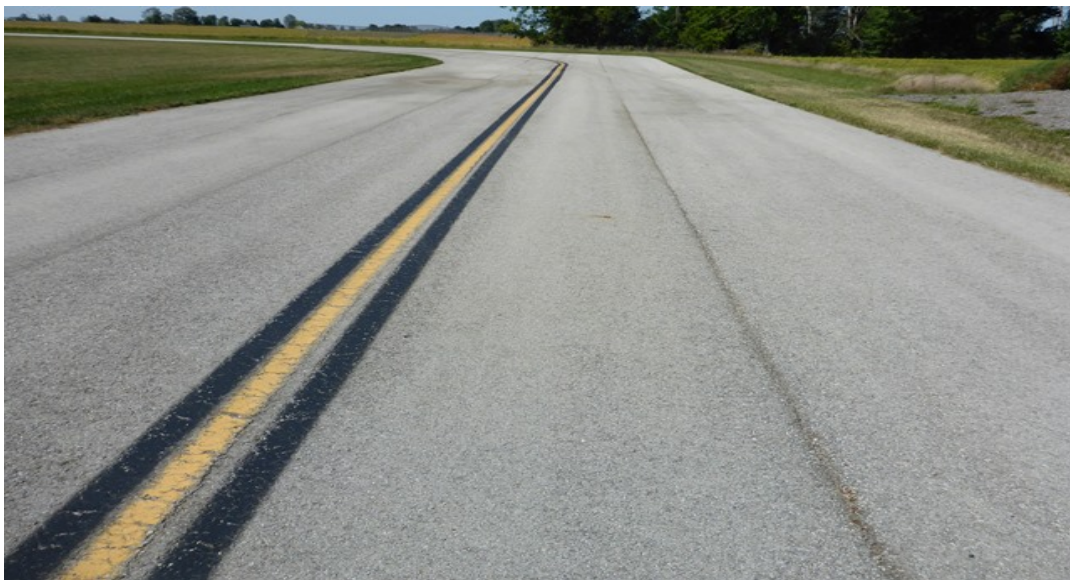
DISTRESS TYPE	SEVERITY	MEASURED QUANTITY	ESTIMATED TOTAL QUANTITY	UNITS	PERCENTAGE OF All DISTRESS
LONG.& TRANS. CRACK	MED	12	14	L.F.	14.5
LONG.& TRANS. CRACK	LOW	187	226	L.F.	37.4
PATCH & UTILITY CUT	LOW	350	423	S.F.	34.2
WEATHERING	MED	100	121	S.F.	3.6
WEATHERING	LOW	1,400	1,695	S.F.	10

APPROXIMATE AMOUNT OF DISTRESS RELATED TO LOAD ON THE PAVEMENT IS:	23 %
APPROXIMATE AMOUNT OF DISTRESS RELATED TO MATERIALS PROBLEMS IN THE FEATURE IS:	51 %
APPROXIMATE AMOUNT OF DISTRESS RELATED TO AGE OF PAVEMENT AND TRAFFIC REPETITIONS IS:	27 %

LEGEND	DESCRIPTION	COST	LIFE EXTENSION
▲	RESURFACING	\$12,204	23 YEARS
▼	SURFACE TREATMENT	\$3,322	6 YEARS
◆	CRACK REPAIR	\$297	1 YEAR
●	NO ACTION	N/A	N/A
-	MINIMUM SERVICE LEVEL, CURRENTLY 55

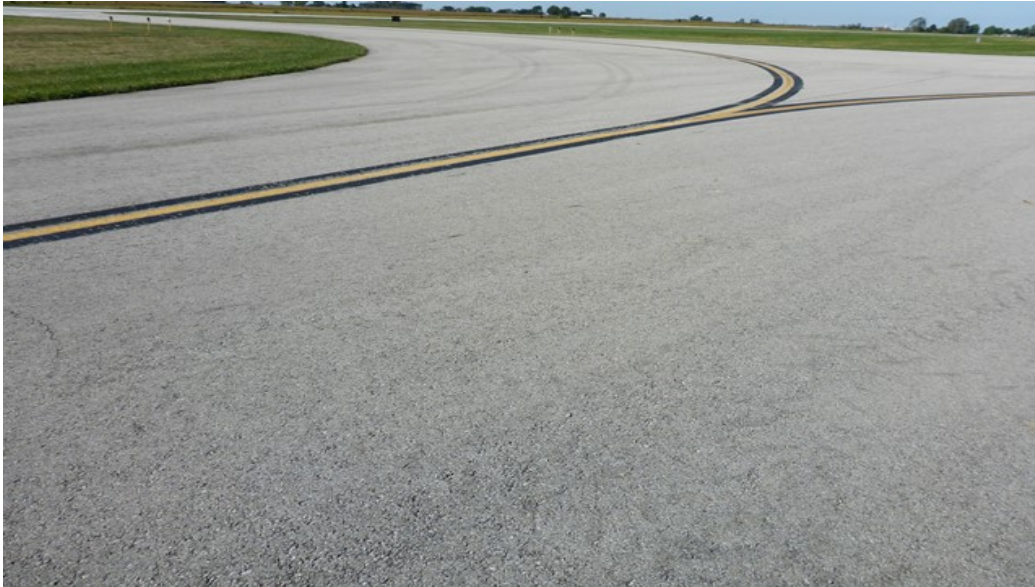
DISTRESS TYPE	SEVERITY	MEASURED QUANTITY	ESTIMATED TOTAL QUANTITY	UNITS	PERCENTAGE OF All DISTRESS
LONG.& TRANS. CRACK	LOW	136	246	L.F.	100

APPROXIMATE AMOUNT OF DISTRESS RELATED TO LOAD ON THE PAVEMENT IS:	0 %
APPROXIMATE AMOUNT OF DISTRESS RELATED TO MATERIALS PROBLEMS IN THE FEATURE IS:	67 %
APPROXIMATE AMOUNT OF DISTRESS RELATED TO AGE OF PAVEMENT AND TRAFFIC REPETITIONS IS:	33 %

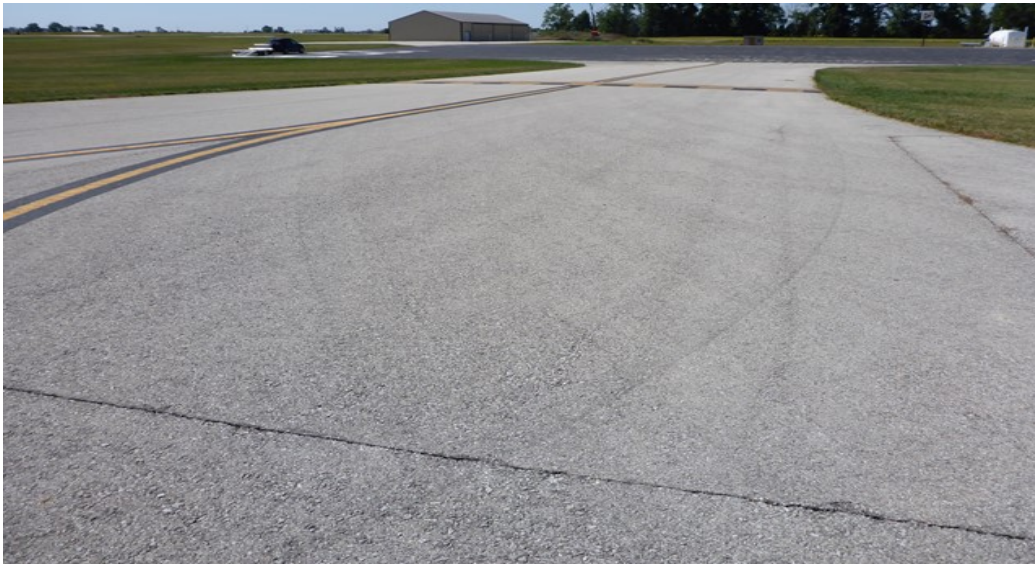
DISTRESS TYPE	SEVERITY	MEASURED QUANTITY	ESTIMATED TOTAL QUANTITY	UNITS	PERCENTAGE OF All DISTRESS
LONG.& TRANS. CRACK	LOW	48	60	L.F.	86.1
WEATHERING	LOW	400	499	S.F.	13.8

APPROXIMATE AMOUNT OF DISTRESS RELATED TO LOAD ON THE PAVEMENT IS:	0 %
APPROXIMATE AMOUNT OF DISTRESS RELATED TO MATERIALS PROBLEMS IN THE FEATURE IS:	62 %
APPROXIMATE AMOUNT OF DISTRESS RELATED TO AGE OF PAVEMENT AND TRAFFIC REPETITIONS IS:	38 %

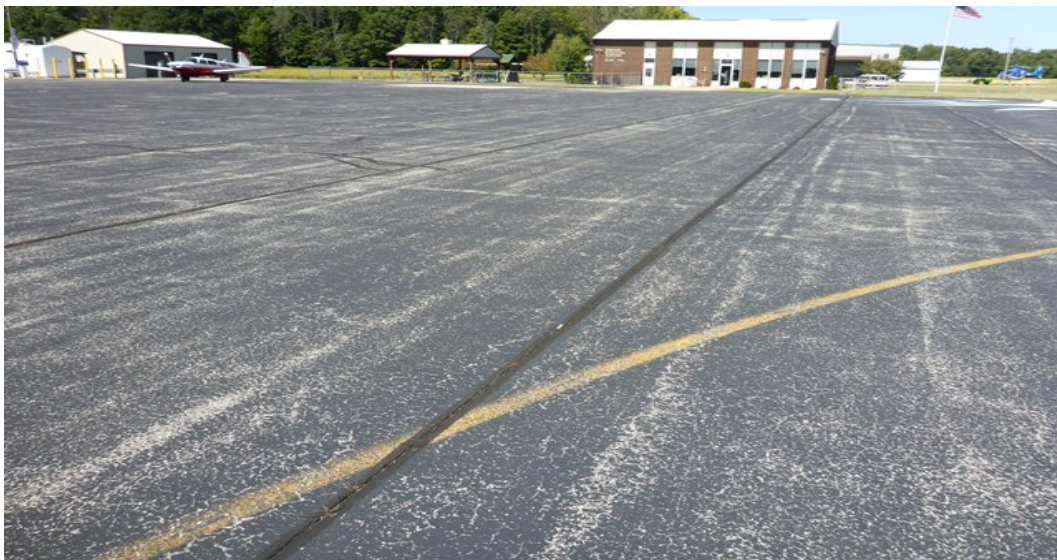
DISTRESS TYPE	SEVERITY	MEASURED QUANTITY	ESTIMATED TOTAL QUANTITY	UNITS	PERCENTAGE OF All DISTRESS
BLEEDING	N/A	72	195	S.F.	3.9
LONG.& TRANS. CRACK	MED	116	314	L.F.	18.7
LONG.& TRANS. CRACK	LOW	3,255	8,837	L.F.	69.1
PATCH & UTILITY CUT	LOW	550	1,493	S.F.	8.1

APPROXIMATE AMOUNT OF DISTRESS RELATED TO LOAD ON THE PAVEMENT IS:	5 %
APPROXIMATE AMOUNT OF DISTRESS RELATED TO MATERIALS PROBLEMS IN THE FEATURE IS:	65 %
APPROXIMATE AMOUNT OF DISTRESS RELATED TO AGE OF PAVEMENT AND TRAFFIC REPETITIONS IS:	29 %

LEGEND	DESCRIPTION	COST	LIFE EXTENSION
▲	RESURFACING	\$97,741	23 YEARS
▼	SURFACE TREATMENT	\$26,860	7 YEARS
◆	CRACK REPAIR	\$11,347	1 YEAR
●	NO ACTION	N/A	N/A
-	MINIMUM SERVICE LEVEL, CURRENTLY 55

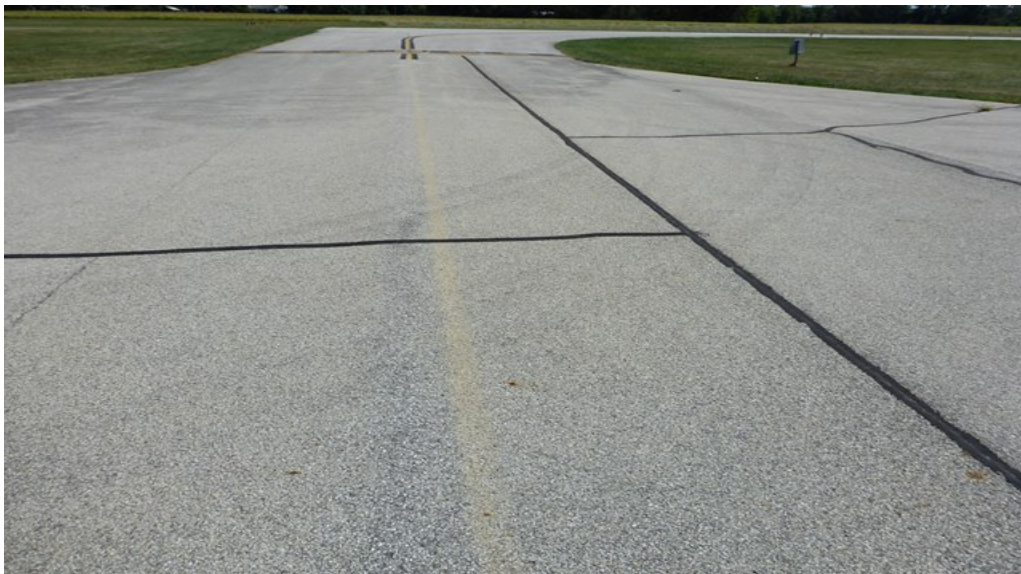
DISTRESS TYPE	SEVERITY	MEASURED QUANTITY	ESTIMATED TOTAL QUANTITY	UNITS	PERCENTAGE OF All DISTRESS
LONG.& TRANS. CRACK	LOW	369	1,739	L.F.	58.4
WEATHERING	MED	900	4,242	S.F.	27.4
WEATHERING	LOW	3,100	14,612	S.F.	14

APPROXIMATE AMOUNT OF DISTRESS RELATED TO LOAD ON THE PAVEMENT IS:	0 %
APPROXIMATE AMOUNT OF DISTRESS RELATED TO MATERIALS PROBLEMS IN THE FEATURE IS:	53 %
APPROXIMATE AMOUNT OF DISTRESS RELATED TO AGE OF PAVEMENT AND TRAFFIC REPETITIONS IS:	47 %

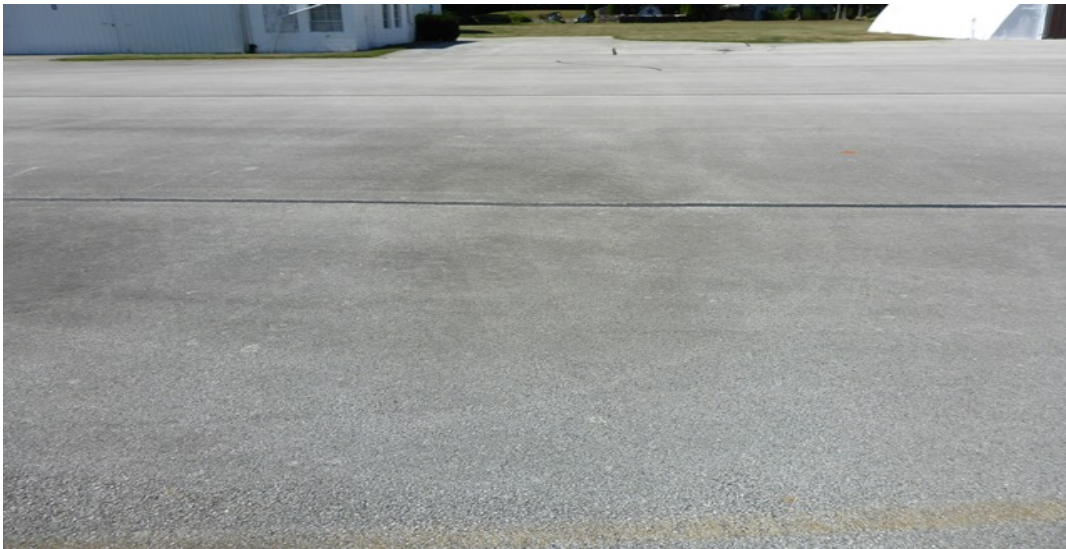
DISTRESS TYPE	SEVERITY	MEASURED QUANTITY	ESTIMATED TOTAL QUANTITY	UNITS	PERCENTAGE OF All DISTRESS
LONG.& TRANS. CRACK	MED	44	92	L.F.	35.2
LONG.& TRANS. CRACK	LOW	397	834	L.F.	60.9
SWELL	LOW	10	21	S.F.	3
WEATHERING	LOW	150	315	S.F.	.8

APPROXIMATE AMOUNT OF DISTRESS RELATED TO LOAD ON THE PAVEMENT IS:	0 %
APPROXIMATE AMOUNT OF DISTRESS RELATED TO MATERIALS PROBLEMS IN THE FEATURE IS:	67 %
APPROXIMATE AMOUNT OF DISTRESS RELATED TO AGE OF PAVEMENT AND TRAFFIC REPETITIONS IS:	33 %

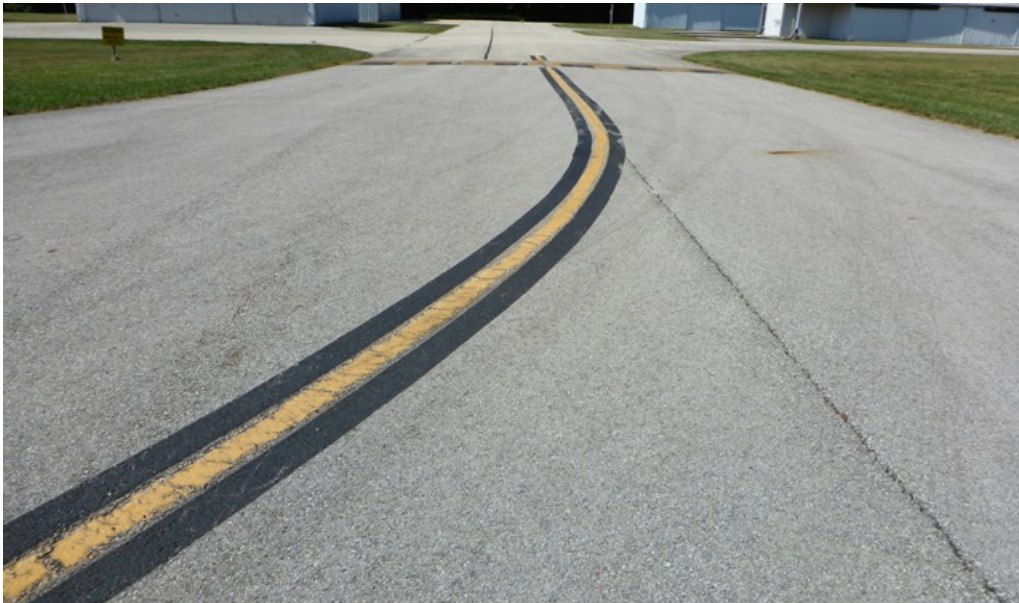
DISTRESS TYPE	SEVERITY	MEASURED QUANTITY	ESTIMATED TOTAL QUANTITY	UNITS	PERCENTAGE OF All DISTRESS
LONG.& TRANS. CRACK	MED	40	40	L.F.	55.7
LONG.& TRANS. CRACK	LOW	103	103	L.F.	39.3
WEATHERING	LOW	300	300	S.F.	4.9

APPROXIMATE AMOUNT OF DISTRESS RELATED TO LOAD ON THE PAVEMENT IS:	0 %
APPROXIMATE AMOUNT OF DISTRESS RELATED TO MATERIALS PROBLEMS IN THE FEATURE IS:	65 %
APPROXIMATE AMOUNT OF DISTRESS RELATED TO AGE OF PAVEMENT AND TRAFFIC REPETITIONS IS:	35 %

LEGEND	DESCRIPTION	COST	LIFE EXTENSION
▲	RESURFACING	\$5,760	23 YEARS
▼	SURFACE TREATMENT	\$1,609	8 YEARS
◆	CRACK REPAIR	\$177	2 YEARS
●	NO ACTION	N/A	N/A
-	MINIMUM SERVICE LEVEL, CURRENTLY 55

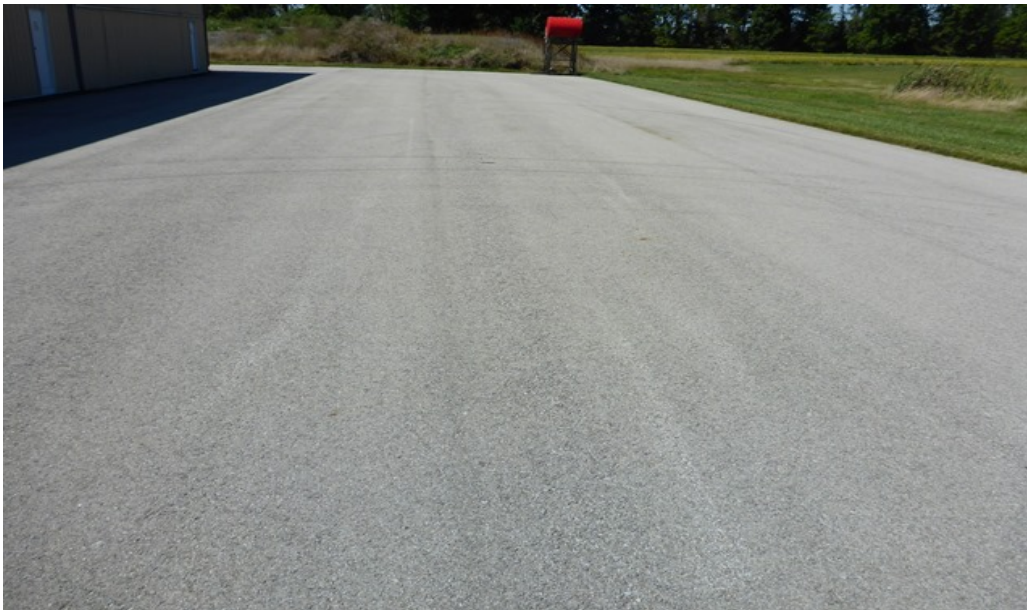
DISTRESS TYPE	SEVERITY	MEASURED QUANTITY	ESTIMATED TOTAL QUANTITY	UNITS	PERCENTAGE OF All DISTRESS
LONG.& TRANS. CRACK	LOW	47	138	L.F.	26.6
PATCH & UTILITY CUT	LOW	594	1,755	S.F.	50.2
SWELL	LOW	1	2	S.F.	4.1
WEATHERING	LOW	1,750	5,171	S.F.	18.9

APPROXIMATE AMOUNT OF DISTRESS RELATED TO LOAD ON THE PAVEMENT IS:	33 %
APPROXIMATE AMOUNT OF DISTRESS RELATED TO MATERIALS PROBLEMS IN THE FEATURE IS:	45 %
APPROXIMATE AMOUNT OF DISTRESS RELATED TO AGE OF PAVEMENT AND TRAFFIC REPETITIONS IS:	22 %

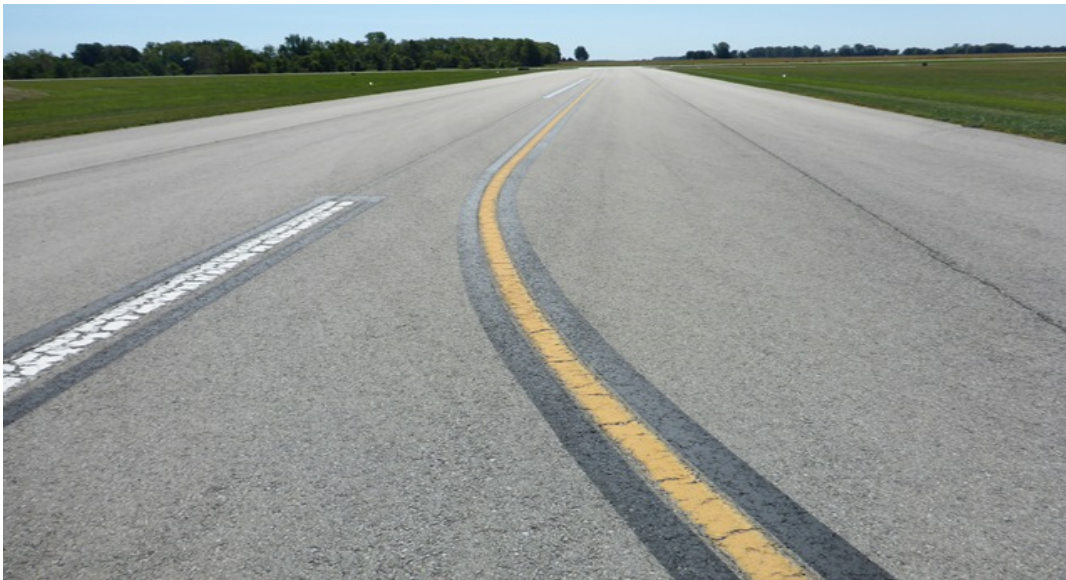
DISTRESS TYPE	SEVERITY	MEASURED QUANTITY	ESTIMATED TOTAL QUANTITY	UNITS	PERCENTAGE OF All DISTRESS
DEPRESSION	LOW	60	196	S.F.	5.8
LONG.& TRANS. CRACK	MED	134	438	L.F.	30
LONG.& TRANS. CRACK	LOW	1,387	4,541	L.F.	64.1

APPROXIMATE AMOUNT OF DISTRESS RELATED TO LOAD ON THE PAVEMENT IS:	0 %
APPROXIMATE AMOUNT OF DISTRESS RELATED TO MATERIALS PROBLEMS IN THE FEATURE IS:	69 %
APPROXIMATE AMOUNT OF DISTRESS RELATED TO AGE OF PAVEMENT AND TRAFFIC REPETITIONS IS:	31 %

LEGEND	DESCRIPTION	COST	LIFE EXTENSION
▲	RESURFACING	\$169,722	20 YEARS
▼	CRACK REPAIR	\$6,173	1 YEAR
●	NO ACTION	N/A	N/A
-	MINIMUM SERVICE LEVEL, CURRENTLY 60
