HAZARDOUS AND REGULATED MATERIALS INSPECTION REPORT

1700-1704 Broadway

Gary, Indiana 46407

February 12, 2025

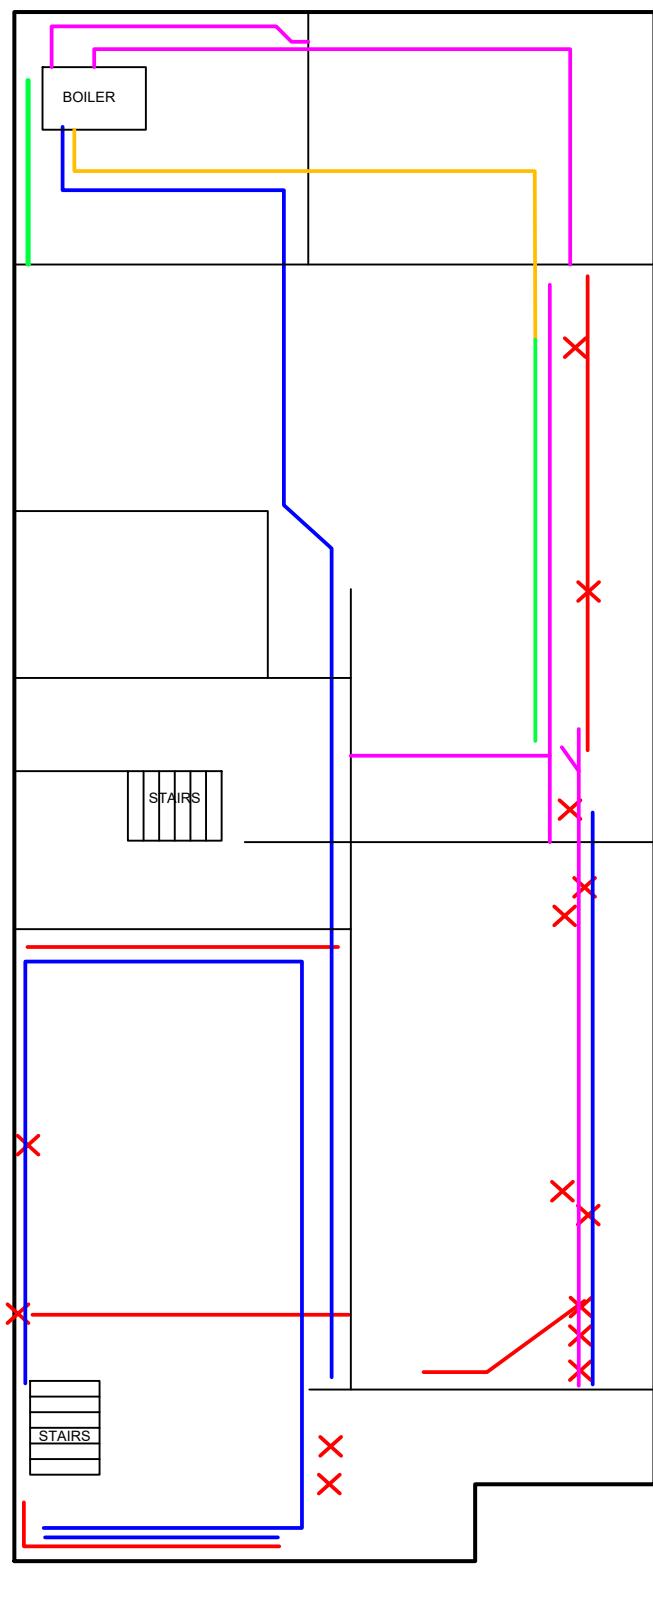
FIGURE 3
FLOOR LAYOUTS W/ TSI LOCATIONS
FORMER LOVELL'S BARBERSHOP
1700 – 1704 BROADWAY STREET
GARY, INDIANA 46407

Based on the results of this inspection, friable RACMs in the form of TSI pipe wrap on horizontal and vertical pipe chases and pipe fittings (mudded joints) cladded on the elbows of pipe chases were identified throughout the site building, primarily within the basement. The TSI pipe wrap and TSI pipe fittings were identified as PACMs and were therefore not sampled. A site map depicting TSI locations is provided as Figure 3.
