**PROPRIETARY MATERIAL
USE JUSTIFICATION**

Unique Special Provision

Rammed Aggregate Piers (RAP's)

Stabilization of Failing Slopes Using Rammed Aggregate Pier Reinforcing Elements

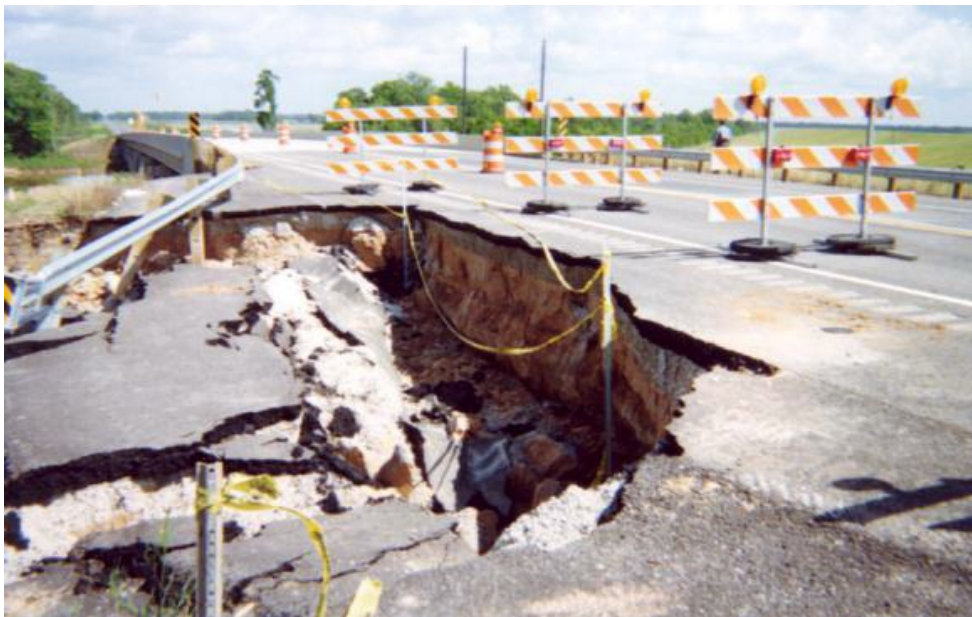
Figure 2- Slope Failure at US-71, Krotz Springs, LA

The southwest embankment of the southeast approach bridge ramp of US Highway 71 over Bayou Des Glaises experienced a recurring slope failure after placement of a new 0.9 m to 1.5 m (3 to 5 foot) high fill embankment as part of the construction of a new replacement bridge. The slope failure produced a 1.2 m (4 foot) high scarp and the failed mass displaced out approximately 3 m to 4.5 m (10 to 15 feet) into the Bayou Des Glaises as shown in Figure 2. The slide caused the Louisiana Department of Transportation to shut the southeast bound lane of the road because of the potential of progressive sloughing towards the centerline of the road.

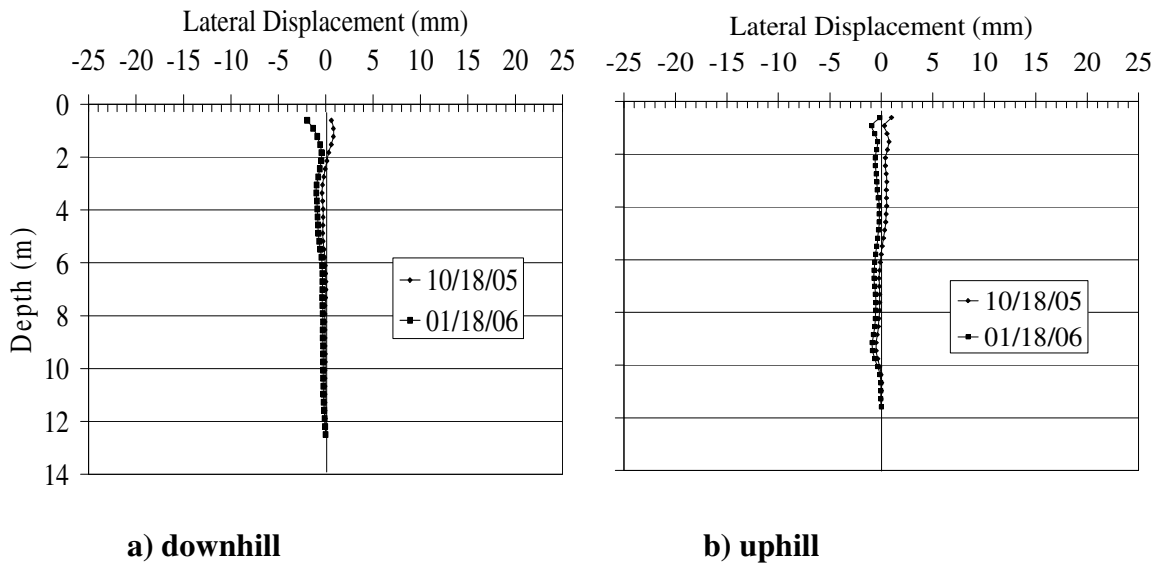
Figure 5- US-71 Slope Repair Lateral Displacement Monitoring Results.

Post-installation lateral displacement monitoring was conducted during a 15-month period after RAP installation. Two vertical inclinometers were installed to a depth of 13.7 m (45 feet). One inclinometer was installed near the top of the slope (uphill) and one inclinometer was installed up the slope from the RAPs area (downhill). The lateral displacement measured in the inclinometers was less than 5 mm (0.2 inches) as shown in Figure 5.

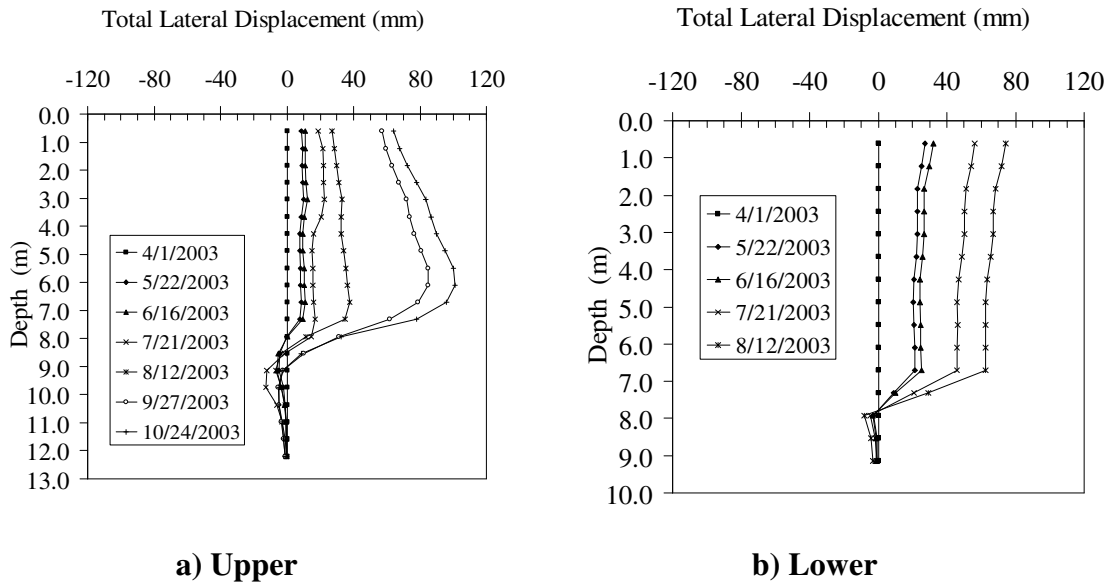
Figure 7- Summary of the Pre-repair Inclinometer Data at Highway 167 Near Batesville, AR.

During the monitoring period both the inclinometers and the TDR cables indicated movement. Figures 7 and 8 illustrate that movement. Incremental movement reported in Figures 7 and 8 illustrate that a distinct failure surface developed at approximately 7 m (23 feet) in the upper inclinometer casing. That failure surface was also detected by the TDR cable at a depth of 7.5 m (25 feet) as indicated by the downward “spike” of the waveforms in the circled region in Figure 8. Significant deformation was experienced in the failed mass, causing the lower inclinometer casing to be sheared four months into the monitoring program impeding further inclinometer readings. The TDR cable, however, continued to report movement until the end to the monitoring program. The shear surface was identified passing through the soft shale.

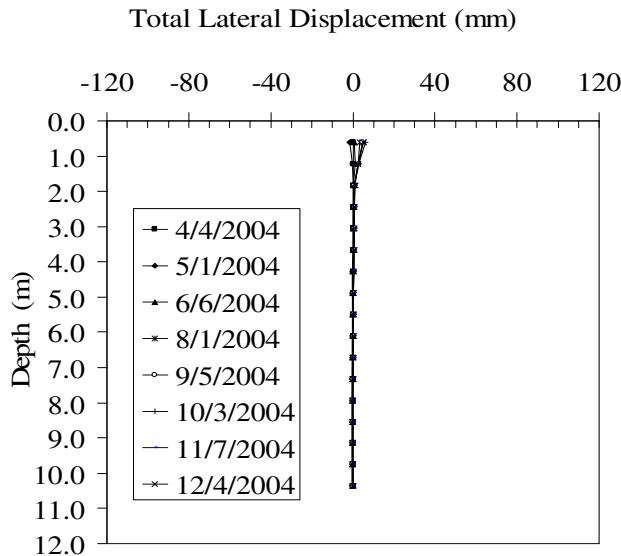
Figure 9- Post-Slope Repair Lateral Displacement Monitoring Results.

Following the slide repair, new inclinometer casings and TDR cables were installed in the vicinity of the pre repair monitoring locations. In addition to monitoring movement of the slope, the Arkansas Department of Transportation also wanted to monitor water levels in the slide area. For that purpose, the inclinometer casings were converted into pseudo-piezometers by perforating the area between the grooves with 6.5 mm (0.25 inch) holes for the lowest 3 m (10 feet) of each casing. The casings were again installed in 200 mm (8 inches) diameter boreholes. However, rather than grouting the full length of the casing like the pre-repair inclinometers, the lowest 5 m (16 feet) of each borehole was backfilled with pea gravel before grouting to the surface with a weak bentonite-cement grout. TDR cables were grouted in adjacent 100 mm (4 inches) diameter boreholes using a bentonite-cement grout having an unconfined compressive strength of 1,725 kPa (250 psi). During the one year monitoring period following the repair, no significant movement was observed at any of the monitoring stations. Figure 9 provides a summary of the movement reported by the lower inclinometer. Water levels in the inclinometer casings were observed at every visit during the post-repair monitoring program. The free water surface in the upper casing ranged from 5.5 to 6.5 m (18 to 21 feet) below the ground surface while levels in the lower casing ranged from 2.6 to 4 m (8.5 to 13 feet) below the ground surface. The trend of the free water surface in both casings was downward during the monitoring period. By comparing these water levels to the stratigraphy portrayed in Figure 6, one can see the free water surface was nearly horizontal across the failure site and was located approximately 1 to 2 meters (3 to 6.5 feet) above the weathered shale.

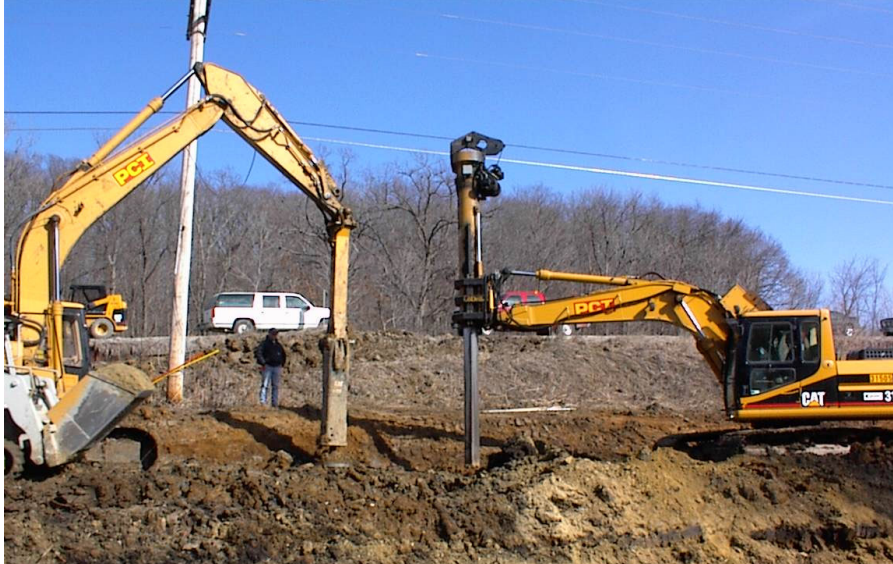
State Road P48 Landslide Stabilization Dallas County, Iowa

Description: Grading operations associated with the construction of State Road P48 coupled with high groundwater and a weak soil/shale zone resulted in a problematic landslide condition.

Subsurface Conditions: Clay fill and glacial till soils underlain by a weak zone of shale at depths on the order of 20 to 25 foot below grade. Friction angles in the shale were on the order of 8 to 10 degrees.

Design Details: *Geopier*® soil reinforcing elements were installed to depths of up to 30 feet to penetrate the weak shale zone and intersect the critical shearing surface. A total of 579 elements were installed to increase the factor of safety and prevent further movement of the slide. A 5-foot soil cap was installed in the tops of the piers to reduce the amount of groundwater infiltration through the piers. The Geopier soil reinforcement solution resulted in a cost of \$170,000 representing a cost savings of over \$700,000 compared to other options being considered.
