INDEX	
SHEET NO.	SUBJECT
1	Joint Repair Index and General Notes
2	Longitudinal Joint Repair, Partial Depth
3	Transverse Joint Repair, Partial Depth
4	Joint Repair, Bottom-Half

INDIANA DEPARTMENT OF TRANSPORTATION	
JOINT REPAIR INDEX AND GENERAL NOTES SEPTEMBER 2021	
STANDARD DRAWING NO. E 509-CCJR-01

INDIANA DEPARTMENT OF TRANSPORTATION	
LONGITUDINAL JOINT REPAIR, PARTIAL DEPTH	
SEPTEMBER 2021	
STANDARD DRAWING NO.	E 509-CCJR-02

INDIANA DEPARTMENT OF TRANSPORTATION					
TRANSVERSE JOINT REPAIR, PARTIAL DEPTH					
SEPTEMBER 2021					
STANDARD DRAWING NO.	E 509-CCJR-03				
	<table style="width: 100%; border: none;"> <tr> <td style="text-align: center; vertical-align: bottom;"> DESIGN STANDARDS ENGINEER </td> <td style="text-align: right; vertical-align: bottom;"> 2/11/2021 DATE </td> </tr> <tr> <td style="text-align: center; vertical-align: bottom;"> CHIEF ENGINEER </td> <td style="text-align: right; vertical-align: bottom;"> 2/11/2021 DATE </td> </tr> </table>	 DESIGN STANDARDS ENGINEER	2/11/2021 DATE	 CHIEF ENGINEER	2/11/2021 DATE
 DESIGN STANDARDS ENGINEER	2/11/2021 DATE				
 CHIEF ENGINEER	2/11/2021 DATE

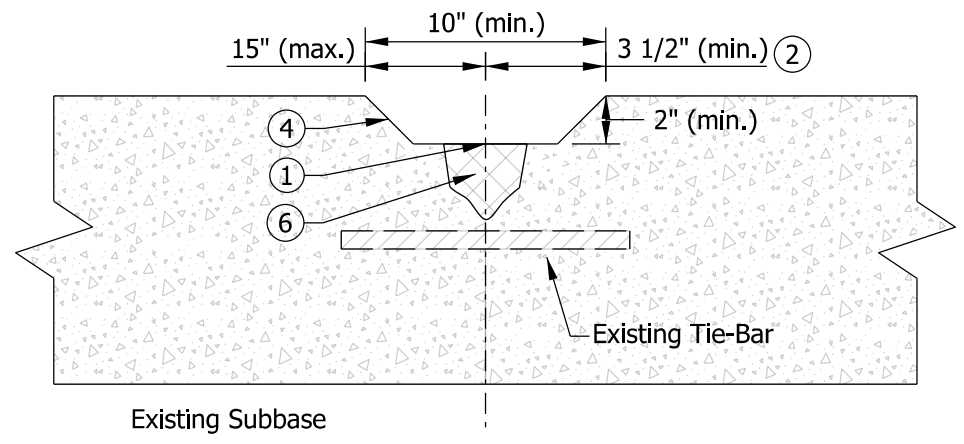
REMOVAL DETAIL STRADDLING JOINT WITHOUT EXPOSED TIE-BAR

- ① Joint shall be reestablished by either preformed joint filler or saw cut option with tooling.
- ② Repairs that involve both sides of the joint shall have at least 3 1/2 in. of milling width on both sides of the joint. The overall milling width shall be at least 10 in.

- ④ Sides of repair shall be tapered 30° - 60° from vertical.
- ⑤ Full depth patching shall be used where the width of unsound concrete at the depth of the tie-bar exceeds 5 in.

- ⑥ 2 in. minimum milling shown, additional hand chipping may be required to remove unsound concrete.
7. Existing tie-bars exposed after removal shall be removed to the face of existing concrete. For tie-bar tolerance, see Standard Drawing Series E 503-CCPJ.

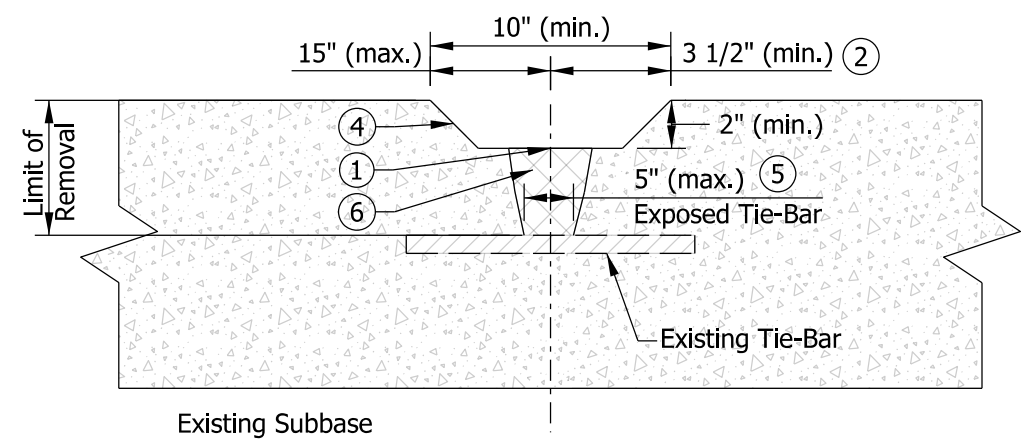
REMOVAL DETAIL STRADDLING JOINT WITH EXPOSED TIE-BAR

8. Any voids resulting from hand chipping that extend below the tie-bars may be filled with repair concrete. Removal of the unsound concrete below the elevation of the tie-bars is not intended.

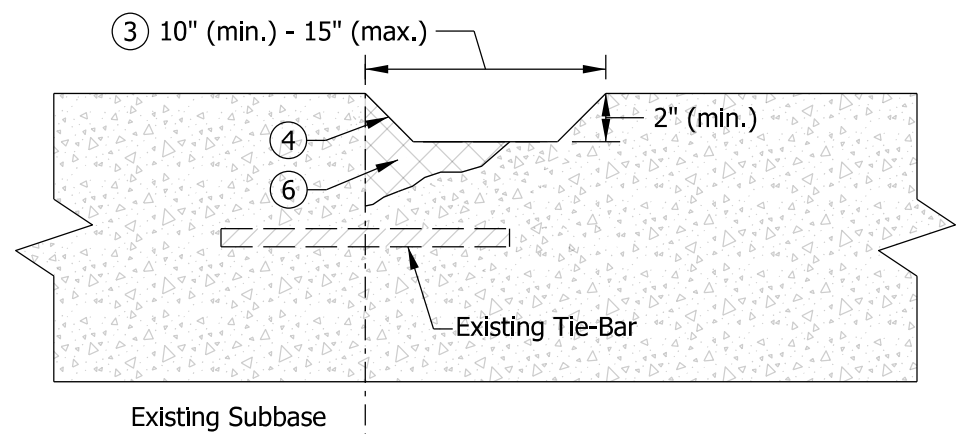
REMOVAL DETAIL ADJACENT TO JOINT WITHOUT EXPOSED TIE-BAR

- ③ Repairs that only involve one side of the joint shall have at least 10 in. of milling width, as measured from the joint, and shall not disturb the concrete in the adjacent slab.

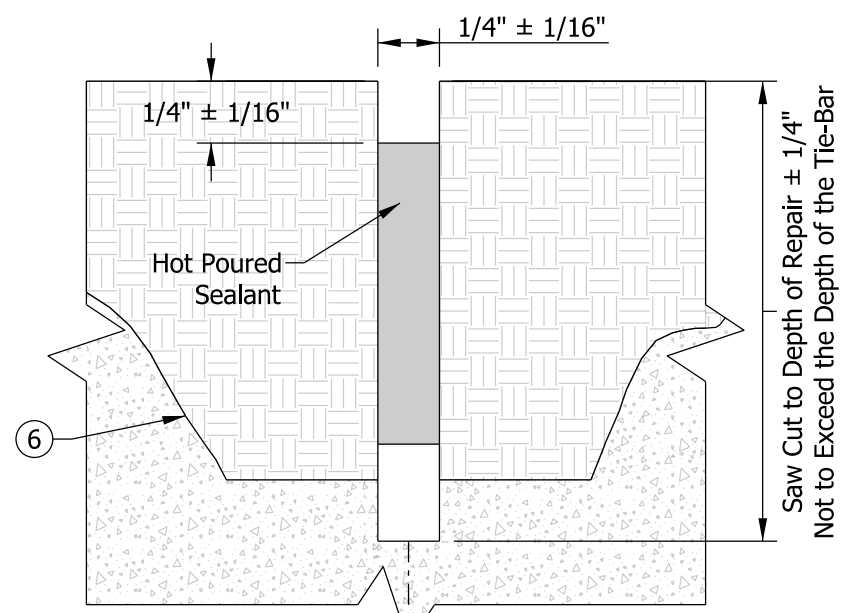
JOINT DETAIL- SAW CUT OPTION

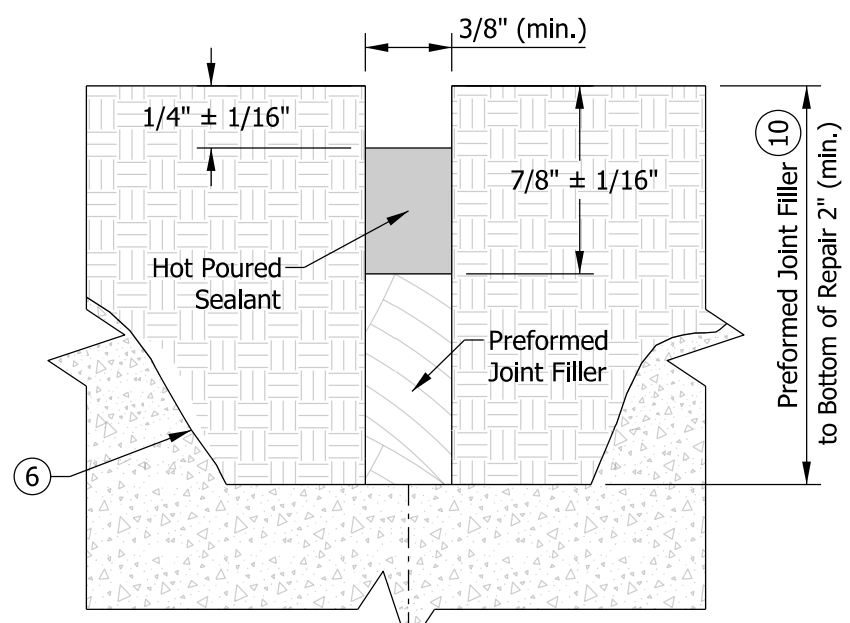
JOINT DETAIL- PREFORMED JOINT FILLER OPTION (Final Configuration)

9. Repairs shall be terminated 12 in. or more from a transverse joint.
- ⑩ Preformed Joint Filler initially installed to top of repair. A portion shall be sawed out to create reservoir for hot pour sealant.

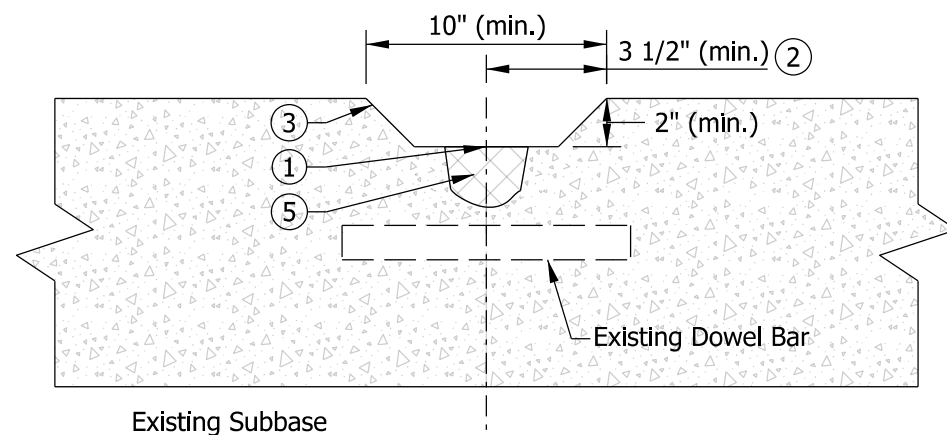
**REMOVAL DETAIL WITHOUT EXPOSED DOWEL BAR
STRADDLING JOINT**

- ① Joints shall be reestablished by installing 3/8 in. preformed joint filler prior to concrete placement.
- ② Repairs that involve both sides of the joint shall have at least 3 1/2 in. of milling width on both sides of the joint. The overall milling width shall be at least 10 in.

- ③ Sides of repair shall be tapered 30° - 60° from vertical.
- ④ Full depth patching shall be used where the width of unsound concrete at the depth of the tie-bar exceeds 2 in.

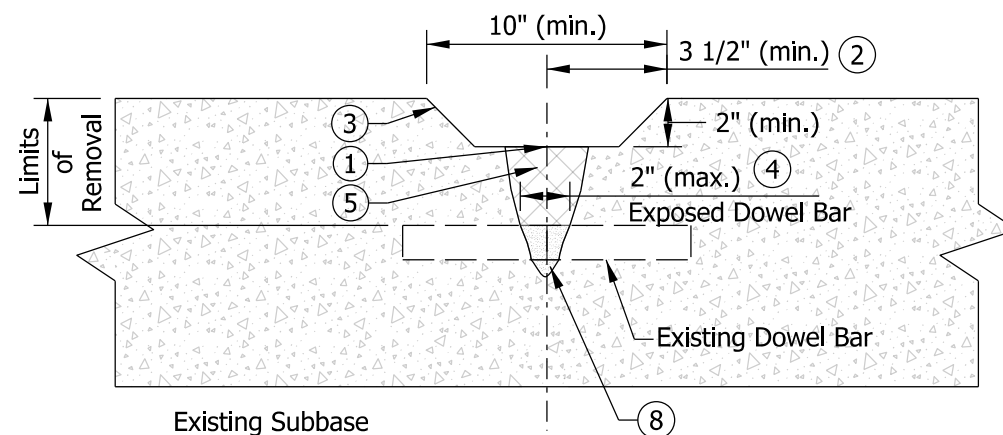
**REMOVAL DETAIL WITH EXPOSED DOWEL BAR
STRADDLING JOINT**

- ⑤ 2 in. minimum milling shown, additional hand chipping may be required to remove unsound concrete.
6. Existing dowel bars exposed after removal that are either misaligned or severely corroded shall be removed to the face of existing concrete. For dowel bar tolerance, see Standard Drawing Series E 503-CCPJ.

7. Exposed areas of dowel bars shall be covered with duct tape as a bond breaker.
- ⑧ Any voids resulting from hand chipping that extend below the elevation of the top of the dowel bars shall be filled with dry clean sand. Removal of the unsound concrete below the elevation of the top of the dowel bars is not intended.

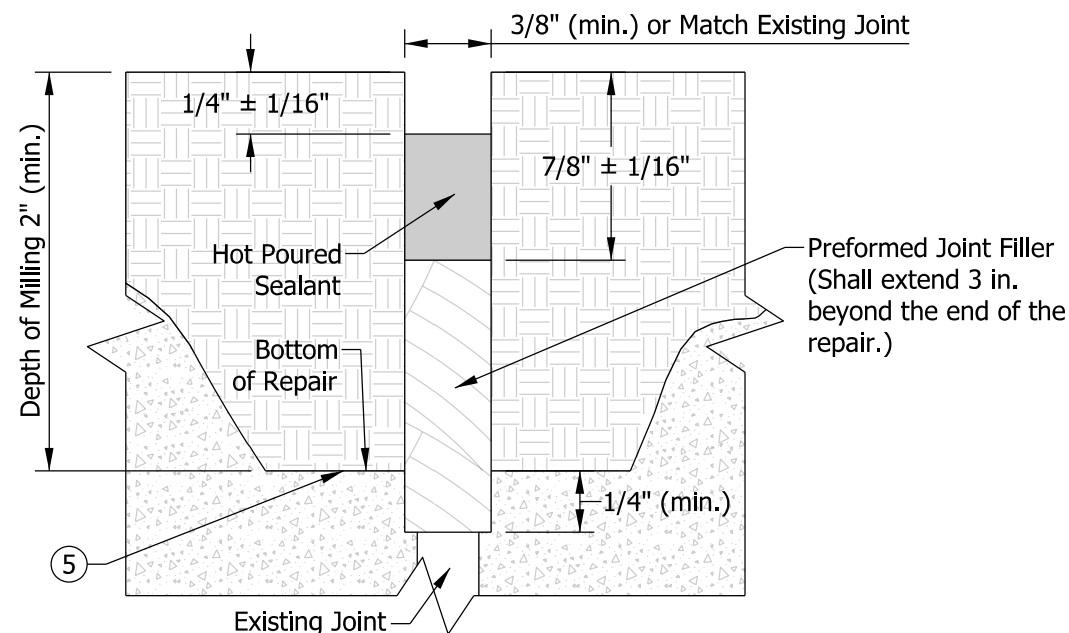
**JOINT REPAIR DETAILS
(showing repair straddling joint)**

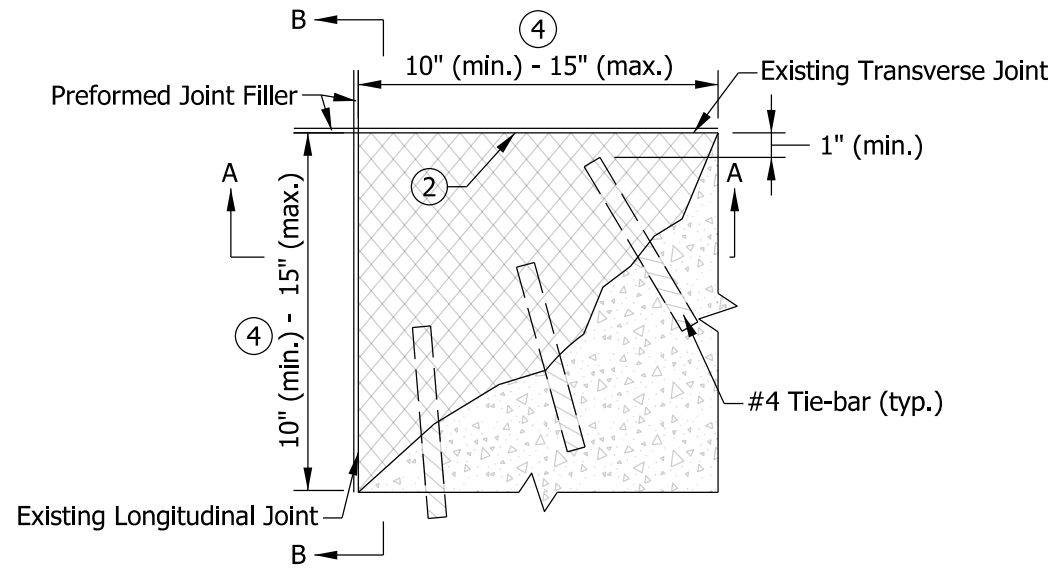
CORNER SLAB REPAIR - PLAN VIEW

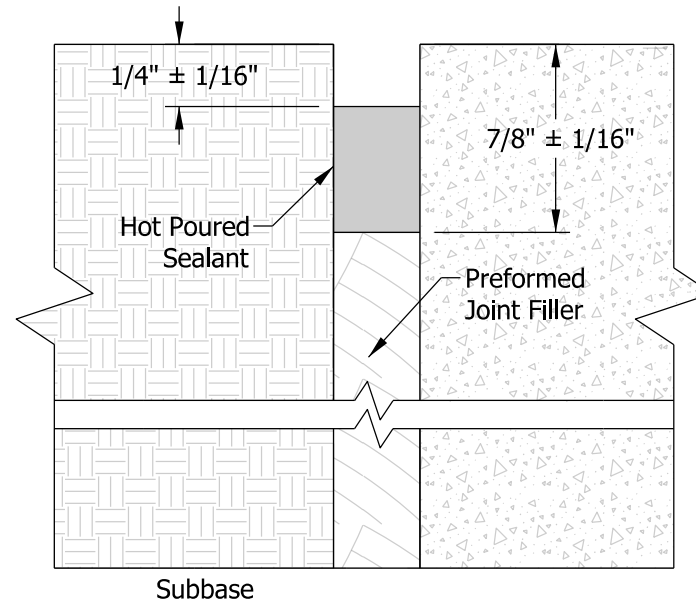
SECTION B-B

(showing repaired concrete)

1. #4 tie-bars shall be installed at 6 in. spacing, center to center while maintaining a minimum 2 in. of cover and 1 in. of clearance from the vertical sides of the joint.
2. Joints shall be reestablished by installing full depth preformed expansion joint filler to match the existing transverse joint prior to concrete placement.
3. Area for joint repair, bottom-half will be measured at D/2.
4. 15 in. maximum or as approved by the Engineer.
5. #4 tie-bars may be installed at an angle to clear the adjacent existing concrete, but shall be field bent horizontal prior to installation.
6. Pay limits for partial depth joint repair.

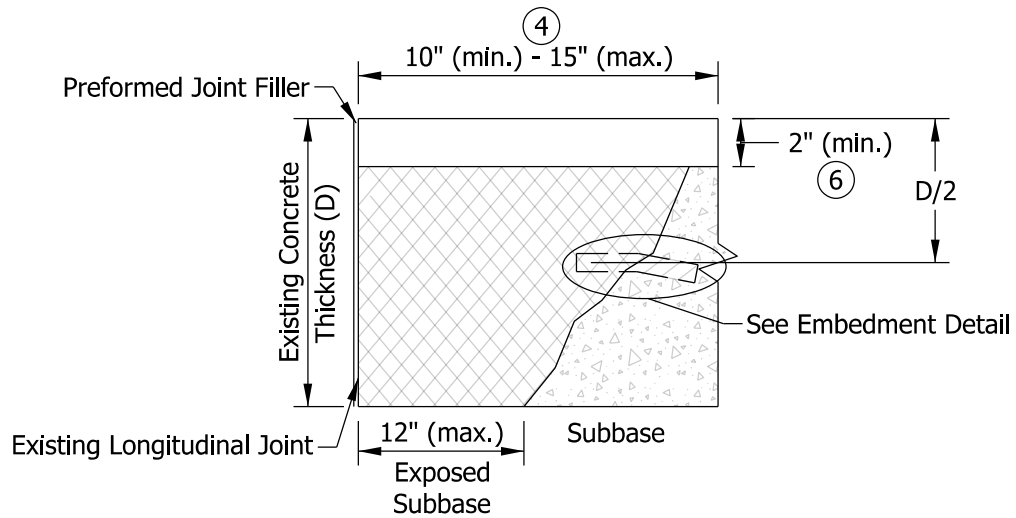
SECTION A-A

(showing concrete removal)

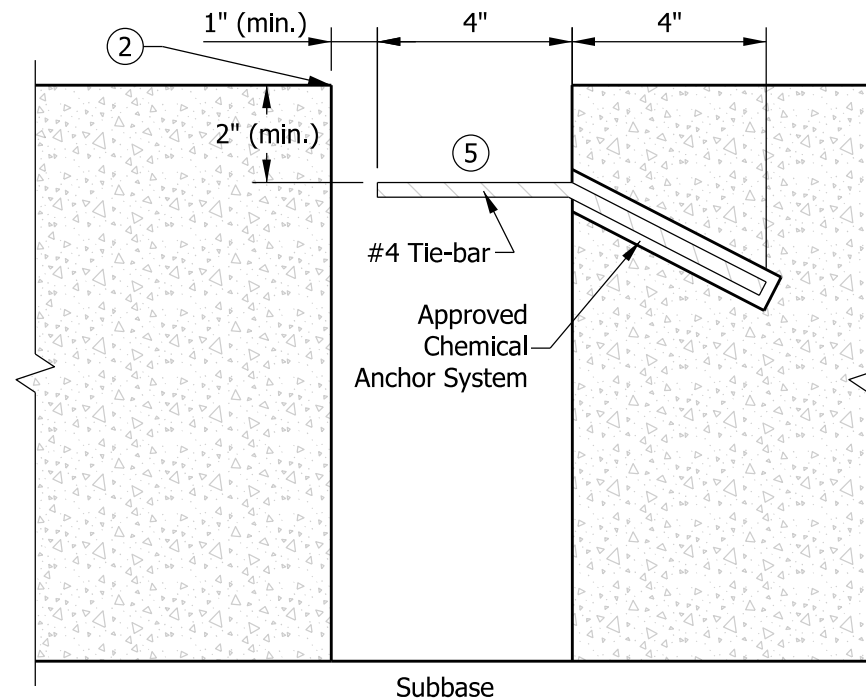
EMBEDMENT DETAIL
