January 2024 to December 2024

ANNUAL STATE OF THE ITR REPORT

This 2024 Indiana Toll Road (ITR) *Annual State of the ITR Report* has been prepared in accordance with the Amended and Restated *Concession and Lease Agreement* (CLA) for the Indiana Toll Road.

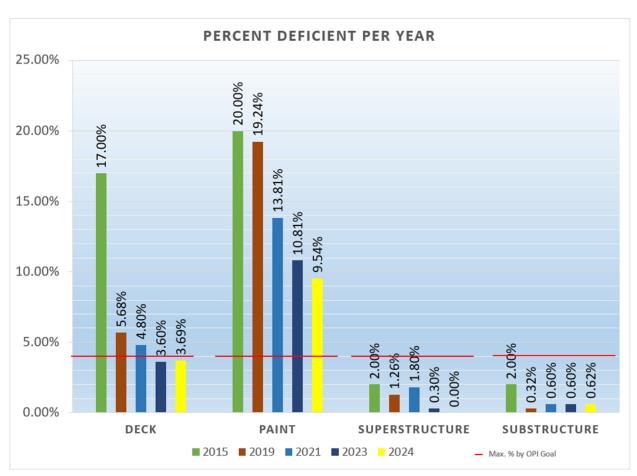
Figure 1.1: Bridge Condition Ratings

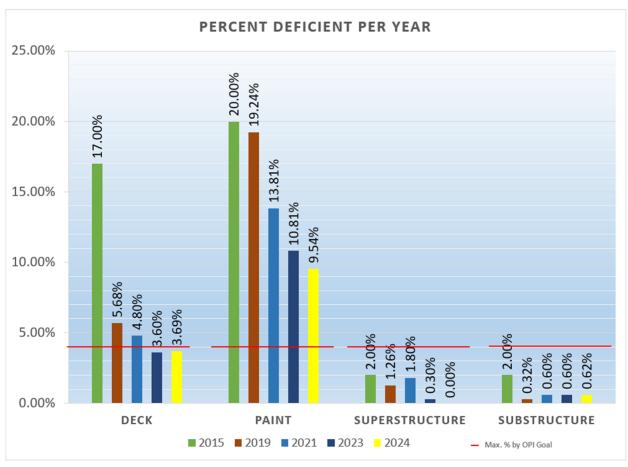
**Figure 3.0: Bridge Condition Ratings** illustrates that there has been an overall decrease in deficiencies in several of the individual items compared to previous years. Decreases in deficiencies for Deck and Paint are due to the implementation of the PUSH projects and additional job order contracts. The three phases of PUSH have addressed over 25% of the structures within the ITR corridor.

Figure 3.0: Bridge Condition Ratings

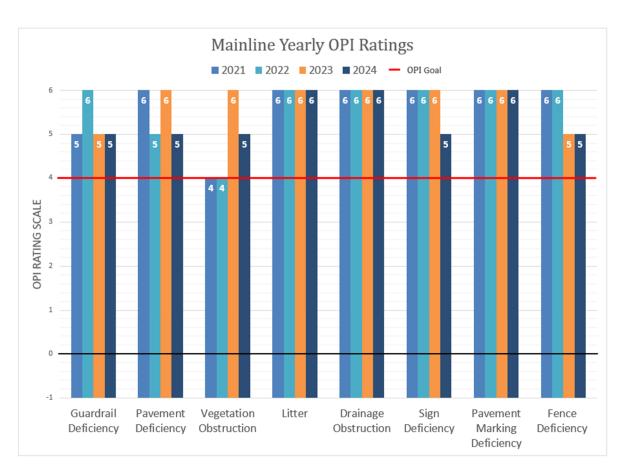
Figure 5.1: Mainline Plaza Yearly OPI Ratings

**Table 5.2: Mainline Maintenance Items for ITR** provides the total accumulated deficiencies for the entirety of the mainline. **Tables 5.3** – **5.7**, located in Appendix E, represent each maintenance district, and list the number of deficiencies, deficiency rates, and OPI ratings for the eight mainline maintenance items. The ratings range from 0 to 6, with 6 being the highest. **Figure 5.1: Mainline Yearly OPI Ratings** illustrates the mainline maintenance OPI rating progression over the past three years in comparison to the 2024 ratings.

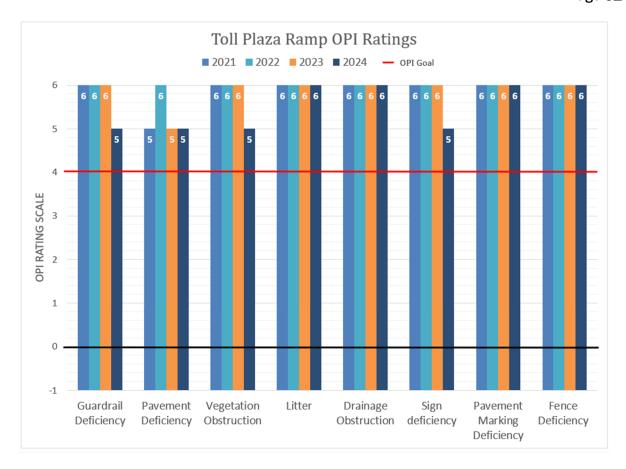
Figure 5.2: Toll Plaza Ramp OPI Ratings

**Table 5.8: Toll Plaza Maintenance Items for ITR** provides the total accumulated deficiencies for the entirety of the toll plazas. **Tables 5.9** – **5.13**, located in Appendix E, represent each maintenance district, and list the number of deficiencies, deficiency rates, and OPI ratings for the eight toll plaza maintenance items. The ratings range from 0 to 6, with 6 being the highest. **Figure 5.2: Toll Plaza Ramp OPI Ratings** illustrates the Toll Plaza Ramp Maintenance OPI rating progression over the past three years in comparison to the 2024 ratings.

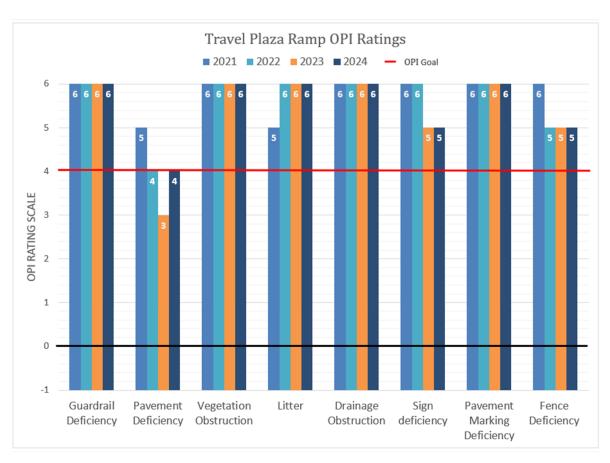
Figure 5.3: Travel Plaza Ramp OPI Ratings

**Table 5.14:** Travel Plaza and Truck Parking Maintenance Items for ITR provides the total accumulated deficiencies for the entirety of the travel plazas. **Tables 5.15** – **5.19**, located in Appendix E, represent each maintenance district, and list the number of deficiencies, deficiency rates, and OPI ratings for the eight travel plaza maintenance items. The ratings range from 0 to 6, with 6 being the highest. **Figure 5.3: Travel Plaza Ramp OPI Ratings** illustrates the Toll Plaza Ramp Maintenance OPI rating progression over the past three years in comparison to the 2024 ratings.

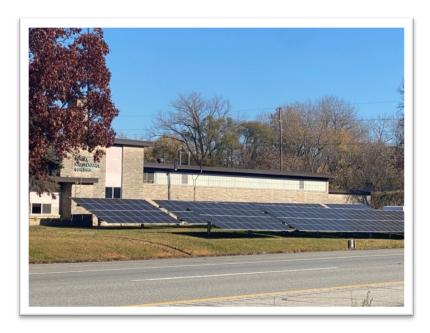
reduce ITRCC's carbon footprint by 900 metric tons of carbon annually. The system is under a routine inspection to ensure maximum efficiency through a maintenance agreement with the contractor. Safety compliance and landscaping to keep areas around the arrays safe for contractors through internal inspections and maintenance.

Image 5.1: Maintenance Unit 1 Solar Panel Layout

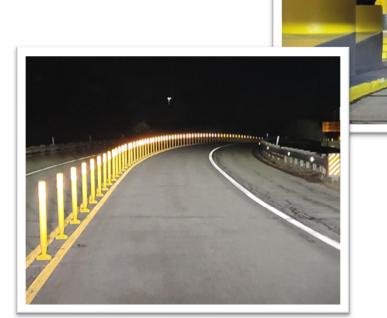
As part of an ongoing effort by the ITR to increase roadway delineation and highway safety toll plazas received additional channeling devices placed in the medians of the approaches of the tolling booths. These permanent devices increase safety for the traveling public as well as help to delineate the roadway for maintenance operations during major weather events. The below pictures represent the devices placed at mainline and entrance/exit toll plazas.
