Bridge 72016 Drilled Shafts for Hwy 93 Grade Raise Project

Joe Nietfeld Midwest Geotechnical Conference, Indianapolis, IN September 23, 2025

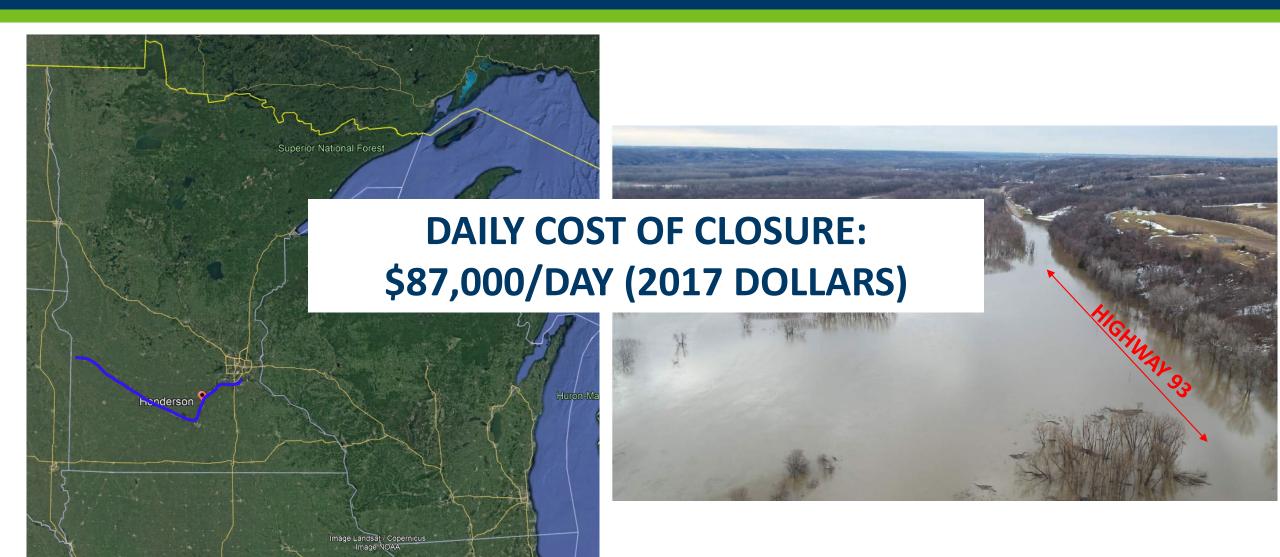
North Limit of Project: City of Henderson Minnesota River South Limit of Project Project MNT07 152509 Project Overview Figure rup by: renonclects Highway 93 Reconstruction

Lower Hwy 19 to act as outlet during flood

- Raise Hwy 93 8 to 14 ft.
- 1 ft. above 2010 Flood Elevations

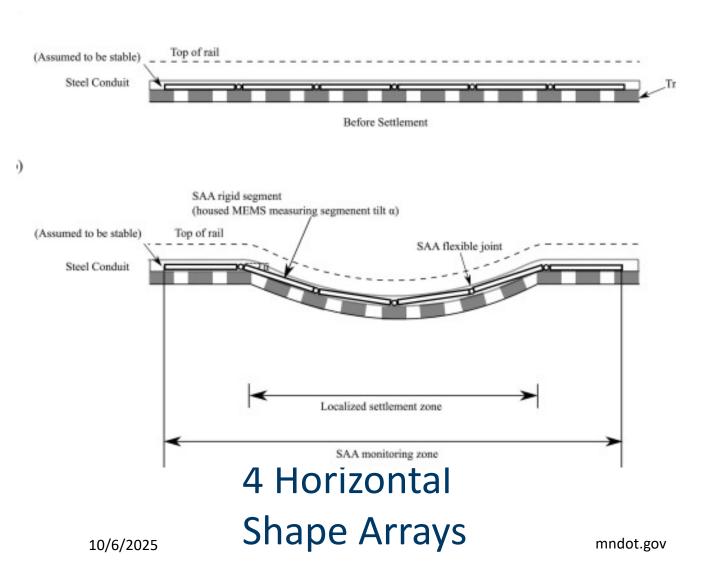
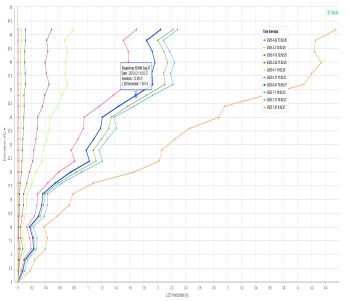
1 Vertical Shape Array

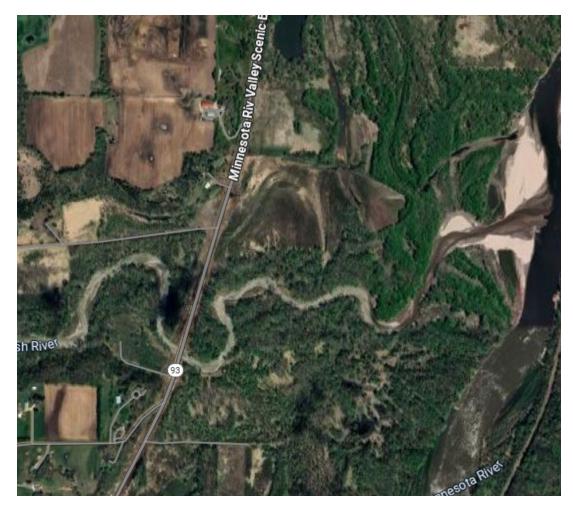
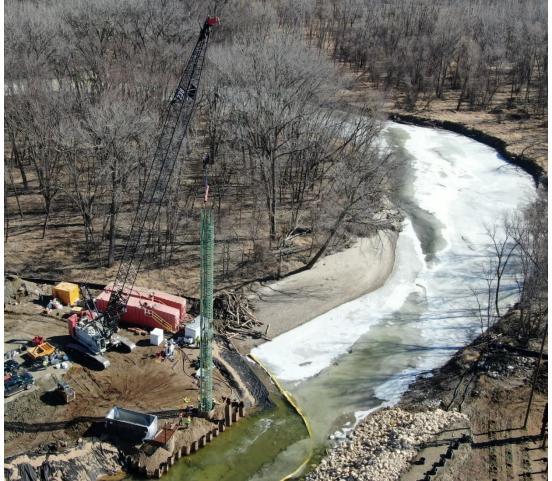
Bridge #72016 Scour

100-year scour 29 ft.

500-year scour 39 ft.

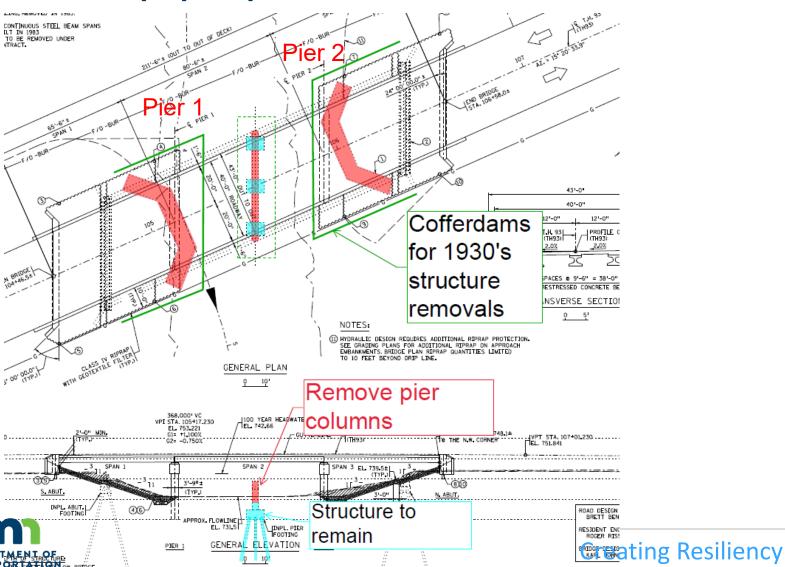
Option 2: 3 span bridge, pile bent piers with 24" CIP pipe pile (maximum diameter with encasement wall)

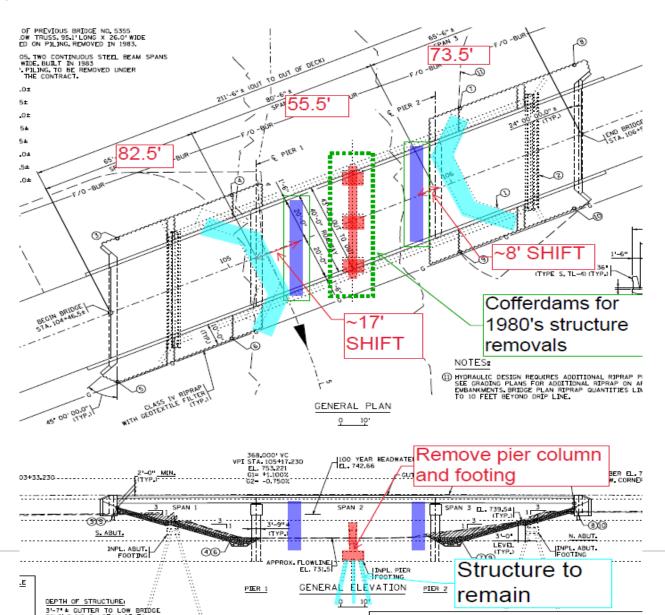
Option 3: 2 span bridge, pile bent piers with two

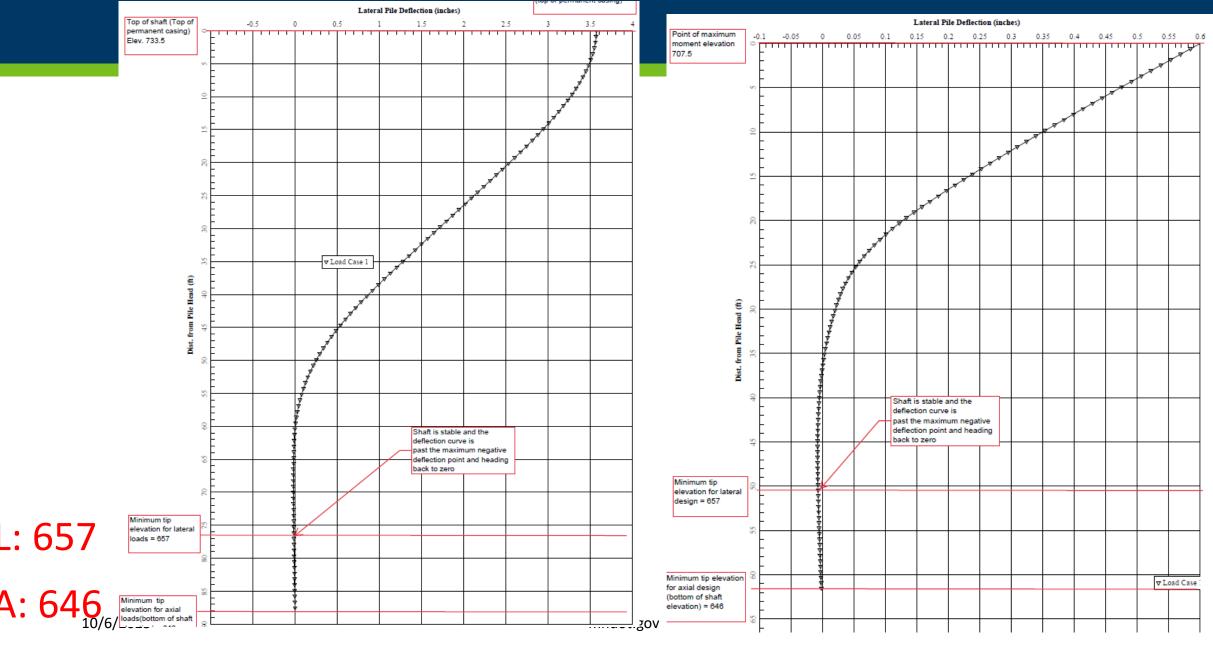
Bridge 72016 drilled shafts- lateral

Bridge 72016 drilled shafts- Lateral Analysis

• Worst case: Extreme Event 2 limit state parallel to pier

Structural Fixity:

- Bridge engineer assumed point of fixity –generated loads
- Geotech ran loads/deflections in LPILE- determined point of fixity
 - Horizontal load at the top of the pile (204 kips)
 - Deflection of shaft at point of max moment (2.3 in. at 35.5 ft.)
- Stability:
 - Extreme Event 2 limit state stability check- deflection of 4.2 inches
 - GEC 10 Section 9.3.3.3.1- 10% of diameter ~7.2 inches ok!

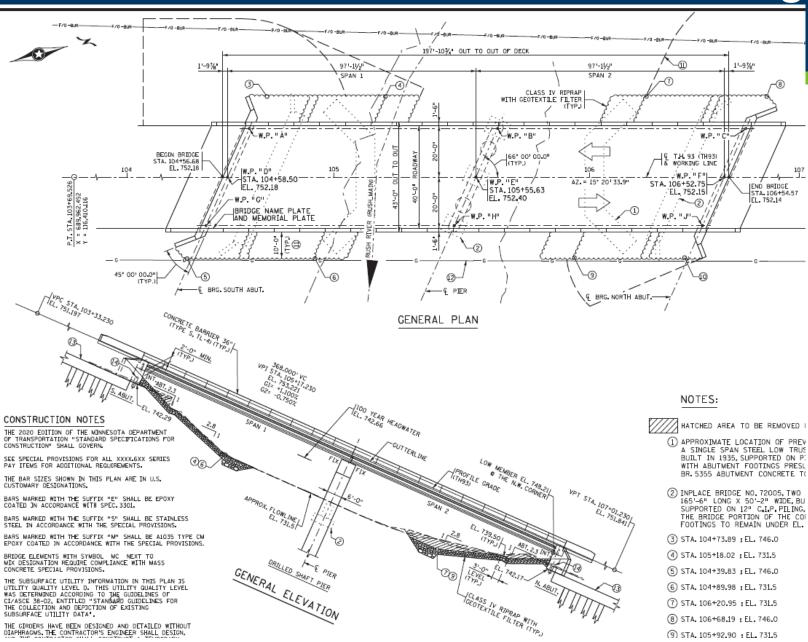
Bridge 72016 drilled shafts- Axial Analysis

Unit (ksf)	Shaft length below scour elevation (feet)	Shaft area (sf)	Nominal Resistance (kips)	Resistance Factor	Resistance factor 20% reduction (AASHTO LRFD 10.5.5.2.4)	Factored Resistance (kips)
Side	3.4	51.5	970.75	3301	0.55	0.8	1452
Tip	60		28.27	1696	0.5	0.8	678
Total							2130

Min shaft depth for axial: 646 ft. elev.

If $N_{60} \le 50$, then $q_p = 1.2N_{60}$ (10.8.3.5.2c-1)

The value of q_p in Eq. 10.8.3.5.2c-1 should be limited to 60 ksf, unless greater values can be justified though load test data.

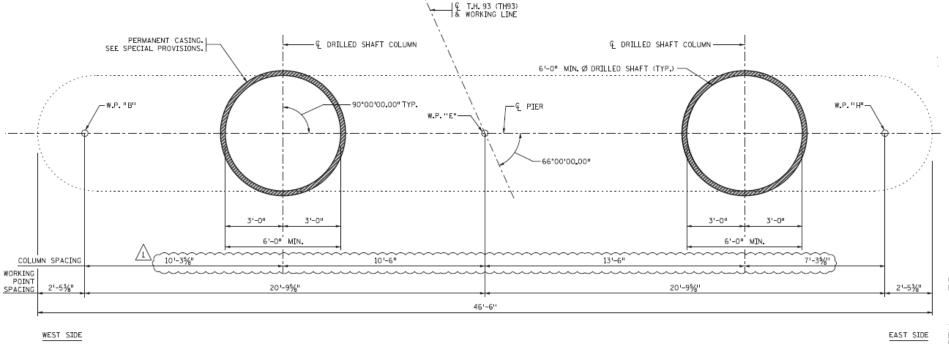
DRILLED SHAFT COLUMN LAYOUT

PIER DRILLED SHAFTS∷DESIGN DATA								
	FACTORED DESIGN LOAD (KIPS)	Øs	ø _p	fs NOMINAL (KSF)	f _P NOMINAL (KSF)	Rn PROV'D (KIPS)*	LOAD CASE	
PIER	2,124	0.40	0.44	7.40	3.40	60	2,130	STRENGTH
	1,540	1.00	1.00	5.40	90	4997	EXTREME

^{*} BASED ON 100 YEAR SCOUR CONDITION

PIER COMPUTED PILE LOAD - TONS/SHAFT					
FACTORED DEAD LOAD	733.6				
FACTORED LIVE LOAD	321.7				
FACTORED OVERTURNING	6.7				
* FACTORED DESIGN LOAD	1062.0

PIER COMPUTED PILE LOAD - TONS/SHAFT					
FACTORED DEAD LOAD	586.8				
FACTORED LIVE LOAD	91.9				
FACTORED OVERTURNING	91.7				
★ FACTORED DESIGN LOAD	770.4

* BASED ON EXTREME EVENT II LOAD COMBINATION

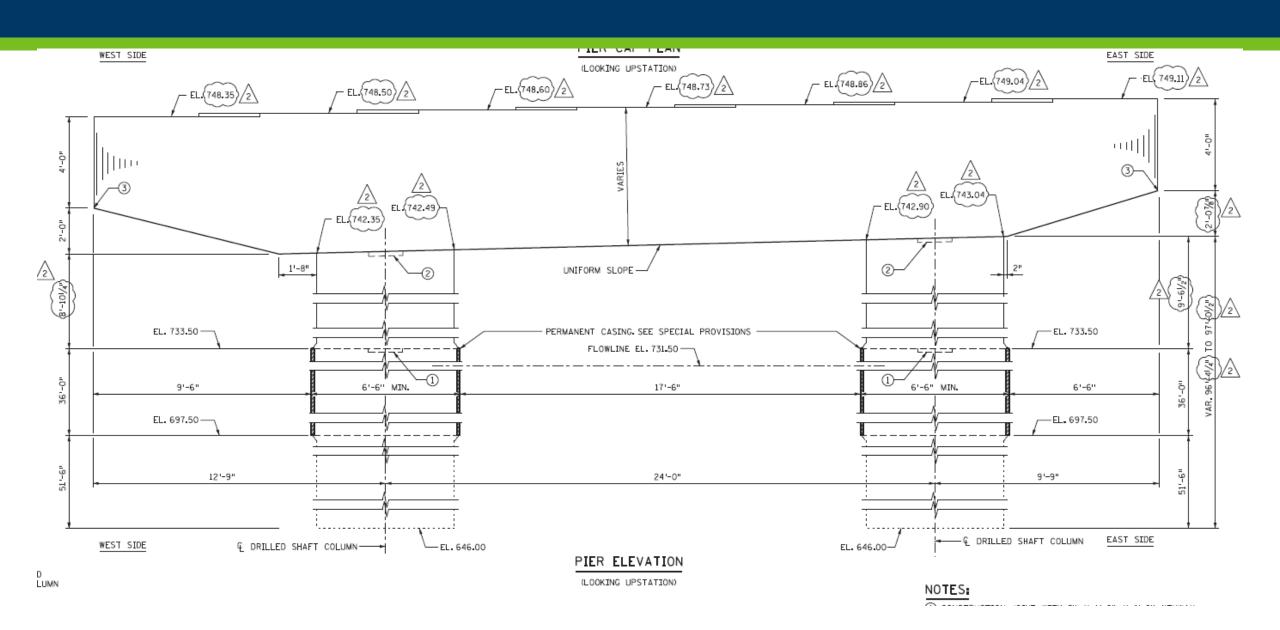
East Shaft

- 6 ft. diameter soil socket
- Shaft length- 87.5 ft. mostly into sand
- ~40 ft. permanent casing an a ~ 50 ft. soil socket. Perm casing 7' diameter. 8' temp casing.

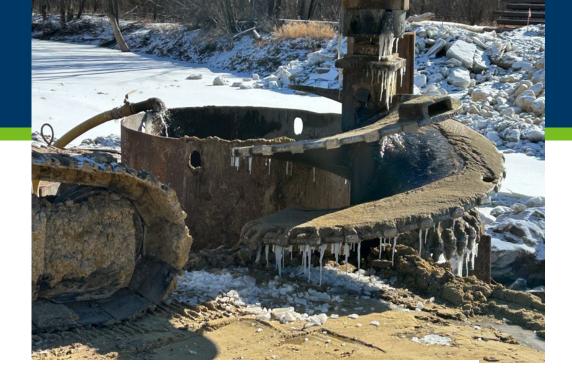
• 1st Hole collapsed on 02-12-2025-(mixing slurry in hole)

Veit has slurry tank not running due to cold weather, during today's drilling, the slurry was not mixed in tank, but in buckets and in the hole. Veit needs to provide slurry test results.

I arrived site at 10 am and checked the water level inside casing after auger broke the ice. The water was tape measured 99 inch from the top of temporary casing, which was at elevation 732.75' similar to river level. I took a sounding and got a measurement of 45.3', which indicated the soil inside hole collapsed into the hole.

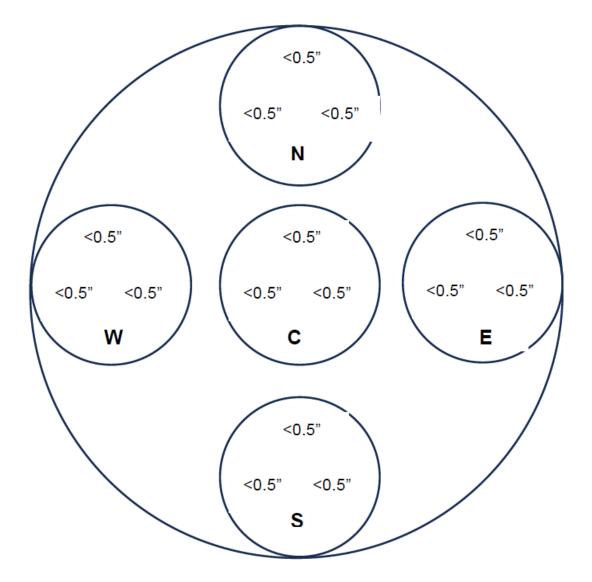
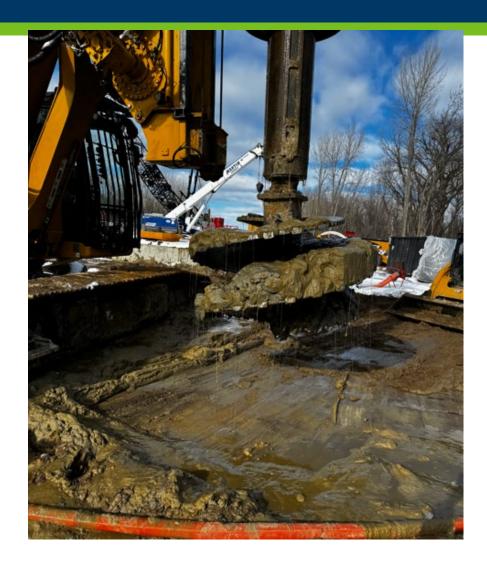
SID results

- Successfully drilled and poured the week of 02-24-2025
- Used slurry additive to keep the hole open and periodically topped off the slurry over 2 days
- For sediment removal on 02-27-2025:
 - Tried an airlift, but were concerned with hole sloughing
 - Used a cleanout bucket instead- waited 1/2 hour tested, waited 1 hour
 - the slurry had significantly less than 1% sand after cleanout
 - Bottom met spec- with SID- more than 50% of test locations with < ½" of sediment

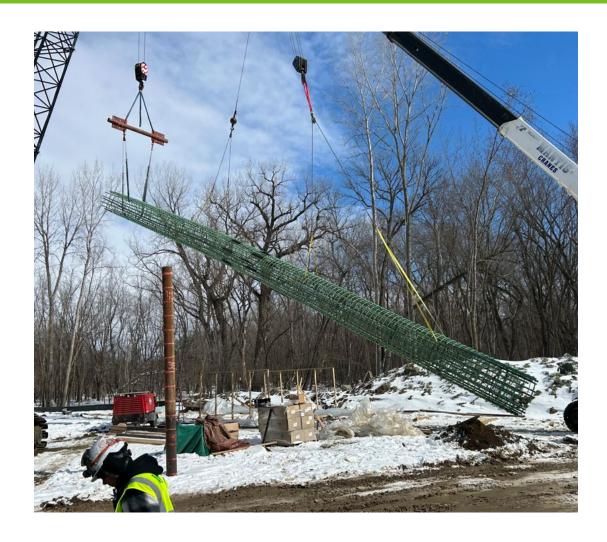
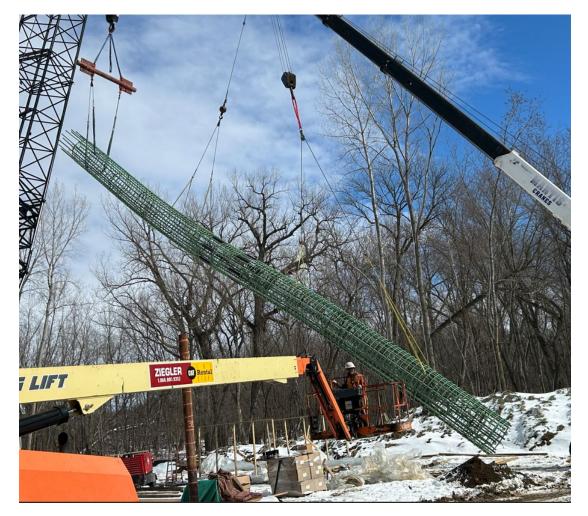
Picking and moving the cage

- 2 crane pick to pick the rebar cage
- Tremie took 1 hour to install.
- Pour took 2.5 hours
- The concrete was placed via. pump truck to a tremie pipe. Veit had to constantly pump out slurry as the concrete was placed, but still maintain the 5' of head.

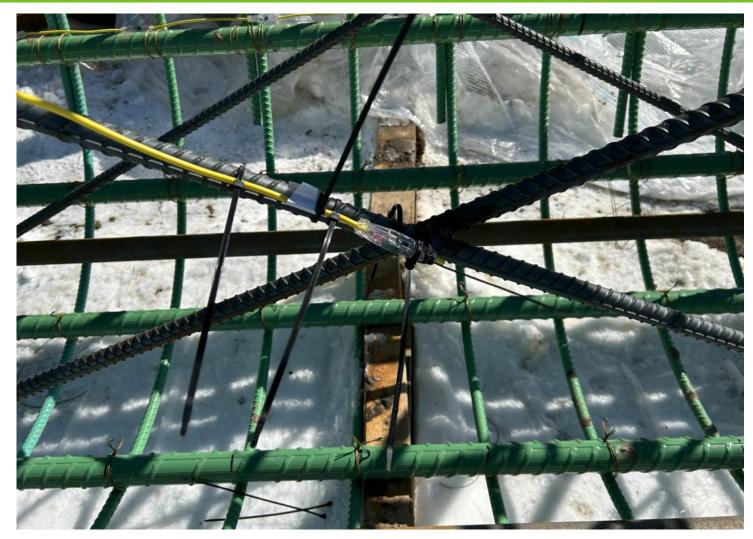
Mass Concrete Temperature sensor

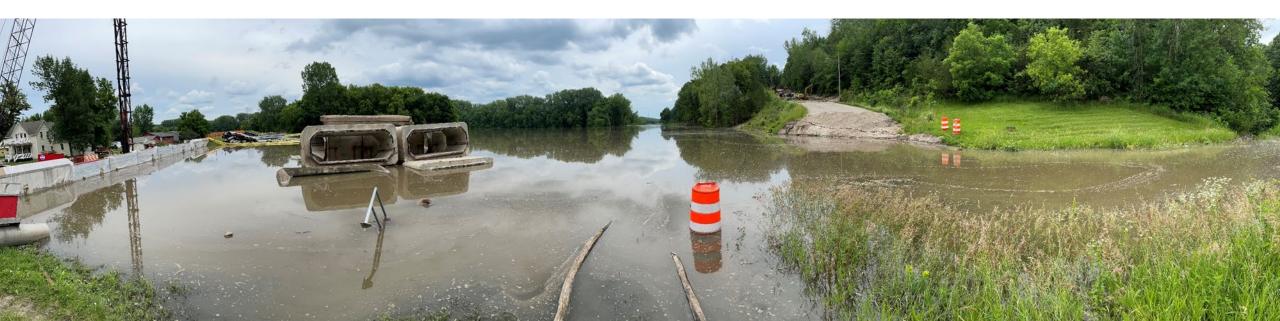
- Heavy rains in May of 2025 led to historic flooding throughout southern Minnesota
- Highway 93 project mostly underwater, with exception of portions of the Rush River Bridge
- 2025 Flood broke the previous flood elevation record at Henderson by over a foot
- Flood waters were within 1.5' of the top of the levee
- Projected floodwaters on final product showed that 2 sections would have been under an inch or two of water.
