National Register of Historic Places
Registration Form

historic name Anderson Downtown Historic District
other names/site number _____ 095-015-46000

Section number 7 Page 2 *Anderson Downtown Historic District, Madison County, IN*

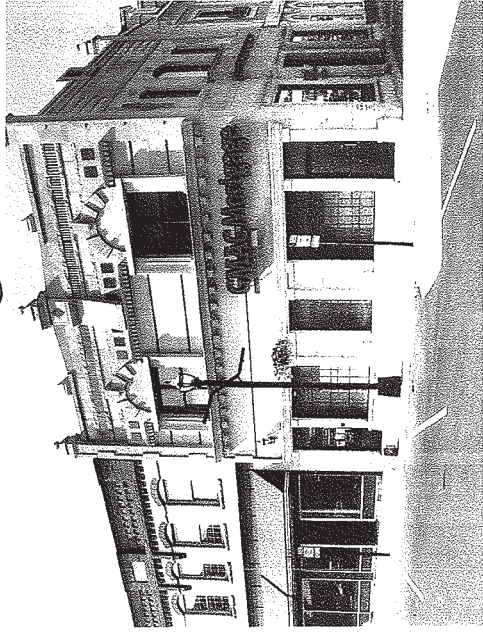
8

25. 1215 Meridian Street Commercial Building (Monument Block) (Contributing)

evident and has been painted to accent it. A limestone nameplate is centered at the top of the building with "Monument Block" carved in it. On each side of the nameplate, 2 rows of 10 inset squares span across the parapet. The second story windows have segmental arched openings on the window top made of brick and elaborate sills of limestone. Windows have been replaced with multipaned windows. A metal molding separates the 1st and 2nd floor. A fabric awning has been installed over the first floor that spans the width of the building. There are 2 storefront entrances, recessed with metal and glass commercial doors. There are 4 large display glass windows that are located across the front of the building from approximately 2' above the sidewalk to the ceiling.

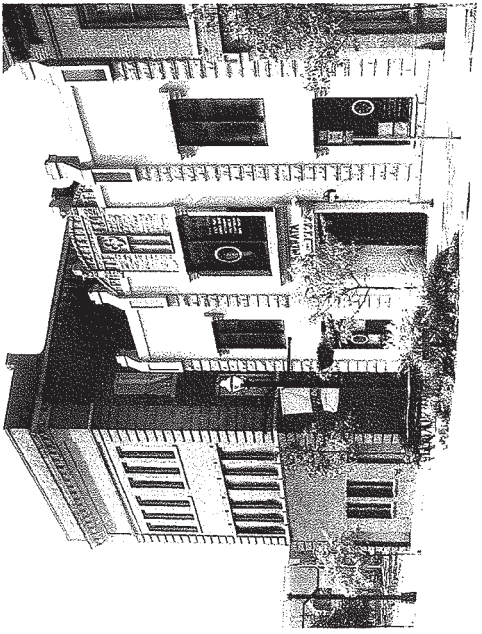
6

24. 1211-1213 Meridian Street Commercial Building (Non-Contributing)

Prior to 2002, this building faced Meridian Street, was classified as Nineteenth Century Functional.. However, in 2002 this building was completely renovated into 4 office spaces on the first floor and 2 condominiums on the 2nd floor. It no longer contributes to the significance of the district.

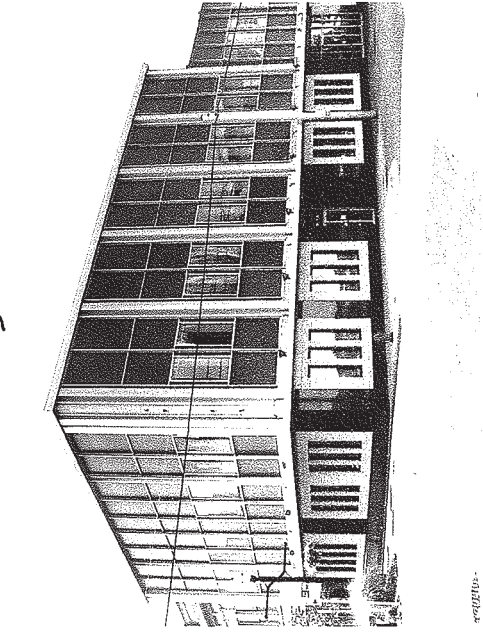
5

16. 1111 Meridian Street Commercial Building (Contributing)

Davisson & Davisson Law Offices currently utilize this building. This two-story brick building has six, 1 over 1 windows, across the second floor, and 4 arched windows along the ground floor with 13 lites in each. The storefront was recently altered. It has a recessed entryway with limestone nameplates above the entry listing the attorneys currently occupying the building. The cornice is set approximately 3' from the top of the building and had dentils. There are four pilasters located on the lower portion of the building with medallions across the front mid portion.

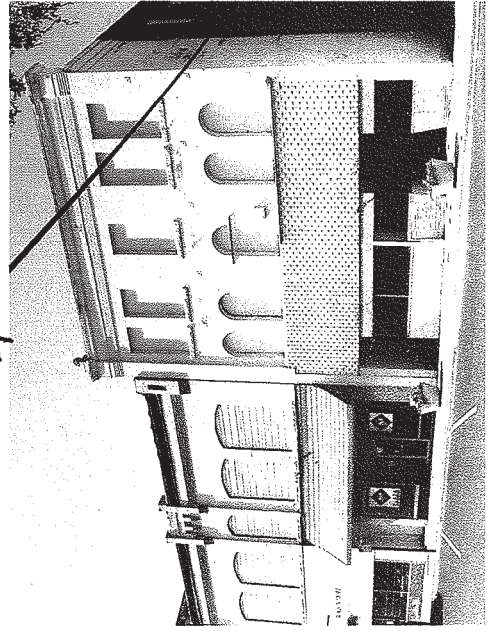
4

14. 1101 Meridian Street Commercial Building (Non-Contributing)

This building houses a combination of offices and vacant space on the ground floor. **The Madison County Historic Society** was recently deeded the building to house their artifacts. The upper two floors are used for storage and vacant at this time. This three-story building went through a radical rehabilitation in the 1970's and was covered with a green, metal façade. Metal, casement windows were installed across the

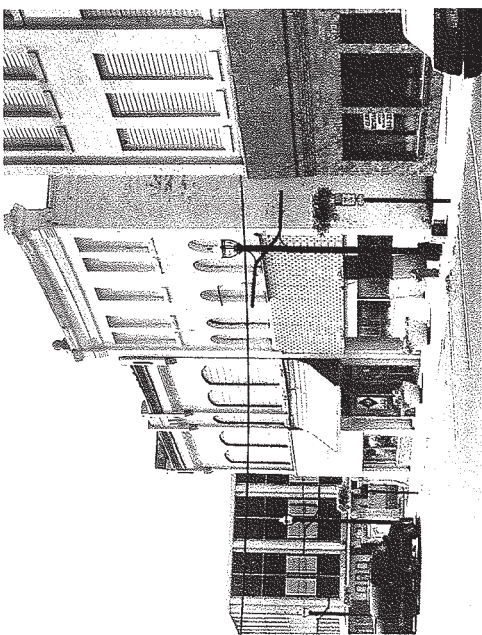
3

11. 1023 Meridian Street Commercial Building (Contributing)

This three-story painted brick building is currently vacant. Most recently, a restaurant occupied the first floor, **Brickhouse**, for a short period. It has residential space on the 2nd & 3rd floor and retail or restaurant space on the first floor. The windows on the 2nd & 3rd floors have been boarded up with plywood. The 2nd and 3rd stories have 5 windows spanning across the top on each floor. The top floor's windows are rectangular with stone sills, whereas the second floor windows are round arch topped. They have all been boarded up. There are two stone finials located on each front, top corner of the building, framing the corbelled brick work cornice.

The ground floor is a recessed storefront entrance and one private entrance to the upper floors. The entrances have glass showcases across the lower levels that rest on approximately 4' brick bases. The lower portion was badly altered in the 1970's. The area between the ground level windows and 2nd floor has had a 1970's retro, variegated, metal designed façade added. Original materials may still be located behind this unoriginal material. Entry doors to both units are single glass & metal entry doors.

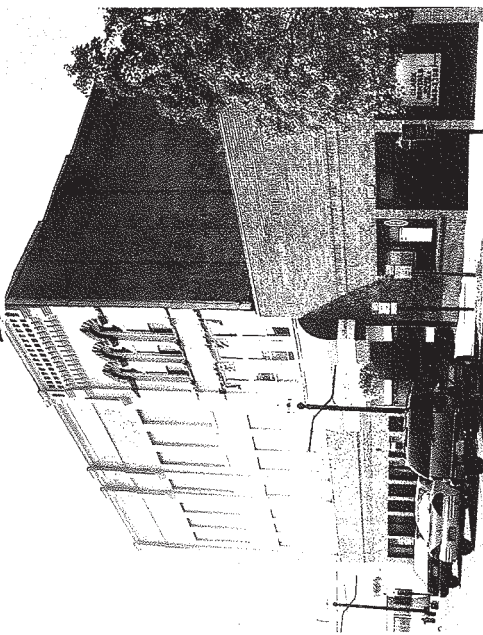
2

10. 1011 Meridian Street Commercial Building (Contributing)
Romanesque Revival / Functional c. 1900

This three-story, brick building is currently vacant. Most recently, a private contracting/building firm, **Fortune Management**, used the first floor as administrative offices. This building is split into two units w/ three floors. The first floor is set up for retail and 2nd and 3rd floors for retail/residential usage. There are 7 windows that span across the front of the building along the 2nd and 3rd floors. They were most likely double-hung 1/1 windows and have limestone sills. All of the windows have been covered with horizontal vinyl siding and is undetermined whether original windows exist. Two pilasters running vertically up the building offset the center windows. The windows are currently boarded up on the 2nd and 3rd floors. The 2nd and 3rd floor brick, façade area has been painted, whereas the ground floor is a brick façade with commercial recessed entries.

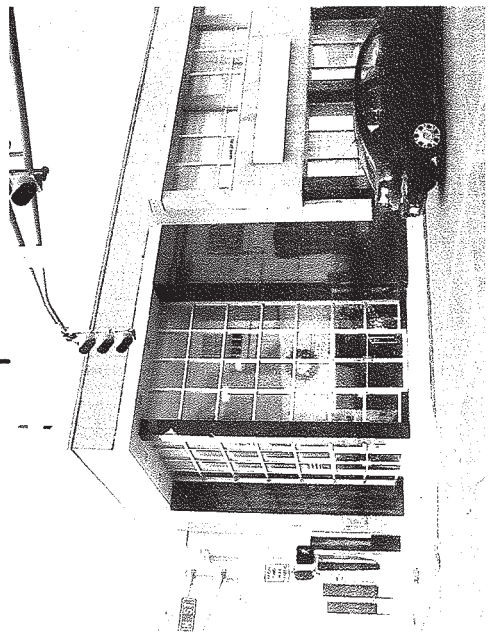
1

9. 1009 Meridian Street Commercial Building (Contributing)
Romanesque Revival c. 1890

This three-story, brick building is currently 100% occupied by retail, **Standt's Jewelry**, on the first floor and residential on the second and third floor. A metal cornice is evident across the top of the building complete with dentils. There are brick pilasters on each side of the east façade as well as between the windows. There are 2 rows of 15 squares inset across the top of the building and painted green. There are two courses of brick corbelling below these squares in the parapet area.

Three windows span across the 2nd and 3rd floor levels, totaling 6, on the facade of the building. The 3rd story windows are topped with rock faced stone round arched openings and have triple-hung sash windows with a 1/1/1 pattern. The 2nd level windows are also triple-hung sash windows with a 1/1/1 pattern, with a rock-faced stone flat lintels with "ears." Second and third floor windows have been replaced w/ replacement windows, same size and openings as originals.

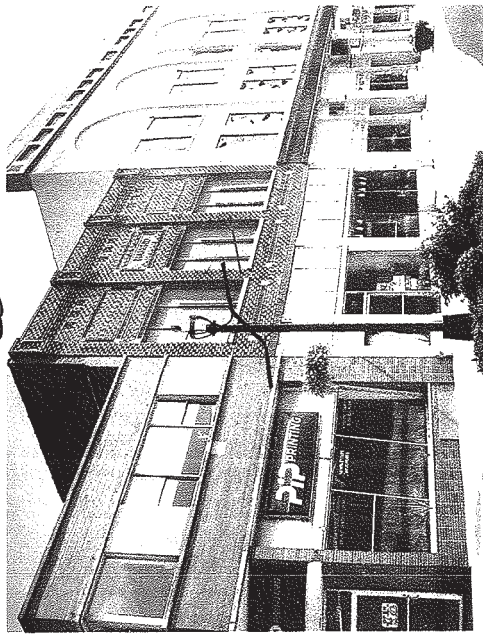
25

20. 1200 Meridian Street Commercial Building (Contributing)

This building currently serves as a **PIP Printing Shop** downstairs and an architect's office upstairs. The structure is rectangular in footprint and has two stories. The primary building materials are brick, glass, and dressed limestone. This structure has a flat roof with slightly overhanging narrow coping. The second story has a series of 10 large single pane windows cased in metal. The second story has a corner window with aluminum corner mullion. On both sides of each large window are double hung single light windows also metal cased. Between each window grouping are limestone panels. Each panel is composed of two limestone sheets. The rest of the second story is composed of brick, and the second story cantilevers slightly over the ground floor. The first floor has its eastern half mostly composed of metal cased windows and doors. There are four of these glass doors on the eastern half of the first floor. On the western half of the first floor the exterior skin of the structure is limestone. This section has three boxed display windows. These windows are framed in limestone. The front of the first floor is composed of five large displayed windows and a glass door each cased in metal. The rest of the front is composed of brick.

Two story rectangular brick 3 bay structures. First floor has storefronts, which have been altered. The brickwork is laid with "Flemish bond" brick, a tan face brick imprinted with a pattern, so that when laid stretcher bond, the pattern makes the wall appear to be Flemish bond. Brick pilasters stand between window openings, the four pilaster strips rise from the top of the storefront level to the cornice. Second floor windows set in groups of 3 with fixed

Miller Huggins currently uses this building for storage, however is for sale. This building is a brick, three-story building with 4 sections of inset arches. Each outer arch is the same size, with middle arches being significantly smaller. Outer arch contains 4 large windows, 2/2 and the middle arches contain 1/1. The building has been recently painted and restored; however the window openings have been covered with Plexiglas. The actual windows still may be in contact, however are not visible from the street since they are behind the Plexiglas. They all have stone sills. A metal band separates the lower, ground level from the 2nd and 3rd floor levels. The ground level has 3 entrance doors, 2 for retail entrances and 1 for an upstairs access. There is a small square flat awning located over the front entrance to the upstairs. There is also a limestone nameplate located in the top middle portion of the building with "1894" sculpted into it and two flowered, limestone medallions on either side.

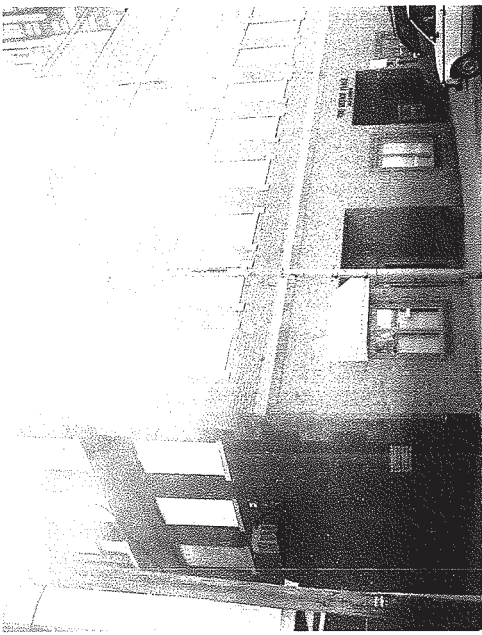
37

4. 19 W. 11th Street Brock Apartments (Contributing)
Arts and Crafts c.1910
Photo #: IN_MadisonCounty_DowntownAnderson37.tif

This three-story, brick building currently houses office space for two groups, Madison County Literacy Coalition and YMCA Judo, on the first floor. The ground floor level has had a new brick façade installed within the last 10 years with 2 recessed entrances, an entrance that is even with the overall building and three windows that span across the front façade or north side of the building.

The eastern most recessed entry has a single steel replacement door with 15 lites (3/15) and a window that abuts the door w/ 5 lites to match the door. There is a modern exterior light in the entryway. There are double windows across the front lower level façade. The middle recessed entry has 1 window (side by side), a modern overhead light and a steel replacement door w/ 15 lites (3/15 pattern) within the recessed area. The upper façade is the original brown face brick. There is a limestone band above the 2nd floor windows across the front of the building, and below the 1st floor windows. The nine even spaced 2nd floor window openings all have limestone squares beneath each corner of each window opening and stone sills. Window openings are rectangular with no lintel treatment, all windows are covered over. In addition, there are 10 limestone plaques with a decorative petal design across the area above the 2nd floor windows. The third floor has nine similar windows. The parapet / cornice features stylized, geometric tassels. There is a limestone nameplate located in the middle upper portion of the building with 'Brock & Brock' sculpted in it. The flanks of the building are of common red brick, the face brick of the north side toothing into the upper walls with coin-like tabs. The east side of the building has nine bays of window openings on the upper floors. Window openings are segmental arched, with double header courses.

The upper two stories are currently vacant and all window openings have been boarded over with horizontal vinyl siding. It is undetermined whether the original windows still exist beneath the vinyl coverings.

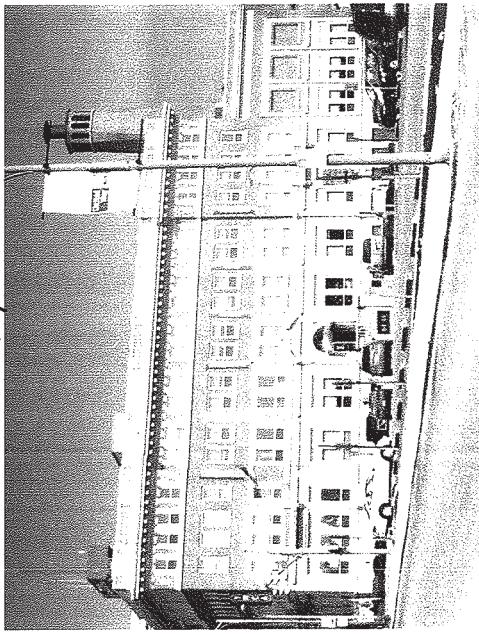
36

7. 28 W. 12th Street YMCA Building (Contributing)
Neo-Classical 1916
Photo #: IN_MadisonCounty_DowntownAnderson36.tif

The **YMCA** currently utilizes 100% of this building. It is a square brick building of 4 ½ stories with buff brick walls and terra cotta details. End sections project slightly forward and have four bays; the center section has five bays of double windows, the center bay is the entrance. Cornice has dentils and egg and dart designs with a classical balustrade with panels and open balusters. Terra cotta cupids above a shield bearing a cross are on the flanking projecting sections. Terra cotta also surrounds 2nd and 4th floor windows. All windows are 1/1 double hung. First floor has terra cotta griffins below 2nd floor balconies with flowers, urns and cupids on top. First floor windows are fixed. There is a limestone water table with YMCA symbol carved at corners. Entrance has a shield with YMCA symbol above a broken segmented pediment with floral designs. Fluted pilasters with Corinthian capitals and female faces in relief flank the round arch opening. The double doors are metal. A metal grillwork fills the arch. Below this is a curved arched metal canopy with the supporting brackets attached to lion heads. Side stone steps and balcony rail lead to the door. Basement windows open below upper floor windows. Wings of the building match in materials, however, terra cotta designs above windows have winged mermaids instead of griffins. There is a lower section to the east, behind it is an original boiler stack, architecturally disguised as a lighthouse-like structure.

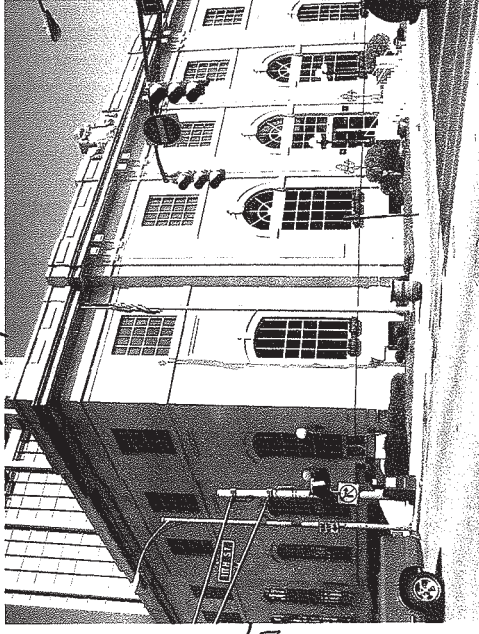
33

3. 30 W. 11th Street Former Post Office (Contributing)
Neo-Classical 1910
Photo #: IN_MadisonCounty_DowntownAnderson33.tif

This building currently houses the administration offices for **Ricker Oil and KR Montgomery Architectural Services**. The building is rectangular in plan and 2 stories in height. It is of dressed limestone with five bays along the front façade. It is topped with a Neo-Classical cornice, which is ornamented in the center with a garlanded oval shield. Below this is a dentilled course with recessed panels. The three bays in the center are defined by engaged pilasters, which are topped by large paired brackets. The windows in the center bays have round arched fanlight transoms with stone surrounds and keystones. A belt course separated the first and second story. Second story windows are paired 4 over 4 double hung, square proportioned windows. On the first floor the outer windows are set in segmental arched openings with two-light transoms over paired 4 over 4 double hung windows.
