National Register of Historic Places  
Inventory—Nomination Form

historic Boonville Public Square Historic District

Boonville Public Square

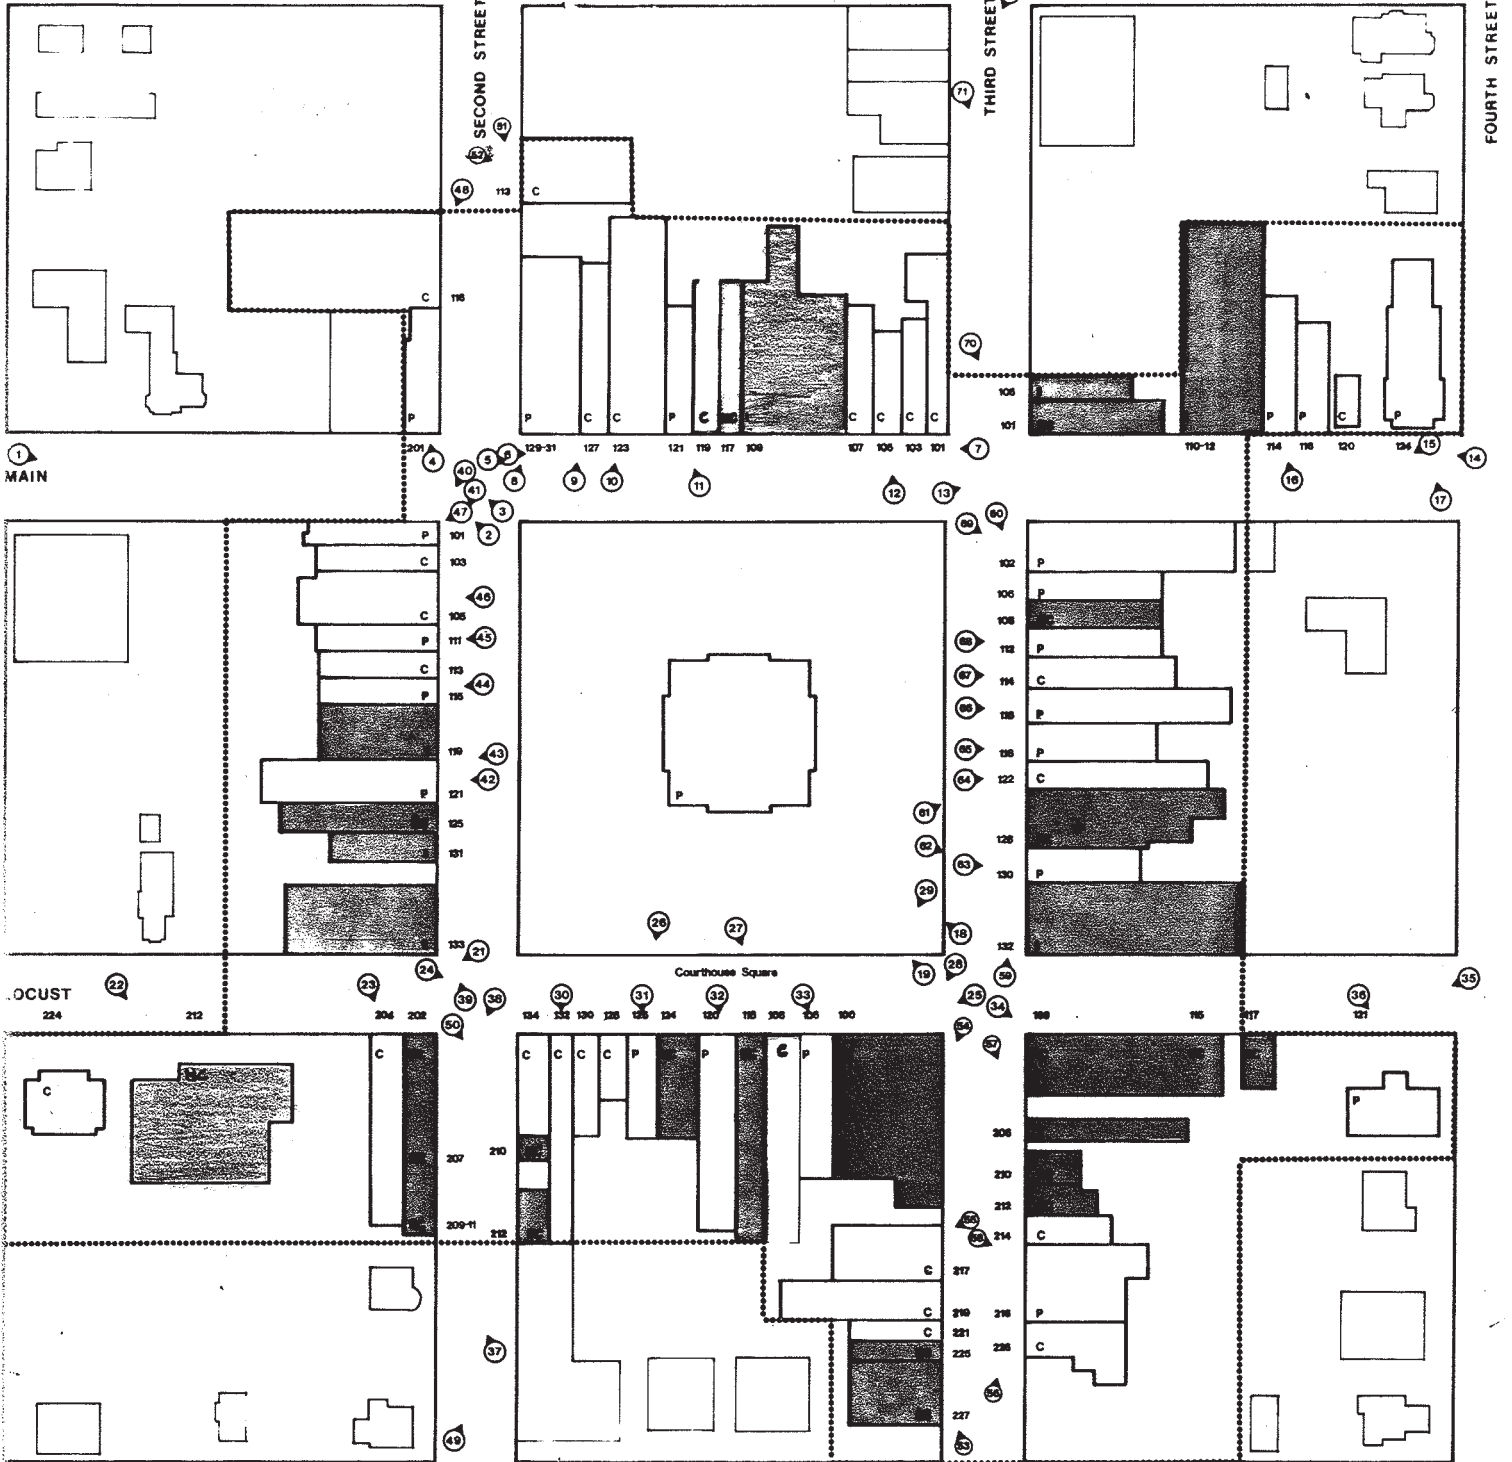
PUBLIC SQUARE HISTORIC DISTRICT  
BOONEVILLE, INDIANA

- BOUNDARY
- [P] PIVOTAL
- [C] CONTRIBUTING
- [■] NON CONTRIBUTING
- [I] INTRUSION
- [1] PHOTOGRAPHS
