National Register of Historic Places Registration Form

historic name Bloomington City Hall
other names/site number Old City Hall; Fire Station: 105-055-67058

street & number 122 South Walnut Street
city, town Bloomington
state Indiana code IN county Monroe code 105 zip code 47401

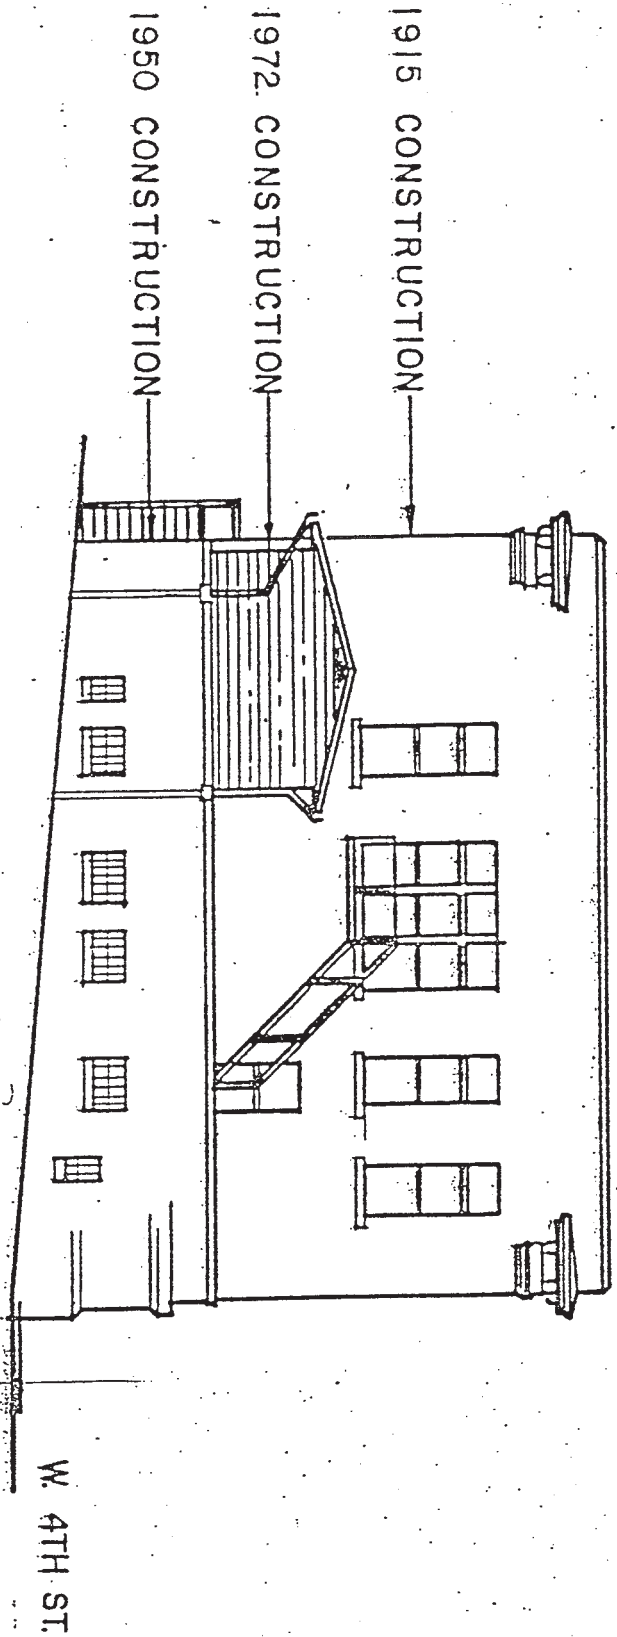
WEST ELEVATION

SCALE: 1/16" = 1'-0"

Two bays on the second floor and three bays on the third floor remain visible of the original building's west facade (see photo 2). The one story 1972 addition is attached to the first bay of the second floor. The window openings are not evenly spaced, but do have uniform widths and lintel and sill heights. The windows are single versions of those on the east and south facade. There are three single windows on the second floor that rest on the parapet of the 1950 addition. Two are grouped in the center bay and one is on the left side of the third bay. There is one single window on the right side of the first bay of the third floor, a triple set in the center bay and two evenly spaced single windows in

There are six multi-paned, metal frame windows across the one story west facade of the 1950 addition. The window openings are cut into the limestone veneer with no decoration. There is one, one over one, wood frame window on the south facade of the 1972 addition. The 1972 addition also has one metal sliding glass door on the south facade and one wood door on the north facade.
