**National Register of Historic Places
Registration Form**

historic name Wood, John, Farmstead
other names/site number _____ 139-003-50041

John Wood Farmstead

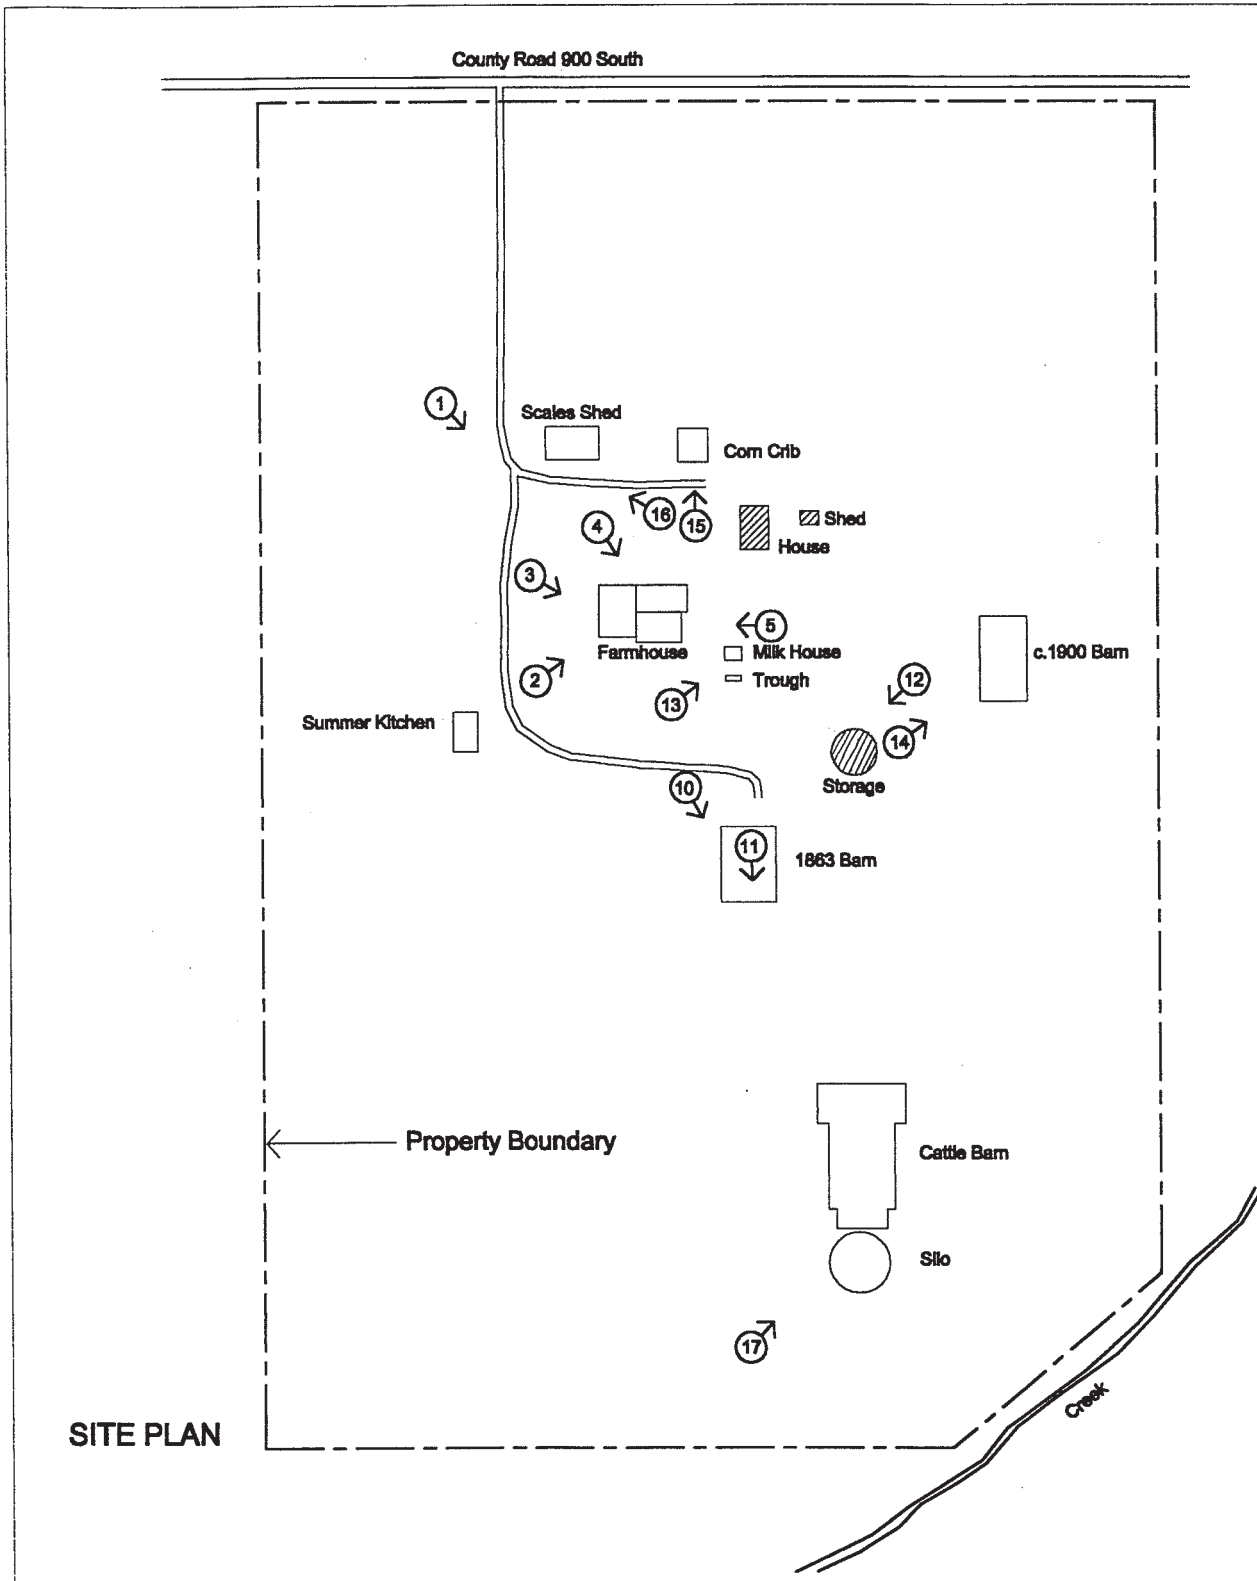
1

The John Wood Farmstead is located near the village of Moscow in Orange Township in southwestern Rush County (see Drawing 1). The farm was established in 1822. There are six contributing buildings: the 1831 brick I-house (Photo 2, Drawings 2 and 3), an early nineteenth century summer kitchen, two transverse frame barns dating from 1863 and c.1900 (Photos 10 and 14), a late 19th/early 20th century cattle barn (Photo 17), and a scales shed (Photo 16). The three contributing structures are a milk house (Photo 13), a silo (Photo 17), and a corn crib (Photo 15). A water trough is a contributing object (Photo 13).

A new, one-story, wood frame addition has been built in the location of the earlier addition to house a bathroom and kitchen (Photo 5, Drawing 1). This addition is sided in clapboards. There is a small porch on the south side. A door here access the new kitchen. On the exposed facades are double hung wood windows with six lights in each sash. Corner boards and porch posts have detailing similar to the nineteenth century addition.

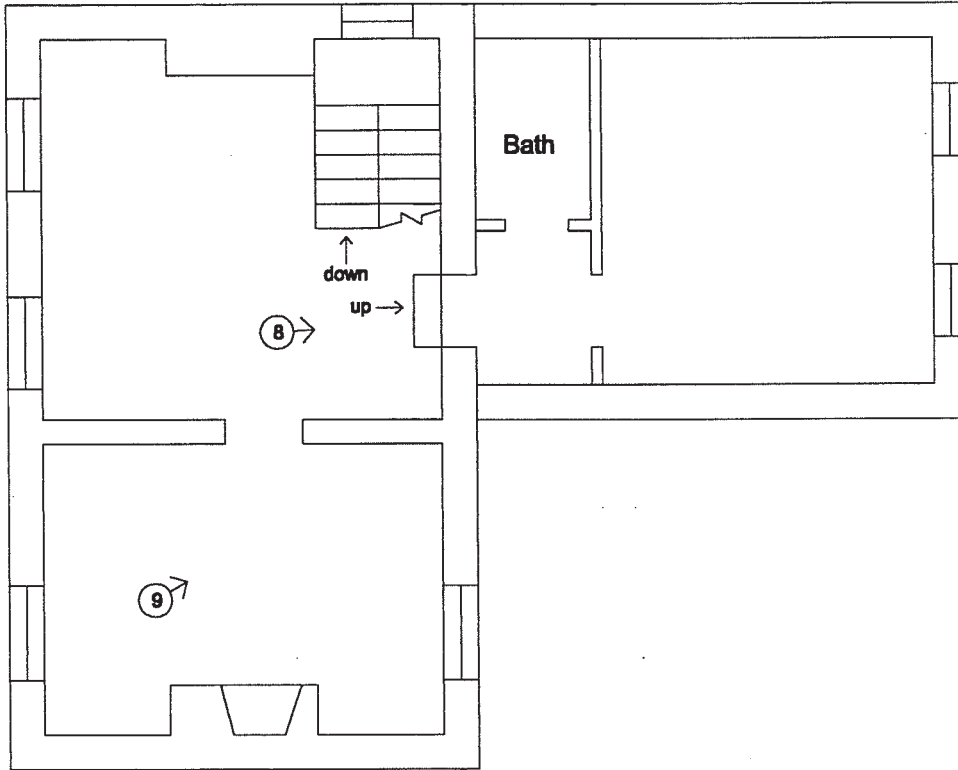
SECOND FLOOR PLAN

Original House

19th Century Addition
