# National Register of Historic Places Registration Form

historic name Glendale Park Historic District  
other names/site number \_\_\_\_\_

street & number 17-64 Glendale Parkway  not for publication  
city or town Hammond  vicinity  
state Indiana code IN county Lake code 089 zip code 46320

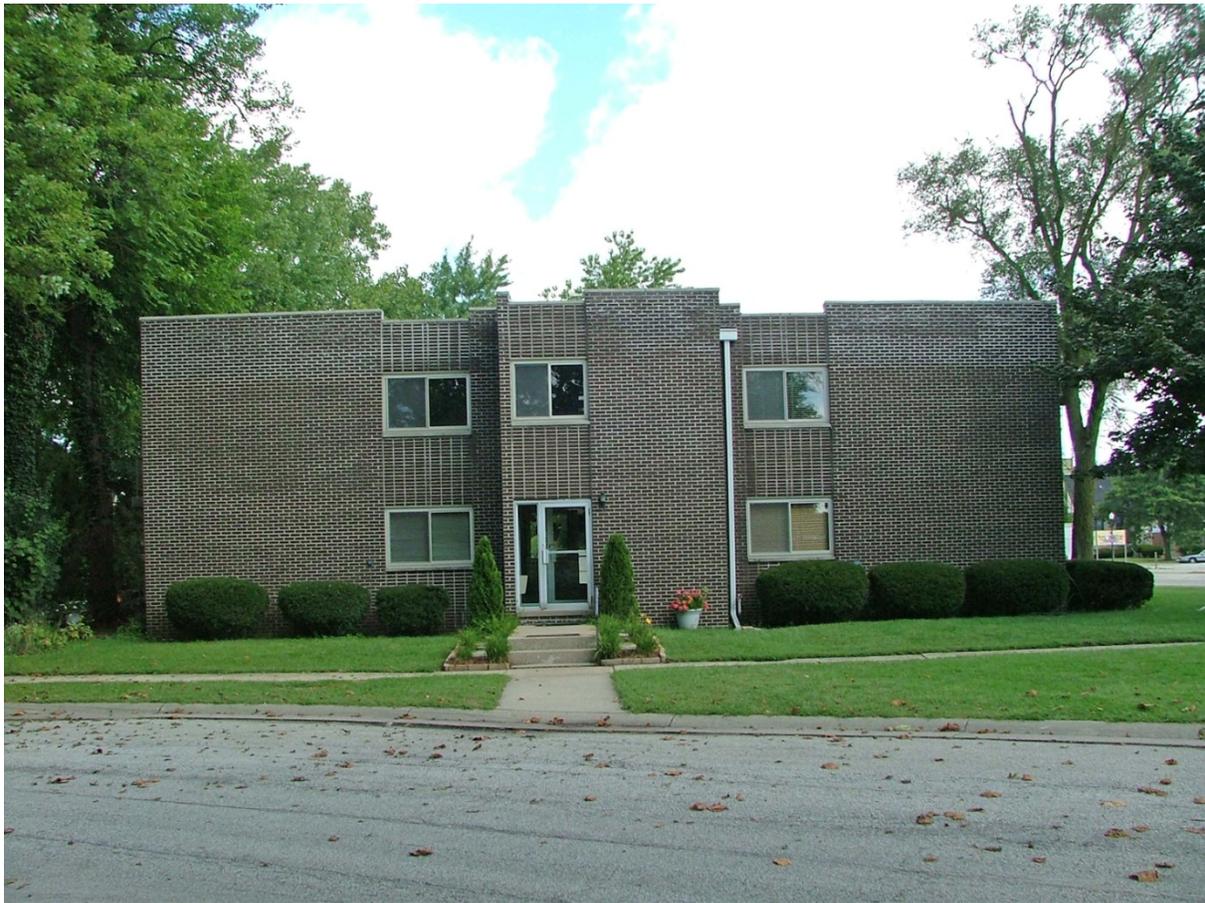
Glendale Park Historic District, Lake Co., IN #001

**63 Glendale Park.** (Photo 1) Apartment Building, Contemporary, 1968. Non-contributing.

This boxy building is constructed of dark reddish brown brick. The brick has been laid in a couple of different bonds to provide some texture and contrast. The structure is designed by placing several rectangular sections together; two outer sections connected to a central rectangular section that extends forward from the façade and contains the entry; directly above the door on the second floor level is a window. A window is located on each floor of the façade immediately adjacent to the extended center section of the building. The windows and door are all metal-framed. The divided windows slide horizontally with each half having a single large light. The door has a single full-length panel of glass as does its narrow sidelight.

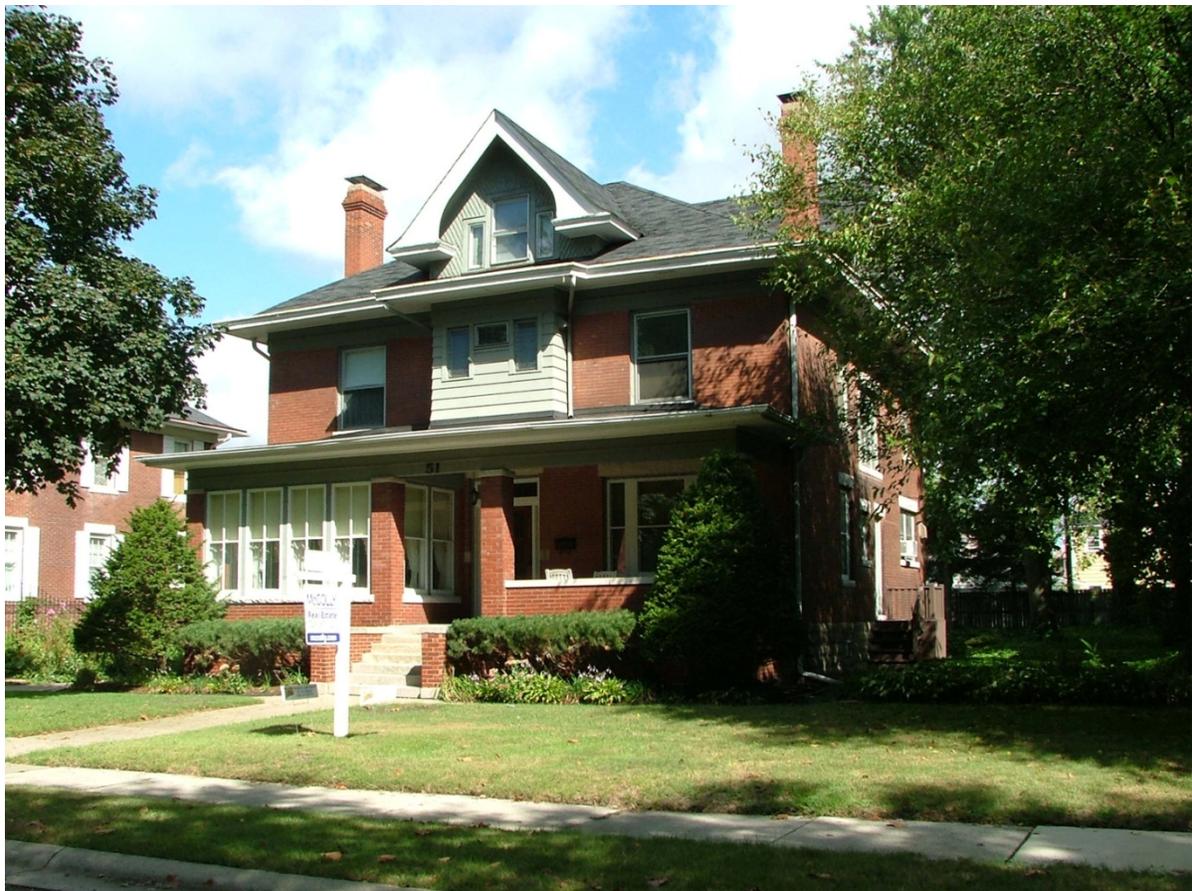
Glendale Park Historic District, Lake Co., IN #003

**51 Glendale Park. (Photo 3) House, c.1907. Contributing.**

This two-and-a-half story house is a variation of the Foursquare type with Arts and Crafts features, is built over a full basement with the wall of the foundation above ground level constructed of cut limestone blocks. The house is constructed of red brick laid in a common bond. The main façade faces south. A wide, one-story porch covers the entire width of the first story of the house and is accessed at its center by seven limestone steps flanked on each side by a low brick wall with a limestone coping. A sidewalk leading straight from the public sidewalk leads to these steps. The east side of the porch is open while the west side has been enclosed. Two brick columns support the porch roof on the east side, one at the porch corner and one adjacent to the access steps; each column is capped with limestone. A short brick wall with a limestone coping encloses the east, or open, end of the porch. The west side of the porch is enclosed with a grouping of four wood, double-hung, 1/1 windows. Each is protected by a wood-framed storm window with 2/2 lights. The windows rest on a limestone sill. This is not the original construction of the porch, when constructed it was open the entire width of the façade and had round columns coming off square concrete block piers. At some point between 1910 and 1915 the original porch was altered to its current configuration (a comparison can be made by viewing historic photos 1 and 2 in Appendix A). The entry is centered on the façade directly in line with the porch steps. The door is framed with a wide wood door molding and has a fixed transom above it. The original wood door has two vertical panels in the lower three-quarters of its length and eight square lights (4X2) in its upper section. It is protected by a wood storm door with a large single light. Centered between the door and the east edge of the elevation is a grouping of three wood framed, 1/1, double-hung windows. The outer two are about one-quarter the width of the center section and all are the same height. The window opening has a limestone sill and lintel. A large beam sits across the four porch columns supporting its hipped roof. The porch roof has a wide eave typical of the Arts and Crafts style. Centered on the second story level, directly above the entry, a section of the façade extends forward from the wall; it is covered with modern siding. Three small windows are located in the upper half of this area. The outer two windows are set

vertically, each with louvered, metal-framed, jalousie window. The fixed, metal-framed, center window sits horizontal connecting to the upper half of the two outer windows. These windows have wood sills. Centered on the brick façade, on both sides of the extended section, is a wood, double-hung, 1/1 window. Each one is covered with a modern metal-framed storm window. The roof over the main structure is pyramidal and covered with asphalt shingles; its eaves are wide and boxed. Two brick chimneys, one on the east elevation of the structure and one on the west, rise above the eaves. Centered on each the east, south, and west slopes of the roof is a large gabled dormer. These dormers each have a steeply-pitched roof and returned cornices. The dormer's façade over the street elevation of the house is recessed under a wide eave and is covered with patterned wood shingles, much like those found on Queen Anne houses. Centered in the gable of the dormer is a wood-framed, 1/1 double-hung window. Immediately adjacent to this window on both sides is narrow single light window. The dormers with their steep roofs, returned cornices and window configuration have a Colonial Revival appearance to them. (see Appendix A photo 1, second from right also photo 2 second from right)

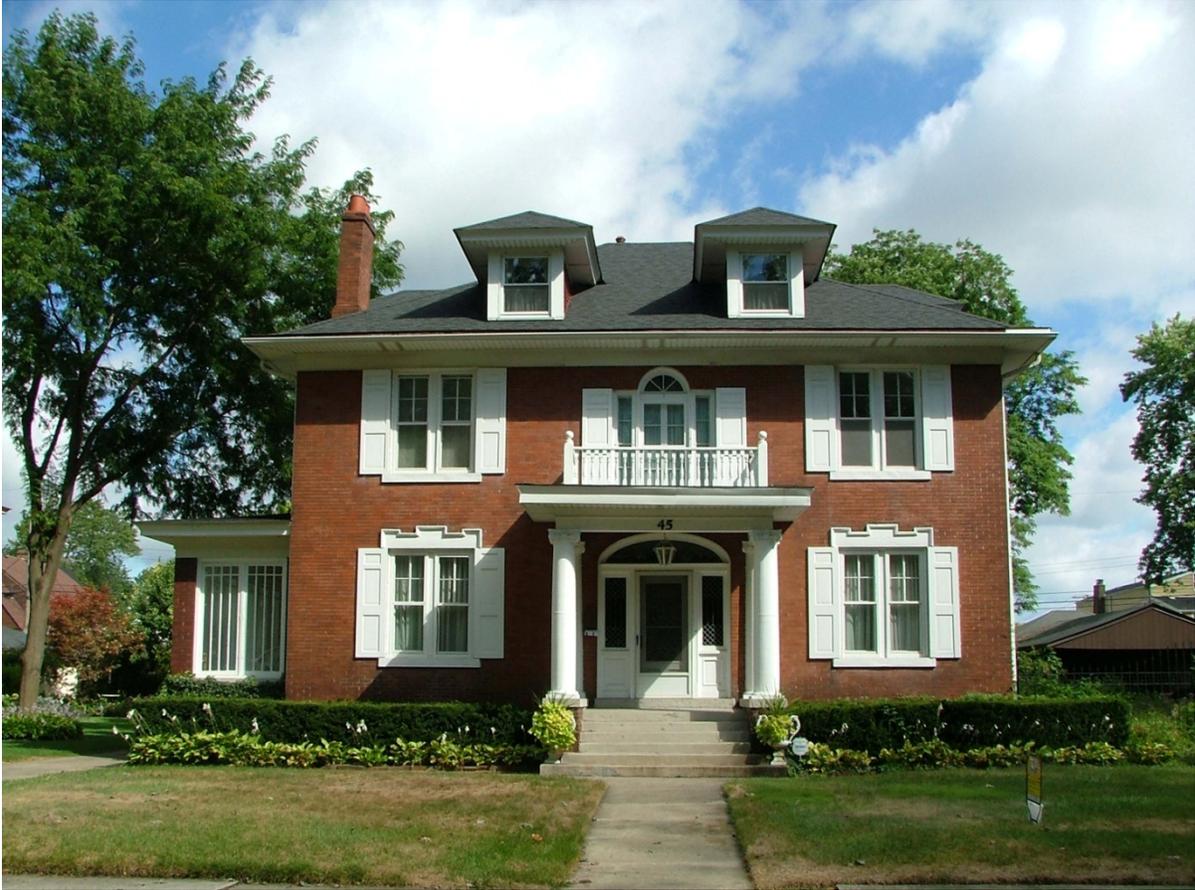
Glendale Park Historic District, Lake Co., IN #004

**45 Glendale Park.** (Photo 4) House, Colonial Revival, c.1907. Contributing.

Constructed of red brick this is a two-and-a-half story, three-bay, hipped roof Colonial Revival house with a one-story flat roof wing attached to its east elevation; the structure faces south. The main portion of the home sits over a full basement. The brick on the façade starts at ground level and is laid in a common bond. Seven concrete steps rise to a small porch set before the main entry. A short wall flanks each side of the steps and each wall has a limestone coping. A one-story, square, flat roof portico covers the porch protecting the entry. Four Ionic columns support the architrave of the portico; the two rear ones are constructed as pilasters. The flat roof features a wood balustrade that runs between four square wood, ball-topped newel posts set at each of its corners. The bays are evenly and symmetrically placed on the elevation. The center bays on the first and second floors contain doors. The main entry door is wood with two vertical lights in the upper two-thirds of its height and two recessed wood panels in its lower one-third. The door is protected by a modern metal storm door with one large light. The entrance is flanked by sidelights; the upper half has glass and the lower half a raised wood panel. The glass section has multiple leaded, diamond-shaped lights in the upper and lower quarters of the window with long vertical stretched hexagon-shaped lights connecting the upper and lower diamond-shaped sections. A large fanlight sits above the door and sidelights; it is also filled with multiple leaded, diamond-shaped lights. The porch is lighted by a metal and glass lantern that is suspended from the center of the portico ceiling. Opening onto the roof of the portico is a wood door with eight (2X4) lights that fill its full-length. The door is flanked on each side by a four-light sidelight and directly over the door is a rayed, half-round window. The sidelights are four-light flanked by a full-length, four-panel shutter. All combined this door opening is Palladian in its design. The other bays across this level are paired double-hung, wood windows each with a 4/1 light configuration. All windows on the main section of the house are the same size and construction. All have wood sills and the window openings are trimmed with wood molding and are flanked by three-panel shutters. Each of the two windows on the first floor is capped with a decorative crenellated wood lintel and the second story window frames rise to the fascia board just below the eave. A wide fascia board runs the full width of the façade just below the wide roof eave; the roof is covered in asphalt shingles. The eaves are covered with a modern siding material and the modillion blocks visible along the eave line in the historic photo have been removed (see photo 2, Appendix A). There are two hipped roof dormers evenly spaced and centered on the roof, each containing a modern metal-framed, 1/1 double-hung window. The fireplace chimney rises above the roofline on the west elevation of the house. A one-story brick sunroom wing is attached to the west elevation of the house. There is a square brick column at each of the two outer corners. The area between the column and the west elevation wall is filled with a pair of fixed, wood-framed windows, each with four long horizontal lights in the lower portion and four square lights in the upper portion. Originally this was an open air porch (see historic photo 2 in Appendix A) and the date of its enclosure is undetermined.

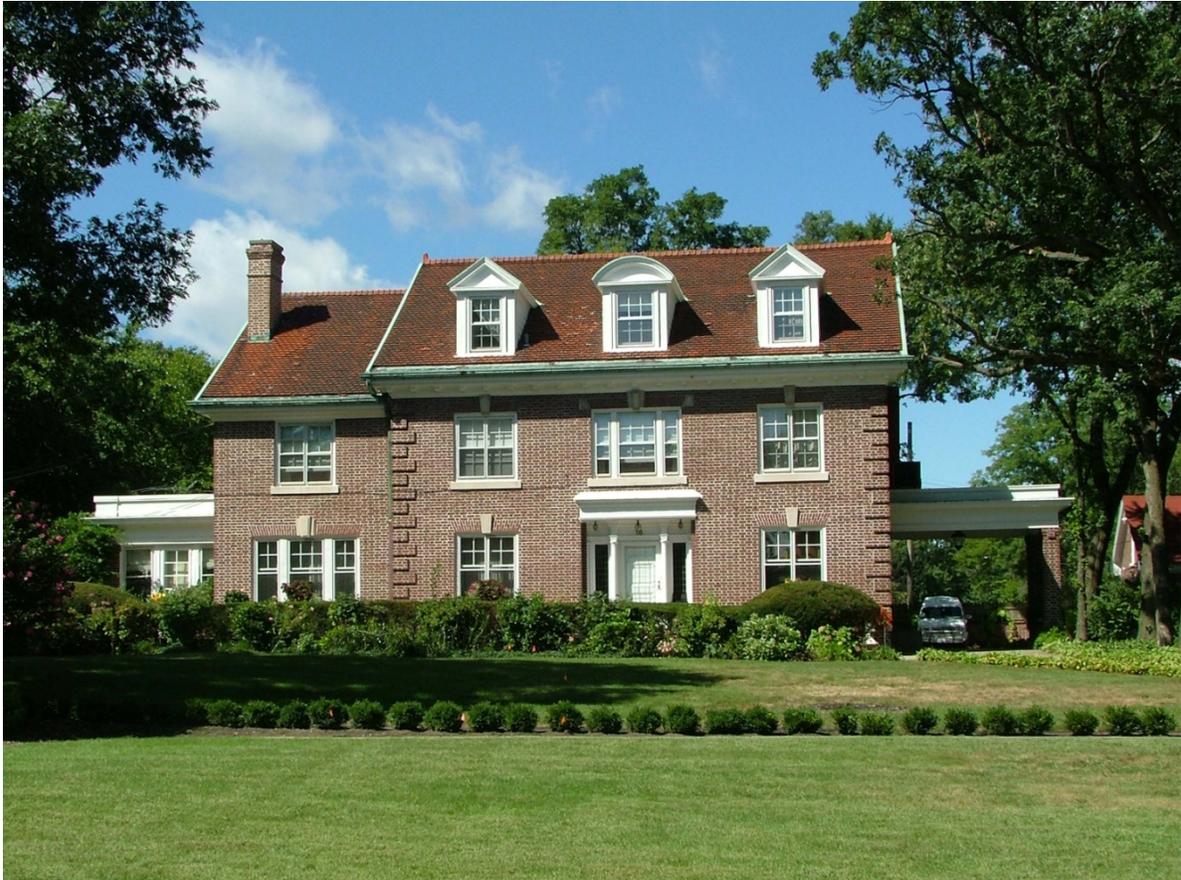
Glendale Park Historic District, Lake Co., IN #009

**18 Glendale Park.** (photo 9) House, Colonial Revival, 1910. Contributing.

Facing east this is large three-story house with a two-story wing and one-story sunroom stepping down off its south elevation. There have been some changes made to the façade since it was first built. The first pertains to the main entry. In the historic photograph (historic photo, Appendix A photo 5) there is a large one-story portico that according to a previous owner, Jerome Kutak, in his paper *The Duchy of Glendale Park*, was beyond repair when he came into possession of the home. He removed the original portico in 1944. Replacement cost to duplicate the original was prohibitive so he researched and applied what is seen on the house today. The second change is the windows. Originally the windows were very large, wood, double-hung, 8/8 construction. At some point they were each replaced with a pair of modern, narrow, 4/4, double-hung windows placed side by side into the historic window openings helping to retain the façade's historic appearance. The historic wood windows were retained in the sunroom at the south end of the elevation, in the three-window grouping on first floor, and the three-window grouping on the second floor just above the entry into the house. The house was constructed using red brick that has been laid in a Flemish bond. There are three bays symmetrically placed on all three stories of the façade of the main section. The brick corners of the three-story elevation of the main section have been corbelled and staggered to resemble quoins. All window

openings on the façade have a splayed lintel of brick with a limestone key; they all also have limestone sills. The slightly recessed main entry is classical with two Doric pilasters flanking the four-panel wood door. On the outer sides of the pilasters is a single-light, wood-framed sidelight that fills three-fourths the length of the door; the bottom quarter has a solid raised wood panel filling it. These are all original to the house. The architrave sitting across the top of the pilasters was installed in 1944. The four outer windows on the elevation are the replacements as described above. The three-window grouping in the central bay directly above the entry has a wood, double-hung, 6/6 center window that is separated by a wide wood mullion on each side from a narrow sidelight of four fixed, vertically-stacked lights. A wide molded fascia board covers the wall just underneath a boxed eave and supporting the eave is a row of modillion blocks. Along the east slope of the roof are three gables, each in line with the windows below them. The outer two dormers have enclosed triangular pediments, while the center dormer has a segmental pediment. Each of these narrow dormers has a 6/6 double-hung window; these are original to construction. The gable roof, as are all of the structure's roof areas, is covered with red slate roofing tiles. Attached to the north elevation of the house is a one-story porte-cochere. Two large, square brick columns support each outer corner of the architrave that supports the flat roof. Attached to the south elevation of the house is a two-story brick wing. Centered on the first floor elevation is a three-window group with the center section being a 6/6 wood, double-hung window and the outer two, separated from the center one by a set of wide mullions, are narrower 4/4 windows of the same construction. The fireplace chimney pierces the roof eave near the south end of the east roof slope; the chimney is corbelled at the top. Attached to the south end of the main section of the house is the one-story, flat roof sunroom. It is constructed in the same manner as the porte-cochere with brick columns at the outside corners of the architrave. The open area between them has been enclosed with a wood entry door with a panel of twelve lights (2X6) in the opening's center and filling the area on either side with a wood, 1/1 double-hung window; the area beneath the windows has been paneled. This house is one of three within the district designed by Hammond architect Addison Courtney Berry.

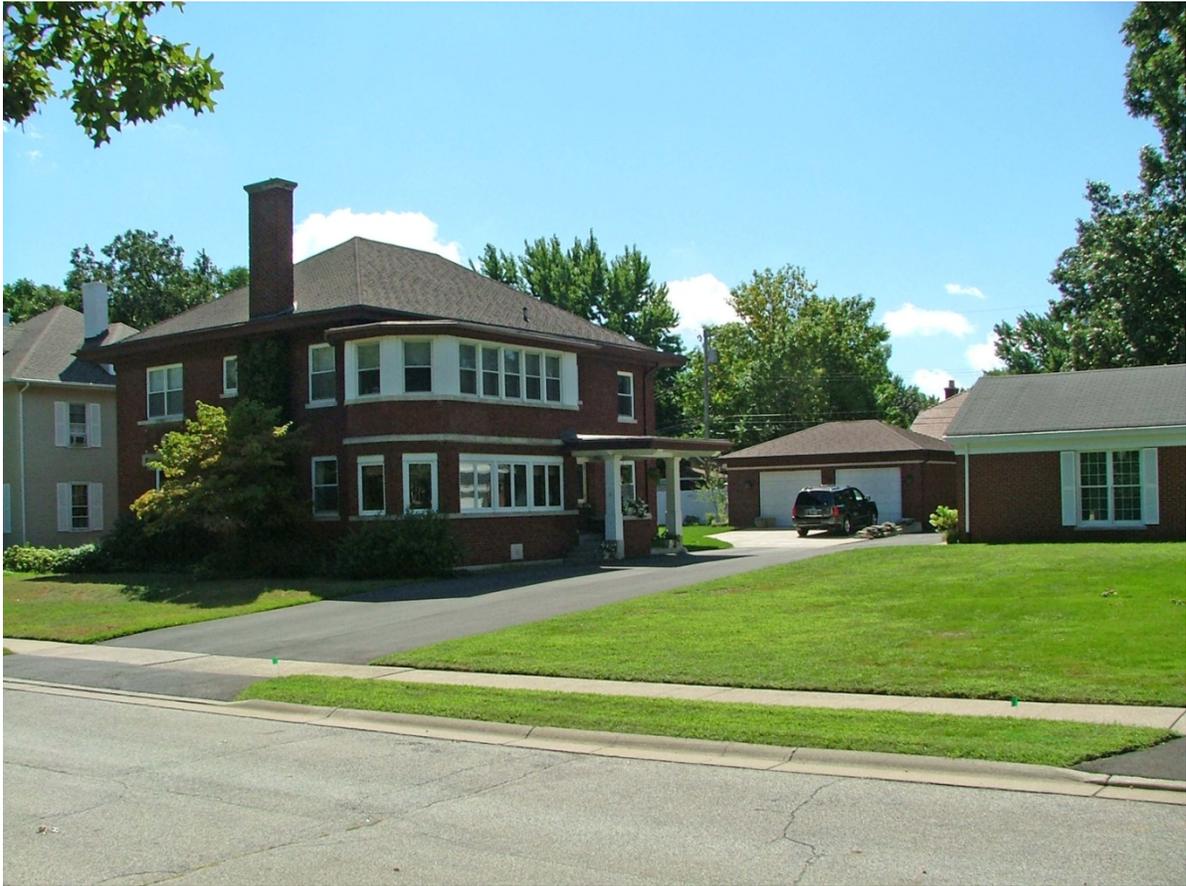
Glendale Park Historic District, Lake Co., IN #012

**38 Glendale Park.** (photo 12) House, c.1916. Contributing.

This early twentieth century house form has Craftsman attributes and is the second house in Glendale Park that is set sideways on its lot; the entry elevation faces west. This two-story, dark brown brick structure sits over a full basement and the brick starts at ground level covering the foundation. The main section of the house is rectangular. A two-story, one room wide, flat roof wing is attached to the north end of the west elevation. This wing extends north beyond the northwest corner of the house terminating in a three-sided bay at its north end. The street side, or north elevation, of the main section of the house has three window openings on each floor as does the three-sided wing. The windows on the main section are evenly spaced across the elevation. A wide brick exterior fireplace chimney has been placed between the center and west windows. The three windows on the first floor of the main section are identical in size and construction; they are wood, double-hung, 1/1, each with a limestone sill. The west window on the main section's second floor is identical to those on the first floor. The center window on the second floor is a narrow, single-light, wood-framed casement window. The east bay on the second floor contains a set of paired windows constructed as those described on the first floor. Directly below this window and above the window on the first floor is a section of decorative brick work using corbelled rowlock and header bricks to create a geometric design. Square, limestone blocks terminate each corner of the design with a large diamond-shaped limestone block placed in the design's center. This sits above a limestone eyebrow over the east window on the first floor. The eyebrow is carved limestone with a horizontal ridge that extends outward from the wall protecting the first floor window. The hip roof above the main section of the house has medium-width boxed eaves and is covered in asphalt shingles. The three-sided bay that extends forward off the northwest corner of the house has a window placed in each facet of the bay. The first floor windows use a limestone string course that extends around from the west elevation as its sills. There are two other limestone string courses that wrap around from the west elevation; one runs horizontally between the first and second story levels and the other runs just below the windows openings acting as their sills. The three windows on the first floor are fixed, single-light, and wood-framed. They are separated from each other by a column of brick that rises at each corner of the facets of the bay. The three windows on the second floor are wood, 1/1 and double-hung, identical to those described on the main section of the house. These are separated by wide wood mullions set at each corner of the facet of the wall. A moderate width roof eave gives way to a flat roof that covers this portion of the house. On the first floor of the west elevation of the wing is a group of three sets of paired wood casement windows; each casement has a single light and uses the limestone string course as a sill. The second story consists of a grouping of five 1/1, double-hung, windows identical to those described on the north elevation. This two-story wing ends just to the north of center on the west elevation. A flat roof, one-story, portico covers the entryway. It extends outwards from the center of the west elevation of the house. The portico extends beyond the west wall of the wing and out over the driveway. Its roof is supported by two square pillars that sit back from the corners of the portico so that a person exiting a vehicle could step out under its protection and the pillars not interfere. Between the entry door and the south end of the elevation there are windows symmetrically placed on each of the floor levels. The southern most are wood, 1/1 double-hung construction. The inner two, just to the south of the entry are wood casements.

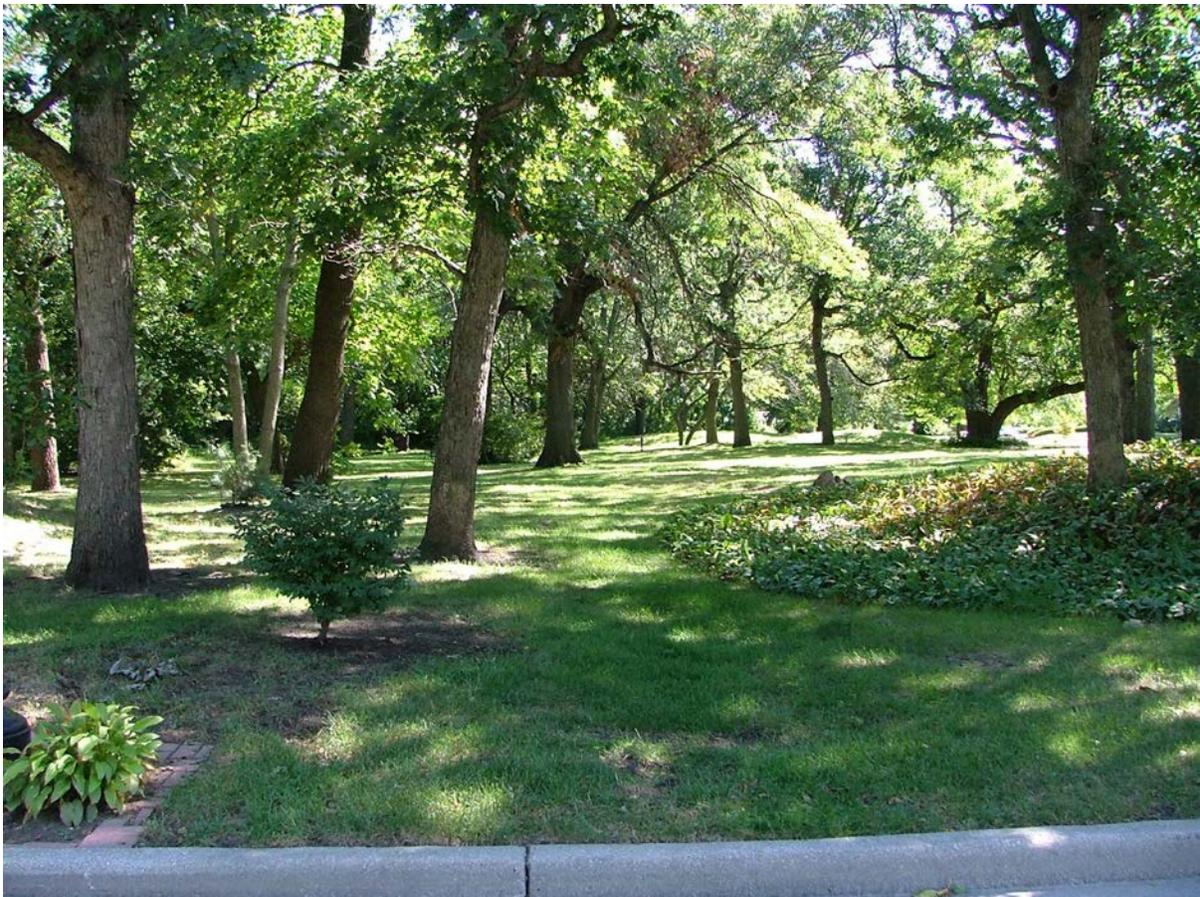
Glendale Park Historic District, Lake Co., IN #018

**Site-Glendale Park (photo 17 and 18)**

Glendale Park is a limited access enclave built around a central park/plaza; it is the first planned non-linear addition to the city of Hammond. At the entry into the development, on Hohman Avenue, the street splits immediately forming an oval parkway that circles the park. The houses within the district have been constructed on lots that ring the outside of this parkway leaving a two-and-a-half acre park in the center of the parkway forming a wide boulevard; the green area of the boulevard forms the park. The original design included another entrance centered on the west end of the district which exited onto Stateline Avenue (see photo location map). Over the years the central park/plaza has been landscaped with small manmade mounds and ridges. The responsibility for the care of this private park has been, over the majority of its existence, the combined responsibility of the inhabitants of the enclave. At the east end of the park, near the entrance from Hohman Avenue, approximately where once a street car waiting shelter stood (see Appendix A, photo 6), is a small commemorative marker pertaining to the park's history; it appears to have been placed there in the mid-1980s. The park is ringed by a series of modern street lights that are very respectful of the districts era of significance. Although the park's plantings have matured over the years the central park/plaza is today still highly representative of its historic appearance. It's landscaping and appearance still provides a rural like setting and a pleasing atmosphere, an island of respite in modern Hammond.
