National Register of Historic Places Registration Form

historic name Keilman, Francis P., House

street & number 9260 Patterson St. not for publication

city or town St. John vicinity

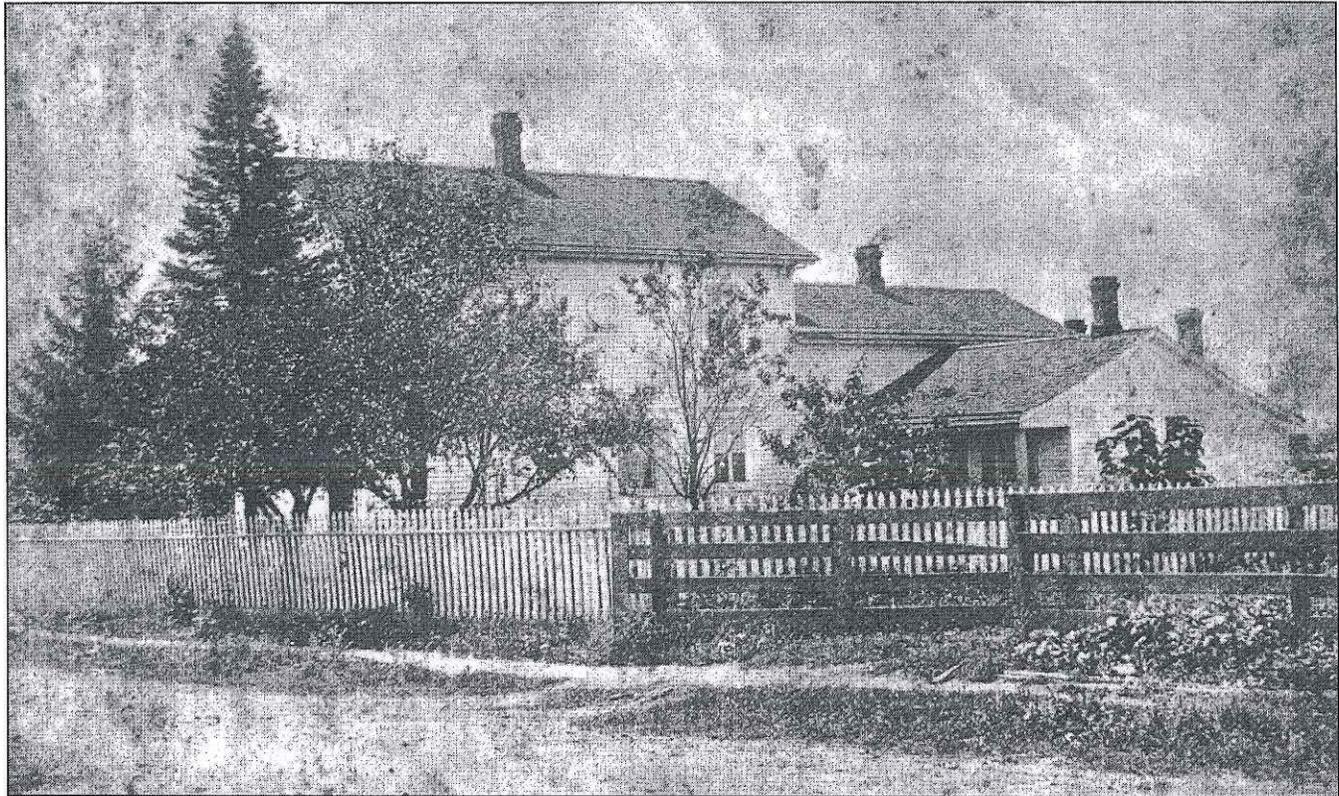
This is a south west perspective of Francis P. Keilman House c. 1900, photographer unknown. This photo shows the addition to the west elevation of the old house showing where it attached to the old summer kitchen. Photo taken from St. John, Indiana : 1837 – 2001 published by St. John Historical Society.

³ A photo of the house c. 1900 showing the summer kitchen is located in Appendix A.

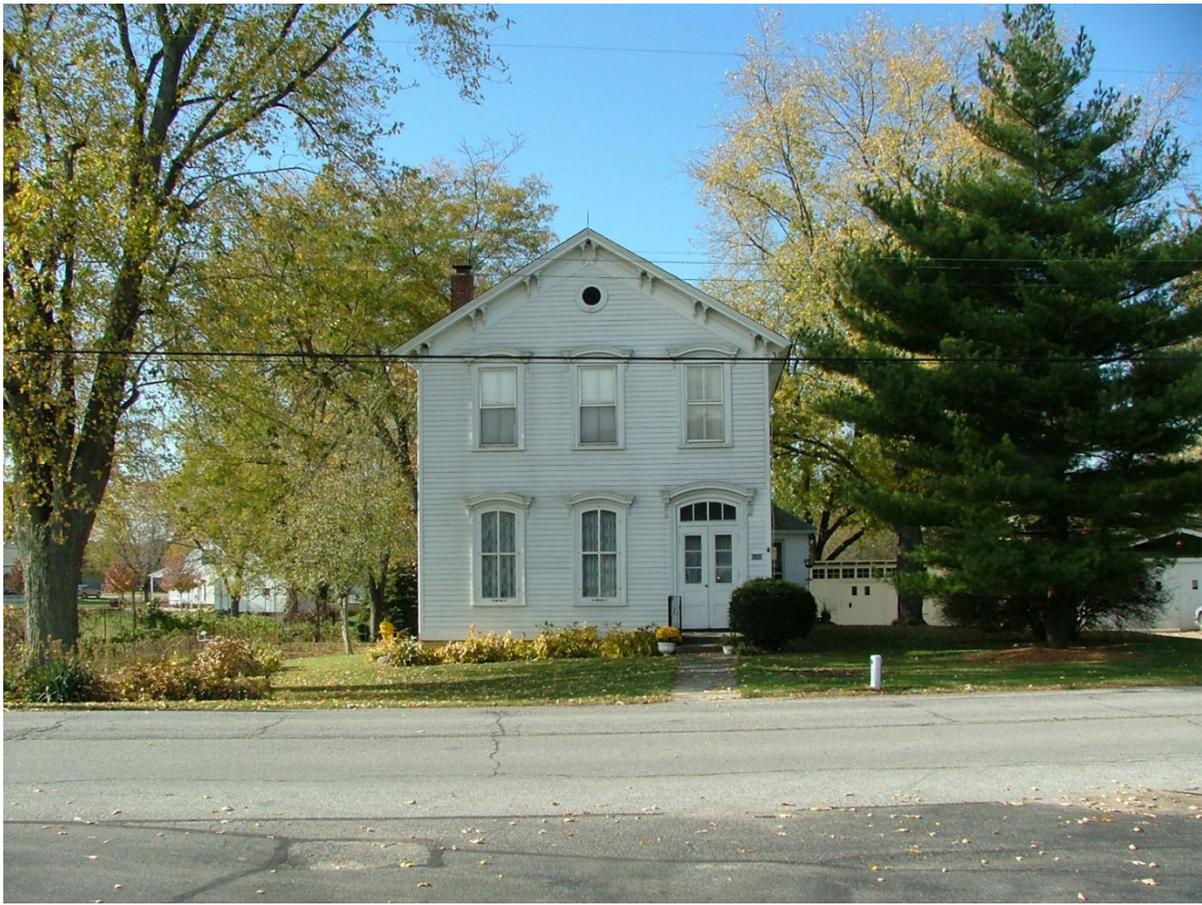
Francis Keilman House, Lake County, IN #0001

Main, or east, façade (photograph 1)

The main façade of the house faces east and sits back approximately thirty feet from Patterson Street. This façade has never been altered and retains all of its historic integrity. The house sits on top of a fieldstone foundation which is covered sporadically with a protective parge coat of cement. The two story elevation is clad with weatherboard with three bays on each of the floors. The builder offset the bays on the façade slightly to the north, yet the façade retains a symmetrical appearance. Centered under the peak of the gable at the attic level is a single circular window. The paired brackets support the eaves of a moderately pitched roofline.

The north bay of the first floor is the main entry into the house. It is covered by the original set of wood double doors. These are in turn protected by a set of historic wood storm doors. The doorway is accessed by two concrete steps that lead to a small stoop placed in front of the entry. The sides of the stoop are flanked by a pair of wrought iron rails. The paneled storm doors are constructed of wood. The upper half of each door has three square lights that fill the full width of the door between the door's stiles; the glass panels are removable and can be replaced with screened inserts.¹ The exterior of the storm doors have been painted white to match the house color while the interior side is stained and varnished to match the main entry doors; they retain their original hardware. The upper two-thirds of the paired main entry doors have a large single light in them. The

lower third of the door has a large single fielded, or raised, wood panel. Both the exterior and interior side of these doors have been stained and varnished. They retain their original iron hinges and bronze locking hardware. The exterior door knob is bronze while the inside is porcelain. Directly above the doors is a fixed segmental arch transom window with four lights with their tops cut in a radius to fit the arched opening. A large, wood, segmental wood hooded crown, each end supported by a small scroll bracket, sits directly above the transom. This crown has flat ends, is molded in a cornice profile, resembling an eyebrow lintel. All windows on this façade are original unless otherwise noted. The two windows on the first floor are the original segmental arched, wood, double hung, with a 2/2 configuration; they are slightly taller than those on the second floor. The first story windows retain their historic segmental 2/2 wood storm windows. Each opening, on both stories, is capped by a segmental hooded crown that is supported at each end by a small scroll bracket and is identical in construction as the one over the front entry. The second story windows are rectangular, not arched, in their construction but otherwise are constructed and finished the same as the ones below them with the exception that they are protected by modern metal storm windows. Centered above them in the gable, at the attic level, is a fixed circular window with a single light. It is enclosed by a wide molded circular trim (photo 2). At the roofline is a wide frieze board that follows the roof eave around the entire older section of the house. Attached to this are seven sets of paired brackets that support the eave of the roof; one pair is centered directly under the peak of the gable with the other six, three pairs per side, evenly spaced along each eave. The brackets and their bed moldings are carefully raked to follow the angle of the eaves, the edge of the eaves is finished with a molded cornice.

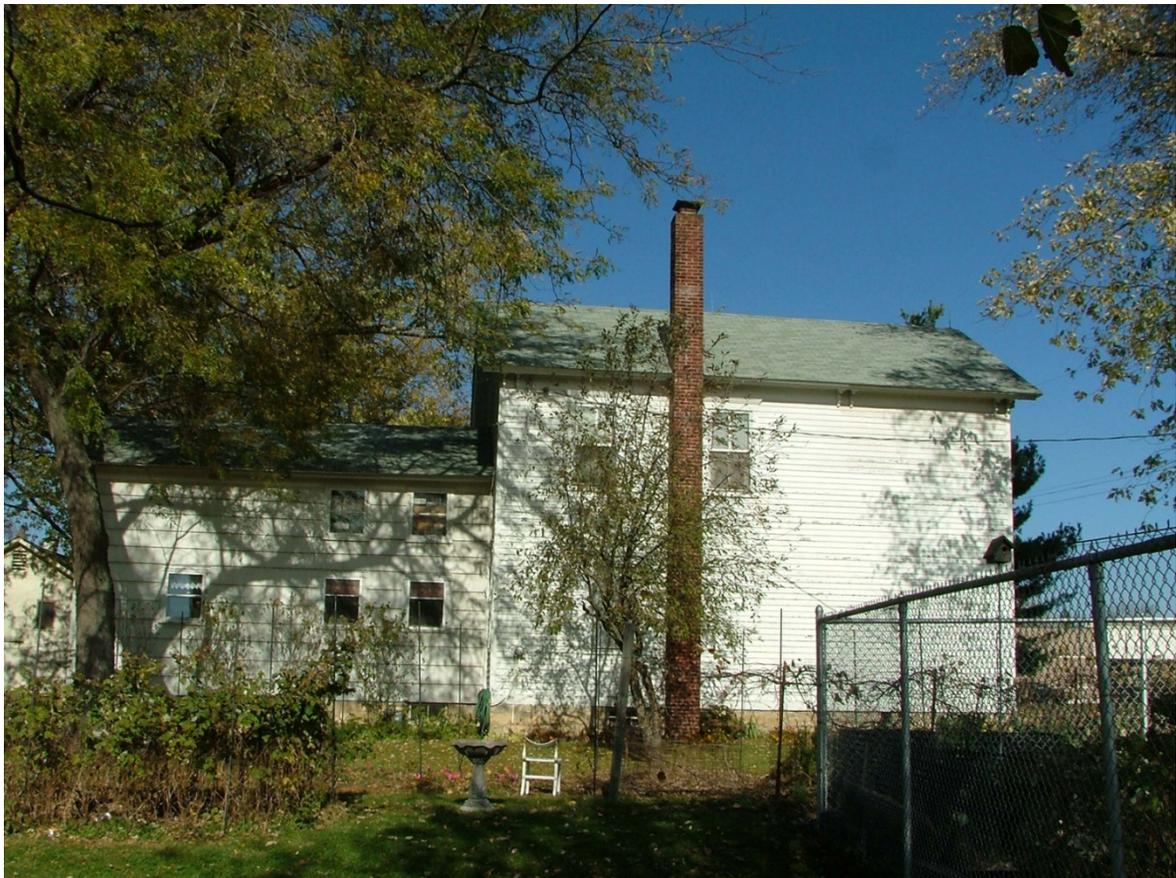
Francis Keilman House, Lake County, IN #0003

South elevation. (photo 3)

The south elevation reveals the c.1900 two story addition attached to the rear elevation of the house. The addition roof steps down in height from the older portion of the house and the elevation is not flush with the older section of the house stepping inward, or northward, a couple of feet. Both sections of the house sit on a full fieldstone foundation with a walk in basement underneath the western three-quarters of the structure and a crawl space under the eastern end of the house. The older portion is clad in weatherboard while the newer section, is covered in asbestos shingle. There are four small windows at the basement level; two in the older section and two in the addition. The elevation of the older section has one window located on the first floor near its western edge with two windows on the second floor; one directly above the first floor opening and one just to the west of the elevation's center. These windows are rectangular in shape. They have no segmental arched hood above them; instead they have plain surrounds with an entablature header. The windows are constructed otherwise identical to those on the main façade. Between the two windows a modern, brick, exterior chimney rises from ground level extending well above the roofline. The structure's original chimney has been removed; it came through the south slope of the roof near the center of the old house servicing the cast iron heating stove. The wide frieze board that started on the main façade continues along the roofline on both. There are five sets of paired brackets, evenly spaced along the length of the older half of the structure's elevation, but there are none placed along the frieze on the addition. The roof is covered with asphalt shingles. The addition has five windows; three on the first floor and two on the second. Four of these windows are in the eastern half of the addition; two on each floor and symmetrically placed. The third window on the first floor is near the west end of the elevation. These are wood, double hung 1/1 windows and are original to the time of construction.

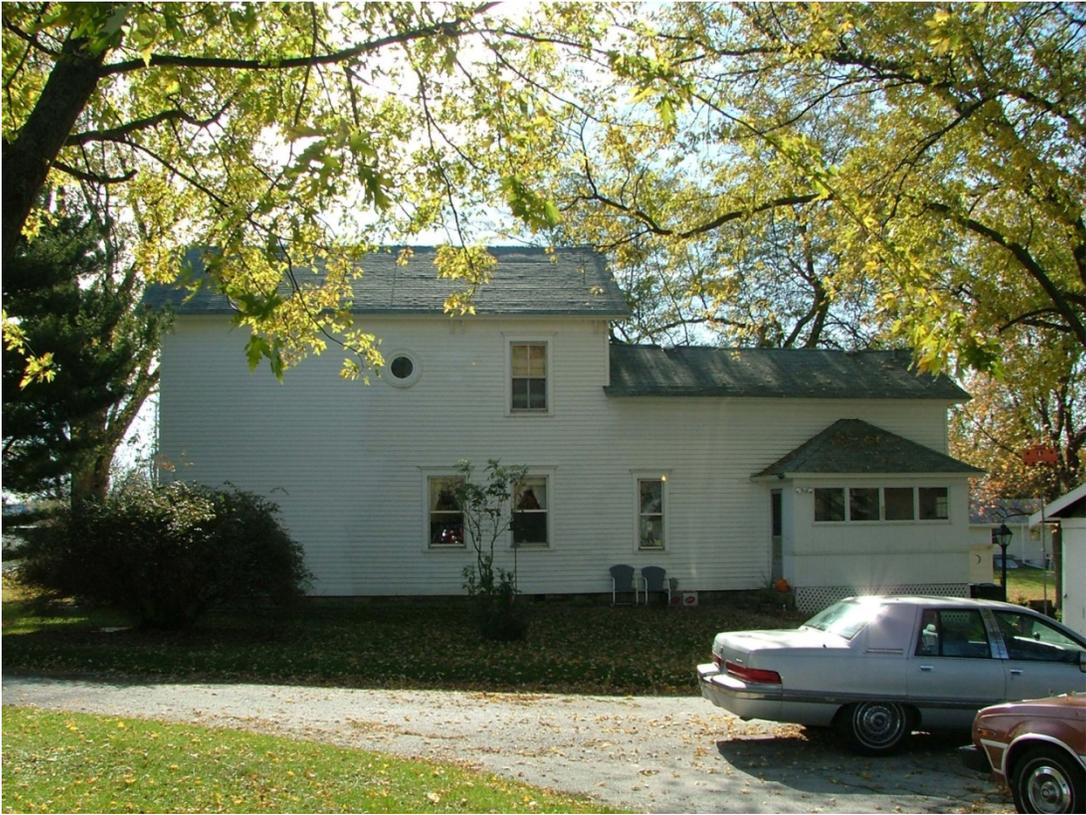
Francis Keilman House, Lake County, IN #0004

North elevation. (photo 4)

The taller c.1857 structure and the addition are flush on this elevation. In the stone foundation there are two small rectangular wood frame windows, one under the older section near the east end of the foundation and one centered in the foundation under the addition. The one story covered entry porch extends forward, towards the north, at the west end of the elevation; it is accessible by two concrete steps on its east side. When constructed this addition originally connected at this end of the elevation to the original stand alone summer kitchen (see photo in Appendix A). According to tradition the kitchen burnt down sometime in the early decades of the twentieth century. A ribbon window of four lights stretches across the upper half of the porch's north elevation. The hipped porch roof is covered with asphalt shingles. Another window is located in the first floor level elevation addition near where the addition joins the older structure. This window sits a few inches lower than those in the older section and is narrower in width than the others on this side; its size is the same as the narrow window described in the description on the west elevation of the older section. Its trim is the same that is found around all of the windows in the older section of the house. This window was probably salvaged and moved to its present position when the addition was made to the house. There are four windows, three are rectangular and one is round, in the elevation of the older section of the house; two on each floor. The first floor windows are evenly spaced in the west half of the elevation of the older house and are constructed the same as those described on the other older elevations. Directly above the west window of these two is the third double throw window. To the east of this window near the center of the older section of the house is an oculus window identical to the one described in the gable of the main façade, it provides light onto the interior second story stair landing.

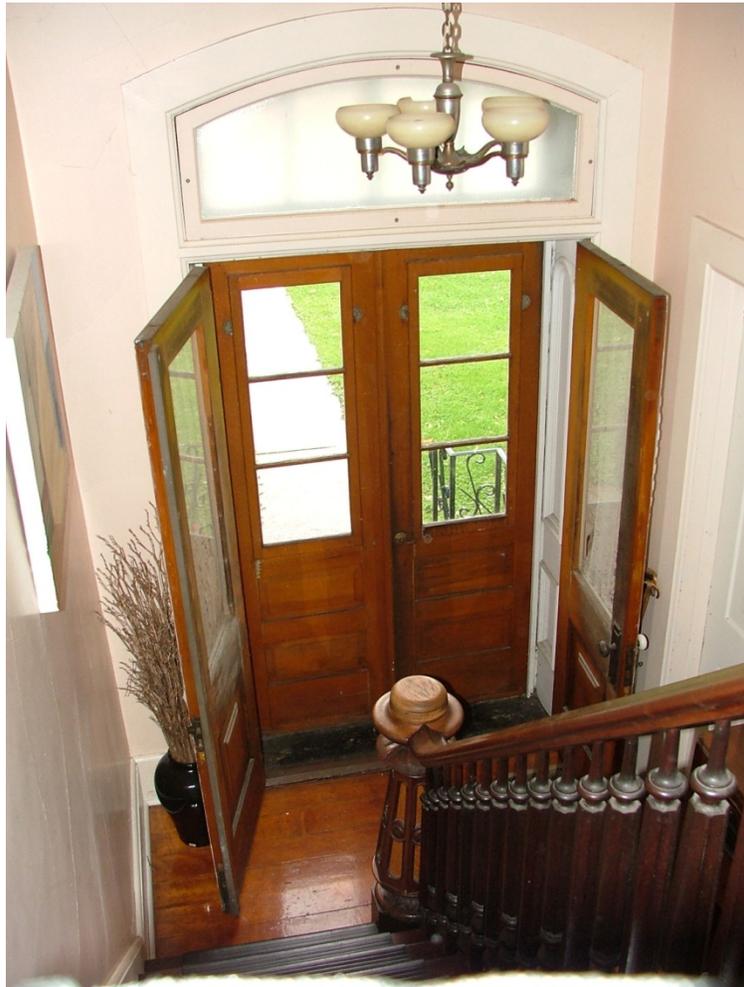
Francis Keilman House, Lake County, IN #0006

On the first floor in the older section there are three rooms and an entry/stair hall (photo 6). The entry hall is situated in the northeast corner of the first floor plan. This room is about one quarter the width of the house and one half of its depth. The floor of the hall is covered with the original wood flooring, as are all of the floors in the older section of the house. The twelve foot tall walls retain their original plaster; as do all walls in the older section of the house. The entry hall has three doors opening into it. The original double wide entry door is centered in its east wall. They retain their original locking hardware and porcelain door knob. A large, segmental arched transom window with two lights sits directly above the doors. This is covered by an interior storm window that fits the arched opening. The ceiling light fixture is not original to the house. A single wide door is located near the east end of the south wall and opens into the parlor. Another single door is located at the west end of the east to west hall that runs on the south side of the stairway; it leads into the dining room located in the northwest corner of the house. The two single wide, four panel, wood doors in the hall are original. The room retains its original ten inch wide molded baseboard and its wide molded door surrounds (the door trim was also used around the windows throughout the rest of the house). All trim on the interior of the house, including the doors, unless otherwise mentioned, are painted white. The straight run stairs go up the north wall of the hall to the second story landing. A large six sided newel post sits at the first floor level of the stairway. Each facet of the post and its base is decorated with an inset of a lighter colored wood, possibly knurled oak. It has a turned and carved newel cap. Carvings that look like sash tassels are carved into the turned area just below where the hand rail connects to the post and leaves are carved in the turned area just

above the newel's base. A molded hardwood hand rail sits atop machine turned balusters; there are two per step. The hand rail and balusters continue up to the landing where it turns and reverses following the stairwell opening of the second floor landing back to the east.

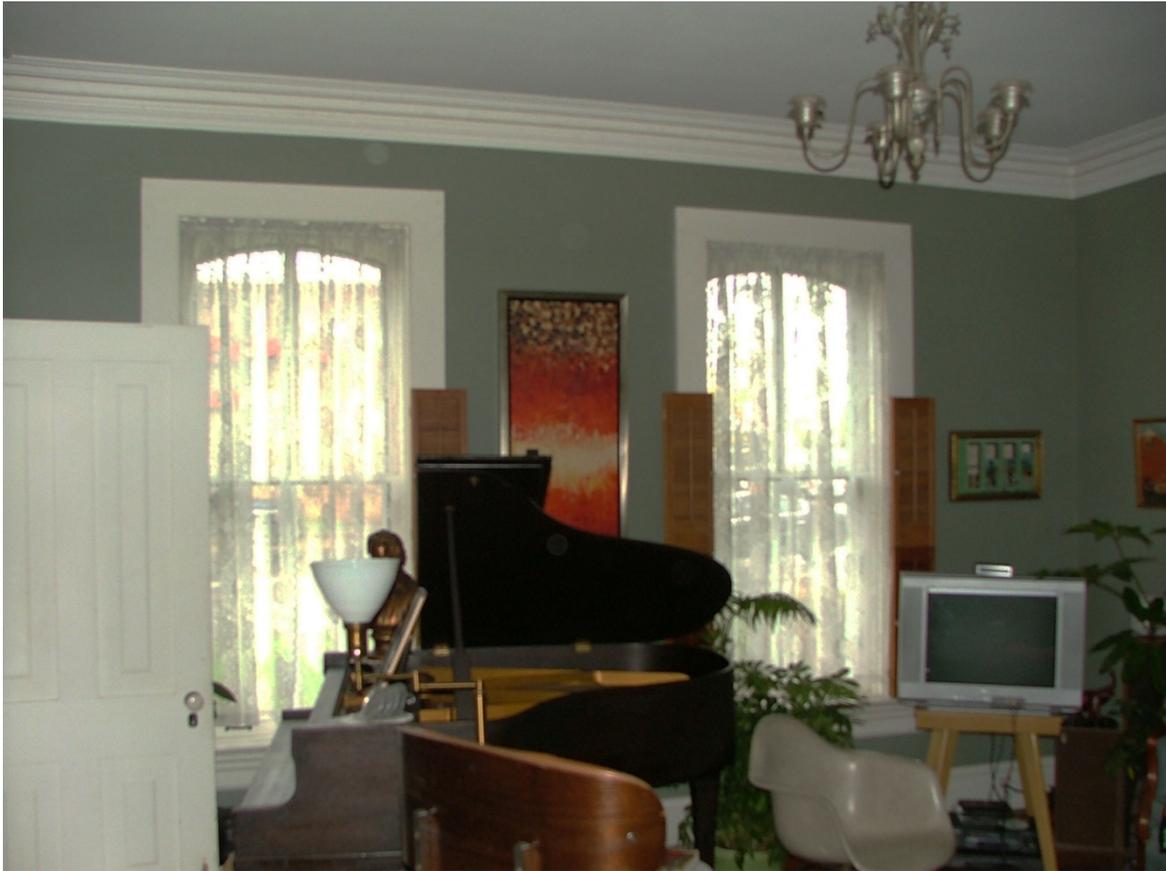
Francis Keilman House, Lake County, IN #0007

The old parlor is located in the southwest corner of the house (photo 7). The floors, floor boards, window trim and wall finish are identical to that described in the entry hall. There are two windows and two doors in this room. The windows are located and evenly spaced in the east wall of the room. These are wood, double hung windows with 2/2 lights and fit a segmental arched opening; this opening is then boxed with a rectangular molded window dressing trim. A door located near the east end of the north wall opens into the entry hall and a wider passage, no doors cover this, exits through the north end of the west wall into the dining room, located in the northwest corner of the old house. The walls in the living room have a wide crown; this is not found in the entry hall. The ceiling light fixture is not original to the house.

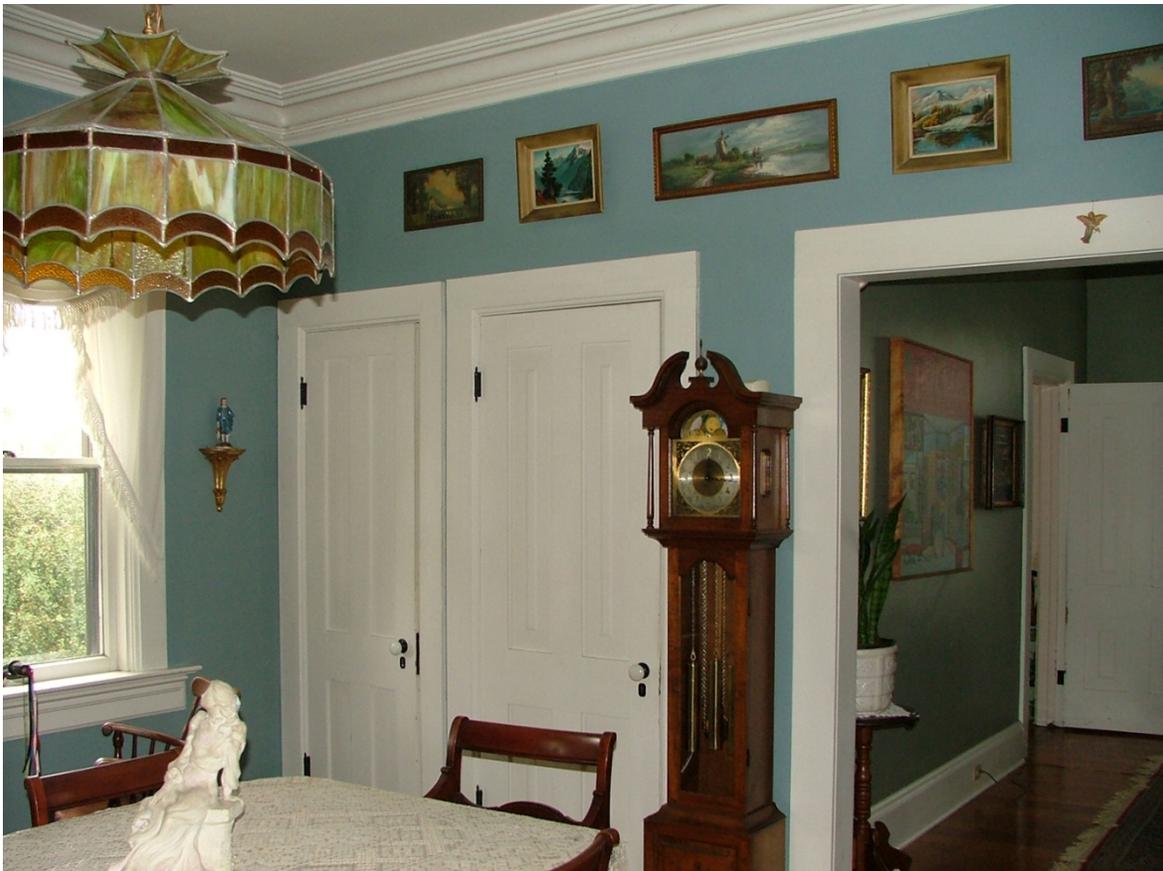
Francis Keilman House, Lake County, IN #0008

The dining room sits in the northwest corner of the old house (photo 8). This room is finished to the same high degree as the parlor including the crown molding. The room contains two windows and five door openings. The windows are located and evenly spaced across the north wall of the room. The east wall of the room contains three openings; the double wide passage coming in from the parlor is located near the south end of the wall. Immediately to the north of this opening is the door that opens into the entry hall and north of this is another single door, though narrower in width, opening into a storage closet built into the area located beneath the stairwell. The two single wide doors are enclosed with a molded trim that is constructed the same size as the one surrounding the double wide entrance into the parlor. This helps to balance the appearance of the room. Each of these single doors retains their original locking hardware, porcelain knobs and iron hinges. There is one door located in the south wall of the dining room just to the west of center. This enters into a room that may have been used as an office in earlier days; today it is a bedroom. In the southwest corner of the dining room is the shaft of the original chimney; in recent years this was altered so that it terminates in the attic. It was in this corner that the cast iron stove that heated the original house set. A glance at the floor reveals where a metal spark plate had been nailed to the floor to protect it from fire. Also, directly above this area in the ceiling is a vented hole that allowed heat to rise into the upstairs of the house. The ceiling light fixture is not original to the house.

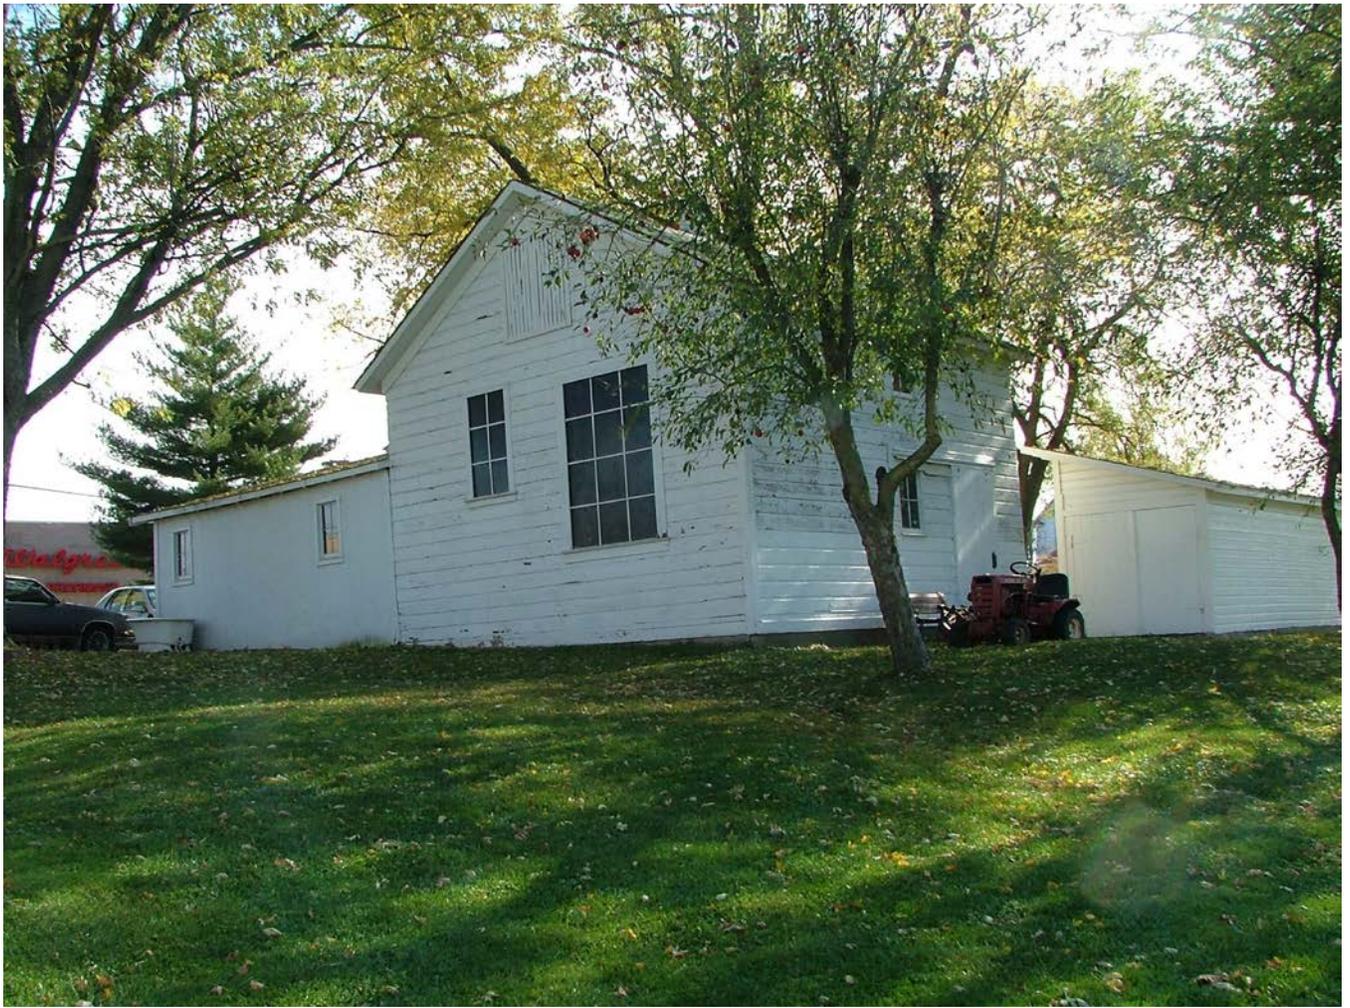
Francis Keilman House, Lake County, IN #0015

Directly to the north of the rabbit hutch is a building that was originally located on the northwest corner of the property, in the area of the meadow, behind the house. According to the present owner, it was originally a stable that was moved to its present location sometime after a fire burnt down the old summer kitchen (reference photo in Appendix A) that stood on part of the ground where this structure sits today. The original wood framed, weatherboard clad, gable roof structure has been modified at an unknown date with the addition of multi-lighted windows to its north and west elevations; the present garage addition was added, c.1941, to its east elevation (photo 15).
