**Indiana Department of Natural Resources  
Division of Reclamation**

**Indiana AML Site # 297  
Enoco Mine  
Knox County, Indiana**

**2010 Abandoned Mine Land Reclamation Award**

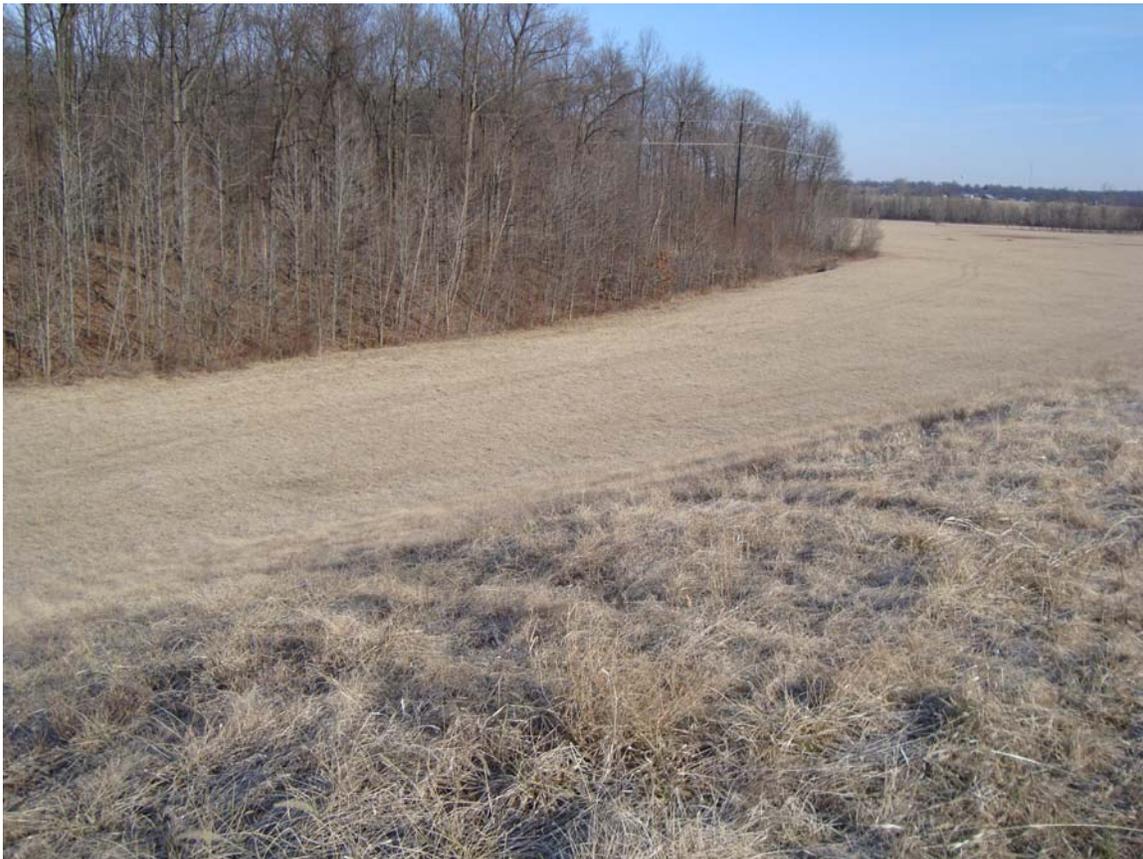
- **Photo 1:** This photograph gives a general depiction of the site conditions prior to the 2009 reclamation activities. The grassy area in this photograph depicts the future location of the SRB cell. This photograph was taken from the top of the reconstructed dam.

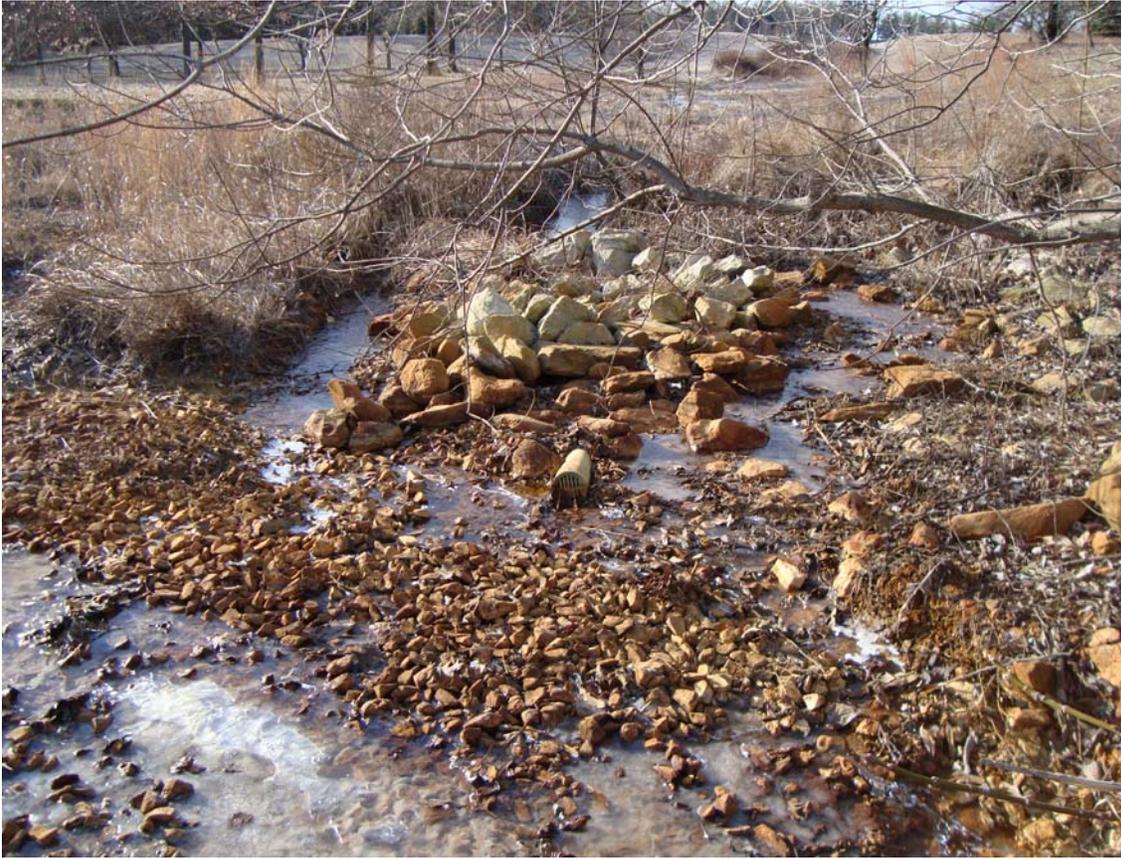
- **Photo 2:** This photograph depicts AMD originating from the drain tile installed in 2004. AMD originating from this location impacted the Smalls Creek watershed degrading downstream water quality.

1,200 ft. dam with a 3:1 slope along the northwest portion of the site to contain the slurry. During the initial phase of reclamation in 1986, two drains were placed within the dam to capture surface and ground water: a category #5 drop structure to capture surface runoff and a toe-drain at the base of the dam to capture groundwater. Though the reclamation efforts at the site have been mostly successful, AMD continued to be a persistent problem at the site. In 2004 IDoR conducted a maintenance reclamation project that involved installing drain tile to intercept a seep that had developed along the southwest corner of the previously reclaimed gob / coal slurry area. Over time however, the seep grew too large, overwhelmed the seep drain, and AMD ultimately began seeping into an unnamed tributary of Smalls Creek. Prior to reclamation activities in 2009, water quality results indicated that AMD originating from the site possessed water quality parameters of the following: pH – 2.90, Acidity- 12,610 mg/L, Alkalinity – Below Detection Limit (BDL), Aluminum – 71.10 mg/L, Iron – 4,224.37 mg/L, Manganese – 1.08 mg/L, Sulfate – 77 mg/L.

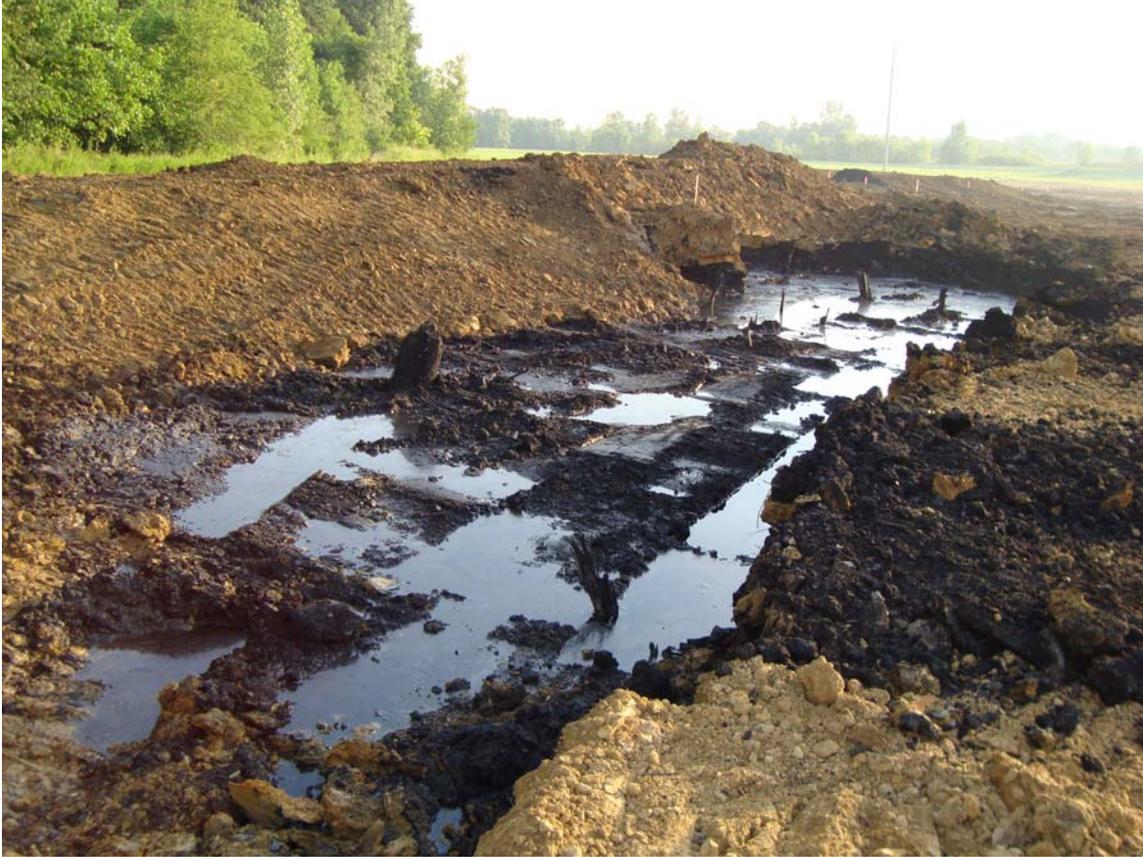
- **Photo 3:** This photograph depicts the bioreactor cell under construction. As noted above, the bioreactor was installed within the area originally reclaimed in 1986.

SRB's are constructed within the existing flow path of the AMD. First, a drainage system consisting of Schedule 40 perforated pipe is placed at the base of a "bioreactor" cell. Next, an organic layer of compost to supply a carbon source to the bacteria is placed within the cell; the piping system is beneath the compost. AMD entering the system percolates downward through the composted material where the anaerobic sulfate reducing bacteria feed on the organic material, converting sulfates into sulfides in the process. Within the SRB treatment cell, the metals begin to precipitate out of solution before exiting the cell through the buried piping system as treated water.

The SRB complex located at the Enoco project site is approximately 7.9 acres in size and consists of 3 separate cells. The SRB bioreactor located at the project site begins with a 1.2 acre bioreactor cell where the process of treating AMD begins. The mixture of organic substrate utilized in the SRB cell consists of approximately 10,000 cu. yds. of the following components by weight: 10% agricultural lime, 10% compost, 50% coarse wood chips, and 30% straw. The AMD is channeled through the substrate and into a network of PVC pipes, where it is then discharged into a 1.0 acre “polishing” or oxidation pond, where precipitates drop out of solution.

After the bioreactor cell was excavated to the required depth, the disturbed coal refuse was covered with a thin veneer (4-inches) of soil. The organic substrate was then placed over the top of the soil veneer, and the system was later activated. Thus far, no complications have arisen that would indicate the buried gob is causing any interference with the system.

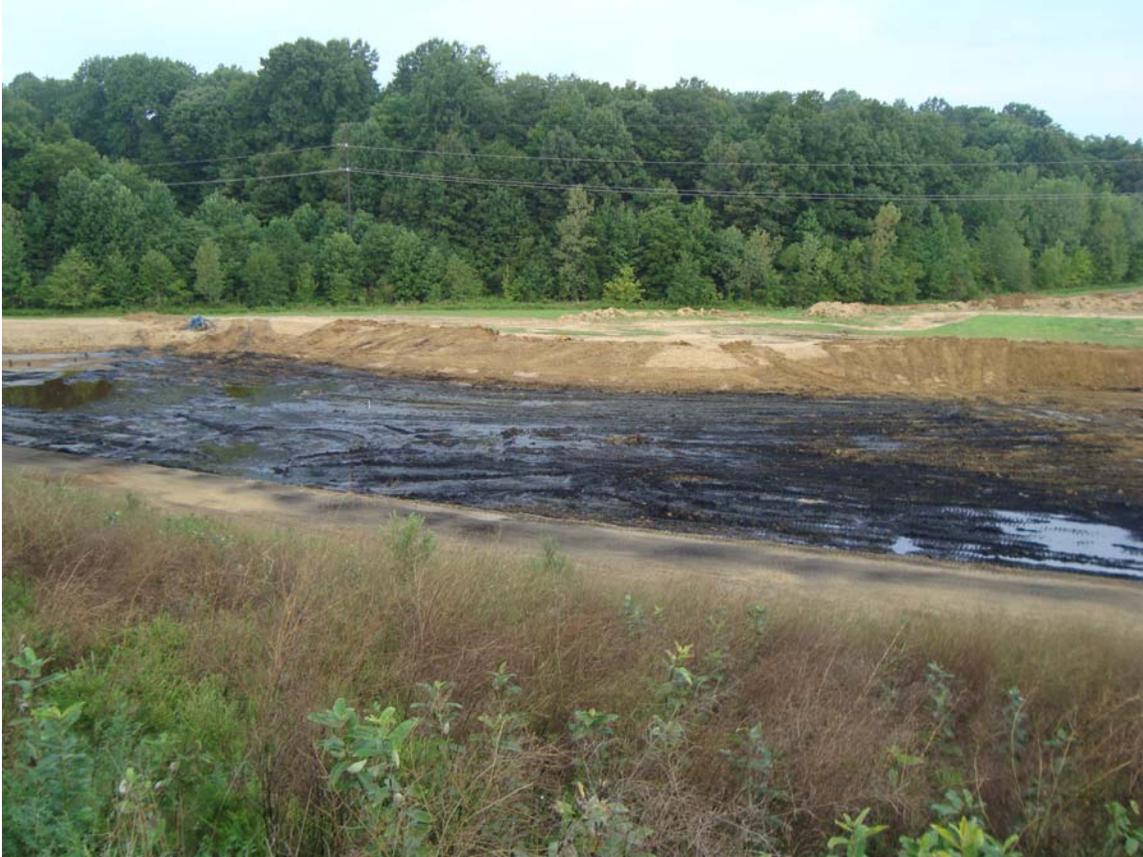
- **Photo 4:** This photograph depicts the future location of the bioreactor cell. This photograph is a good representation of the challenges faced by IDoR to build a successful treatment system on-top of previously reclaimed coal refuse.

**On-site Difficulty of Project:** The greatest challenge encountered while constructing the SRB system was building the bioreactor on previously reclaimed gob. As noted above, one major objective of the 1986 reclamation project was to cover approximately 100 acres of gob and slurry. In order to intercept AMD originating from the drain tile and thus meet the objectives of the 2009 reclamation project, it was decided the SRB system would need to be placed within the previously reclaimed tailings area; however, installing the SRB system required disturbing buried gob.

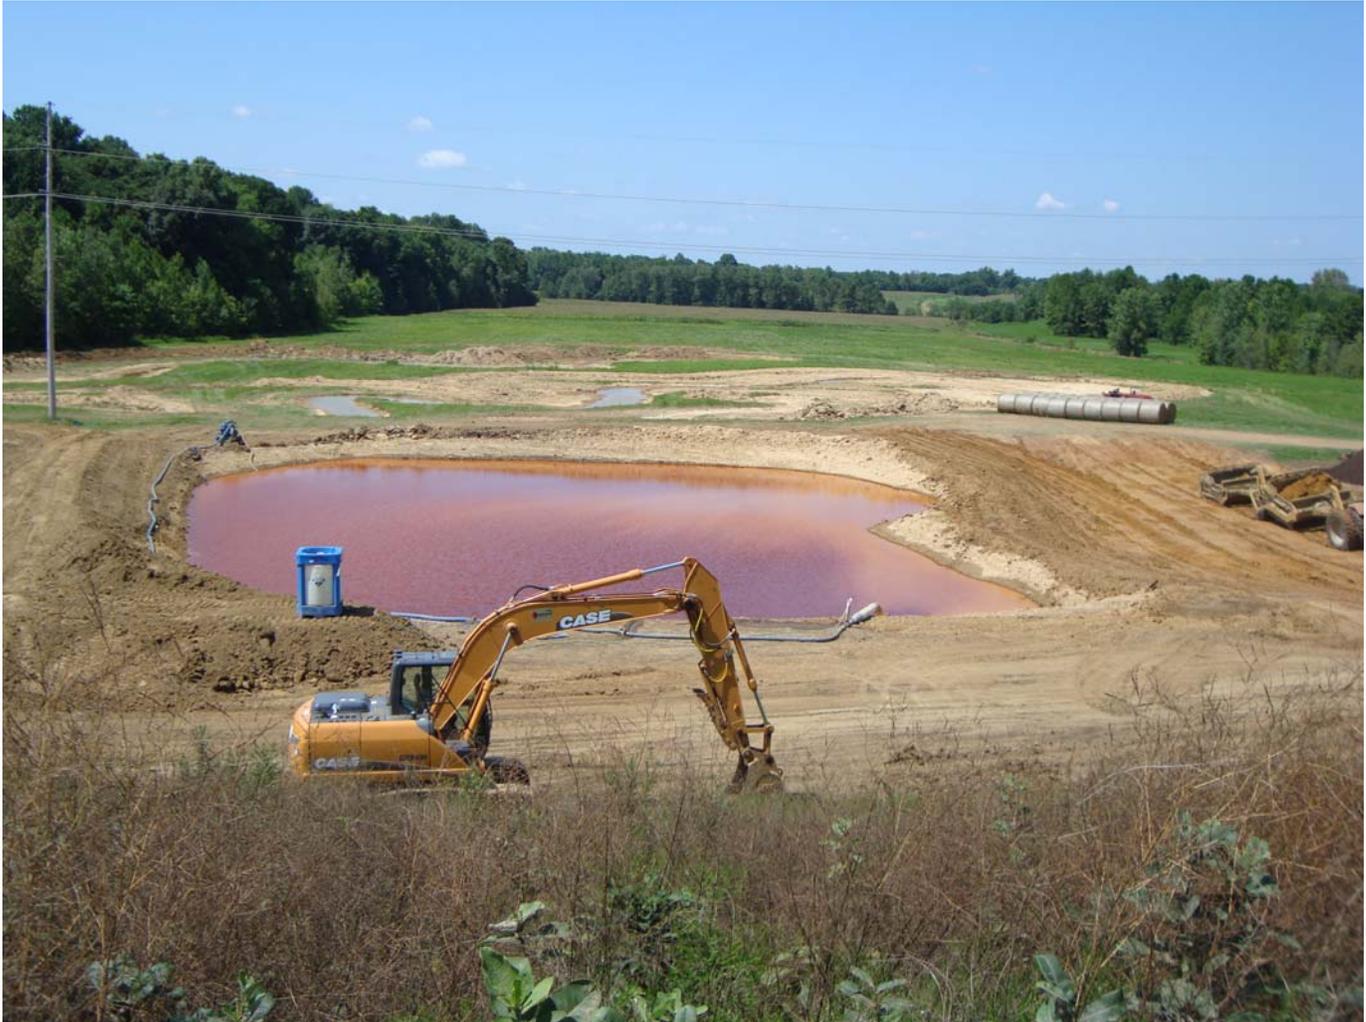
- **Photo 5:** As indicated above, during construction of the bioreactor cell (and oxidation pond), a heavy rain event occurred. As the coal refuse noted in photo 4 was exposed to the open environment, AMD began to generate. This photograph depicts the oxidation pond flooded with  $\text{pH} < 1$  AMD. The AMD seeped from the bioreactor (not pictured), which would be located to the left of the oxidation. The AMD was treated in-place (not discharged) using sodium hydroxide ( $\text{NaOH}^+$ ).

As construction of the bioreactor cell began, thus exposing the gob to the surrounding environment, a large rain event occurred and flooded the bioreactor cell. IDoR took precautions such as building the SRB “backwards” (polishing wetland → oxidation pond → bioreactor cell) so no outlet existed (until project completion) that would allow a large flush of AMD into the Smalls Creek watershed. This practice proved worthwhile as the previously mentioned rain event could have caused a large discharge of AMD into the Smalls Creek watershed. Conditions within the rain flooded bioreactor cell showed pH levels drop below detection levels on a field pH meter (pH <1).

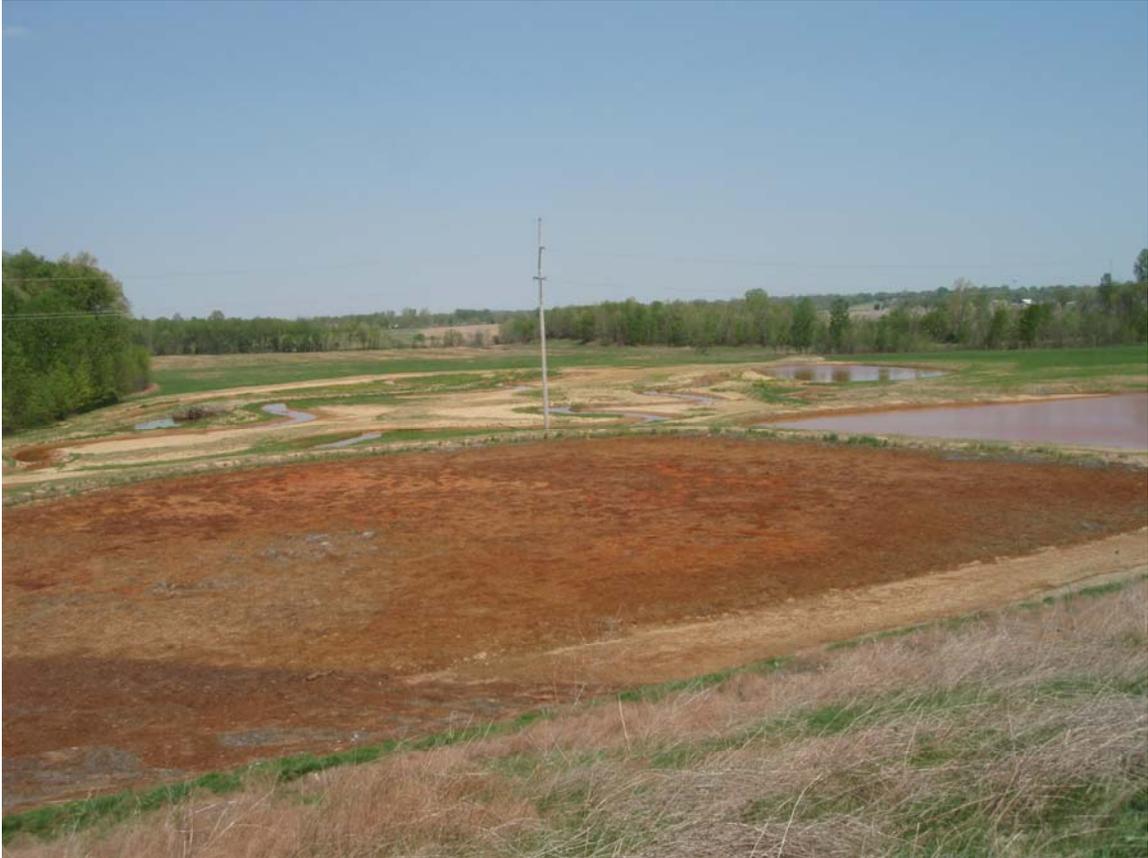
- **Photo 6:** This final photograph is a picture illustrating the site nearly 5 months after the completion of reclamation. The water filled impoundment noted in this picture is the flooded bioreactor cell. To the right of the bioreactor cell is the primary oxidation pond. The polishing wetland, which discharges into the unnamed tributary of Smalls Creek can be noted in the upper left-hand side.

The SRB located at the Enoco project site is designed to maximize the amount of time the AMD and the organic substrate have to interact with one another. Unlike a traditional SRB where AMD is collected in a feed pond and then channeled in to the bioreactor cell, AMD seepage at the Enoco site originating from the gob / coal slurry area is channeled directly into the bioreactor cell. Unlike a traditional bioreactor cell, which has a PVC network extended throughout the entire length of the cell, the piping system associated with the bioreactor cell at the Enoco project site is not extended throughout the cell. In other words, AMD must flow throughout the organic substrate (and is thus retained for a longer period) until it reaches a network of PVC piping (located near the northeast corner of the bioreactor cell) that carries the treated water to an oxidation pond, where sulfide precipitates will continue to drop out of solution.

After the treated water exits the oxidation pond, it encounters a small wetland created by IDoR during the 2009 reclamation project. The purpose of the wetland is to further allow precipitates to drop out of solution prior to entering an unnamed tributary of Smalls Creek. The wetland is similar to the bioreactor cell in the sense that the construction of the wetland makes it conducive to the build-up of organic material. A series of “leaky-rock dams” were placed throughout this wetland cell. Over time, it is believed that organic material

circulating throughout the SRB system will “plug up” the pore spaces within the dams, thus flooding the wetland. This process will not only create a greater retention time for precipitates to drop out of solution but it will also establish a wetland habitat for local wildlife. The table below illustrates water quality data collected from the site:
