EAGLE CREEK WATERSHED MANAGEMENT PLAN:  
AN INTEGRATED APPROACH TO IMPROVED WATER QUALITY

Eagle Creek Watershed Alliance

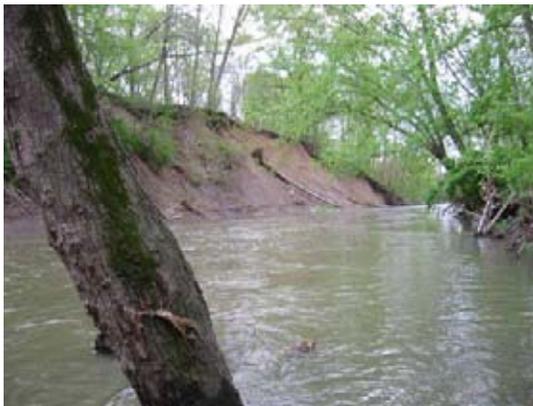
Big Eagle Creek

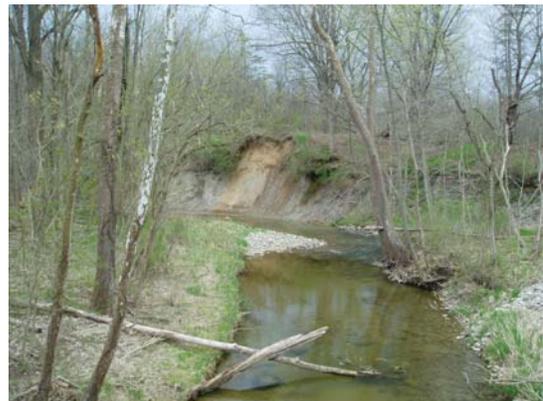
Fishback Creek

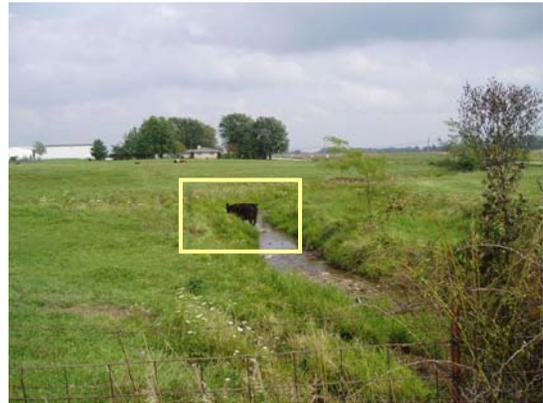
School Branch – Cow in stream.

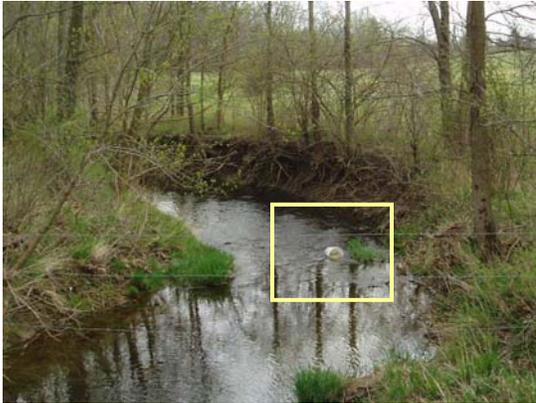
Fishback Creek – Bucket in stream.

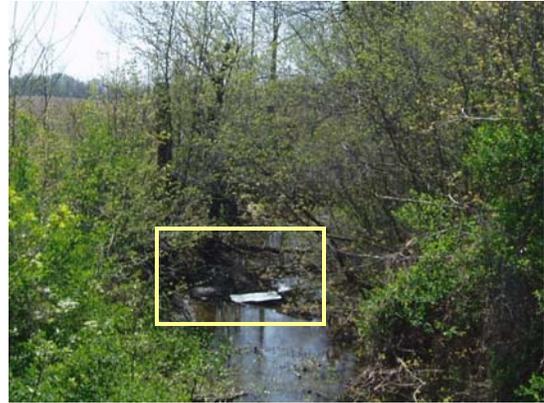
School Branch – Tire and scrap metal in stream.

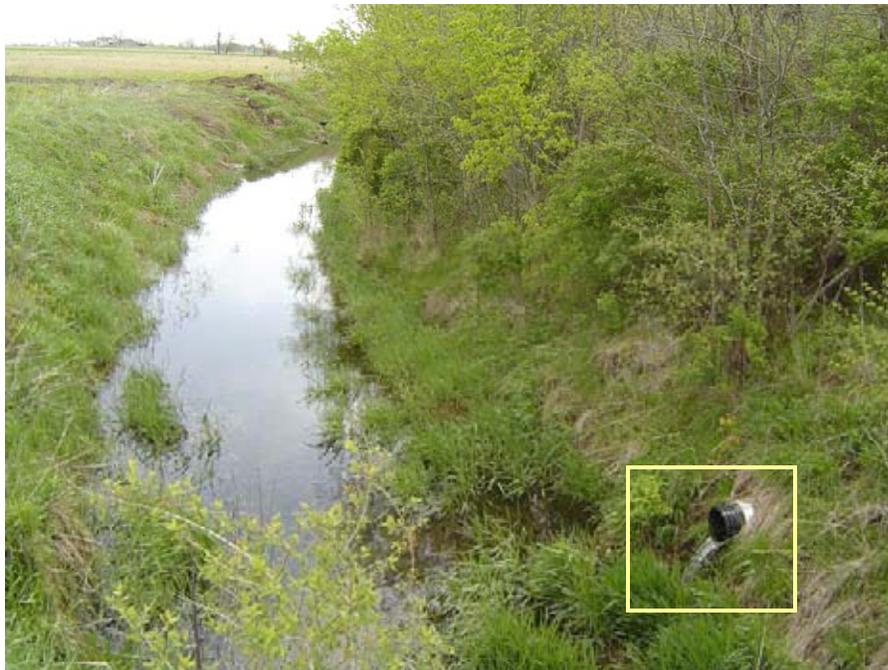
Mounts Run – Pipe discharging into stream.
