INDOT Geotechnical Services Division
Identifying Indiana Landslides

Introduction

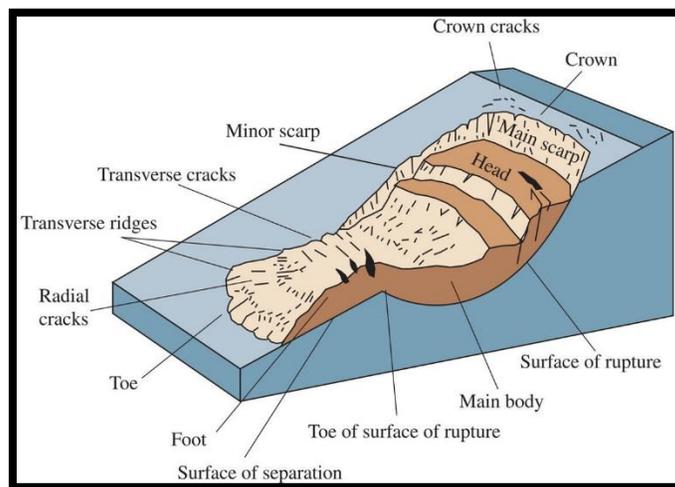
USGS Diagram of landslide, from United States Geological Survey Fact Sheet 3004-3072

The head is the upslope portion of the landslide. A scarp is a steep (nearly vertical) region of exposed soil and rock at the head of the landslide where the failure surface ruptures the ground surface. Head scarps can also be referred to as main scarps as shown in the USGS diagram in the introduction of this document.

Tension cracks are breaks in the ground surface which are found throughout the landslide mass. Types of tension cracks are represented on the USGS diagram in the introduction of this document.

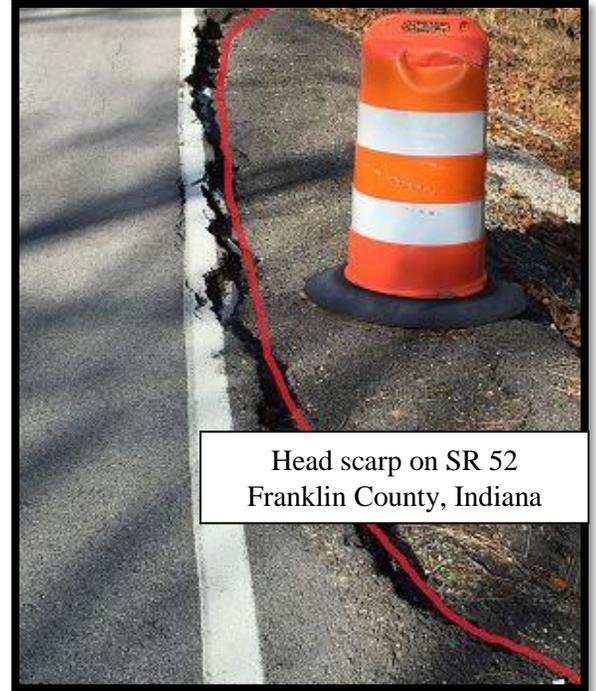
Head scarp on SR 52
Franklin County, Indiana

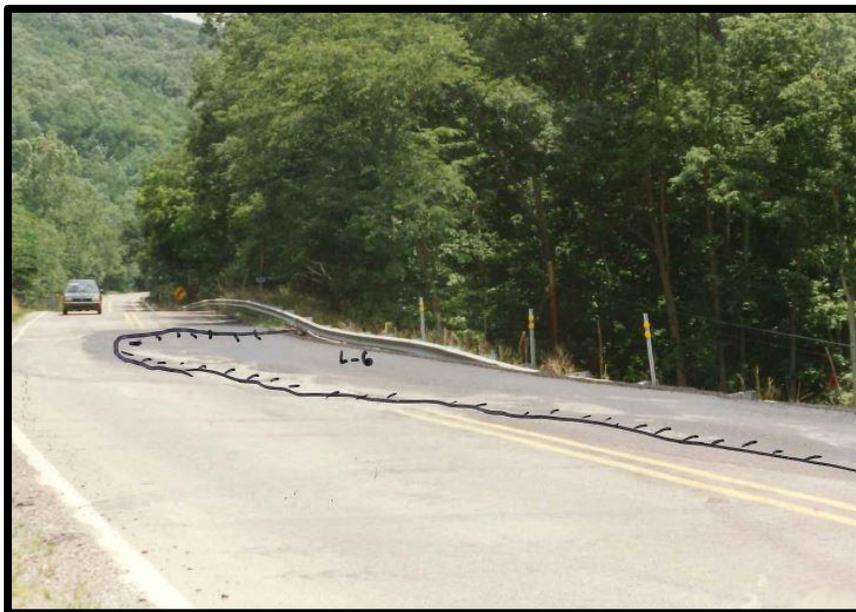
Likely head scarp on SR 62
Perry County, Indiana

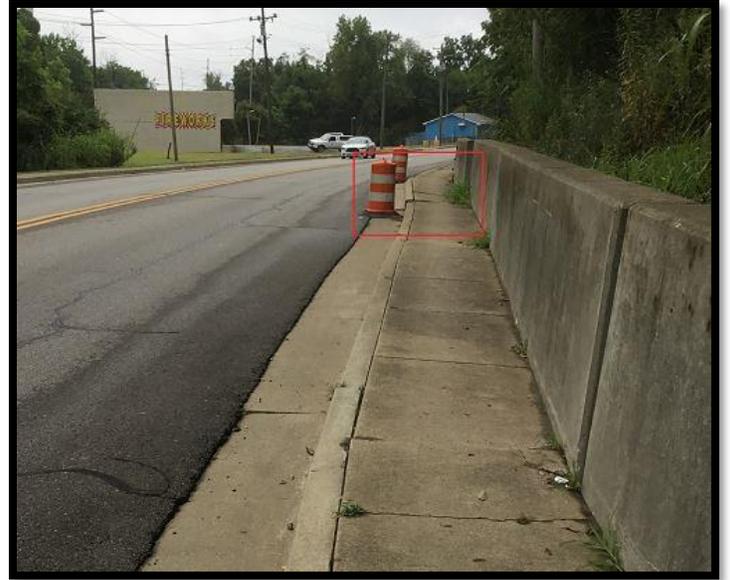
Photo: Uplift in sidewalk on SR 111,
Floyd County, Indiana

The toe is the downslope portion of the landslide. The intersection between the lower part of the surface of rupture of a landslide and the original ground surface is the toe bulge. Toe bulges can fill in drainage ditches along roadways and even cause uplift in the roadway's pavement as seen in photo below.

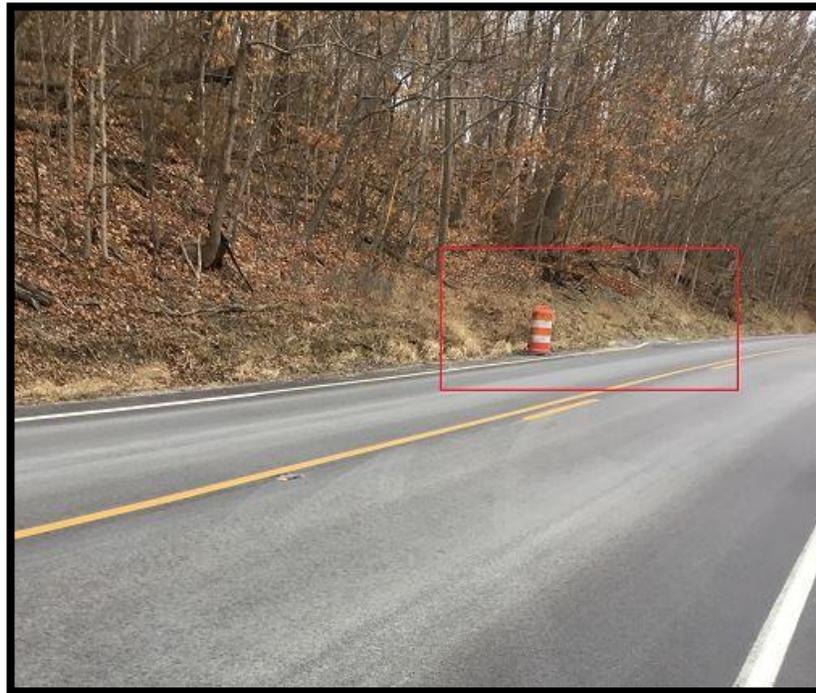
Photo: Uplift in pavement on SR 66 Spencer County, Indiana

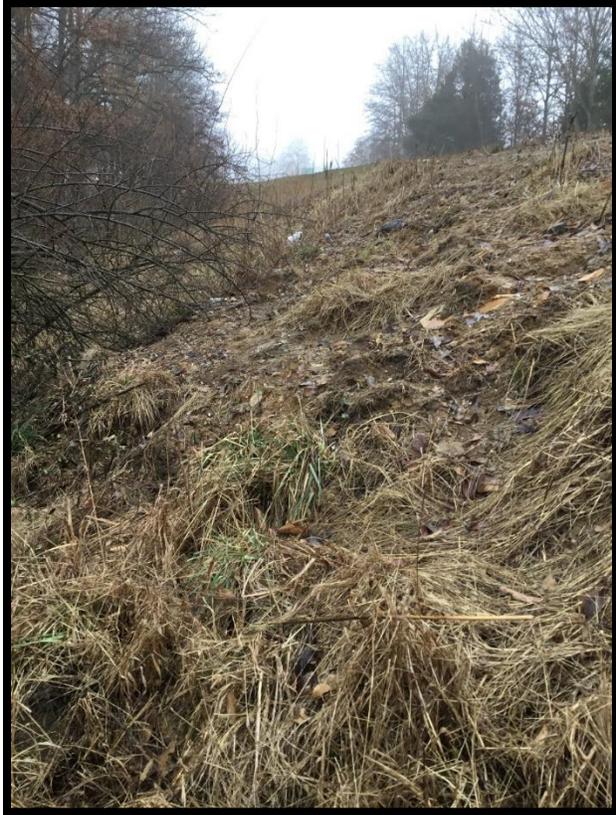
Hummocky/bumpy surface near SR 64
Pike County, Indiana

Hummocky terrain is where the slope is bumpy and uneven. Signs of hummocky terrain can include water puddles on the slope, uneven vegetation, grass appearing in large clumps, and oddly-placed boulders.

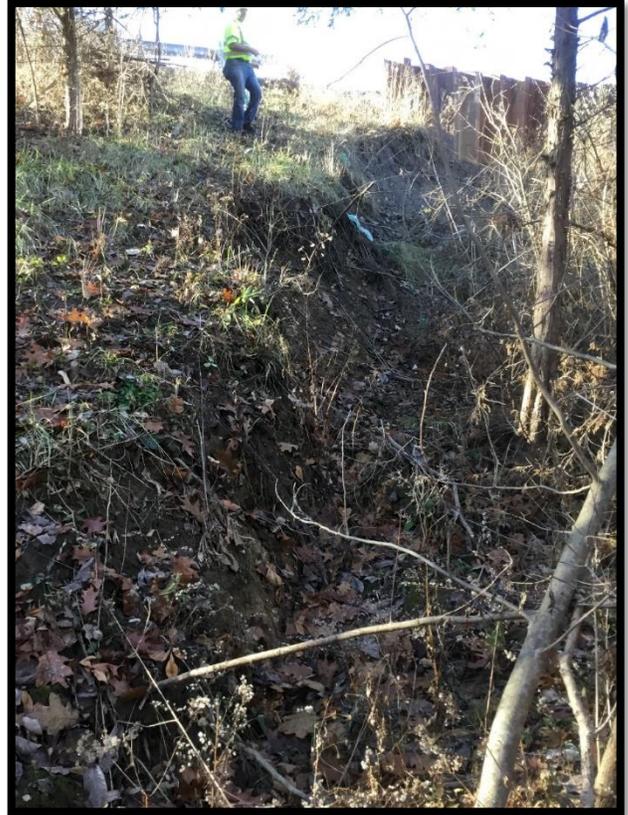
Uneven ground near SR 63
Vigo County, Indiana

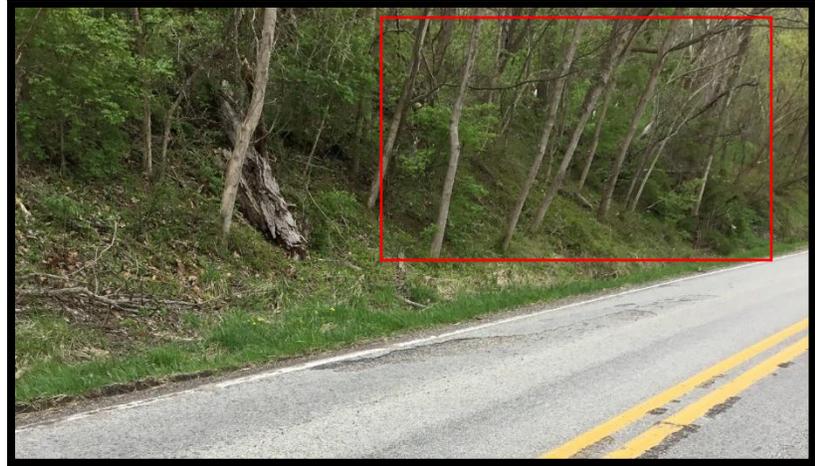
Trees leaning on US 52 Franklin County, Indiana

If the slide has been a slow continuous movement, trees growing will compensate for the movement of their base, resembling a J-shape. Trees and poles may begin to tilt over time as the slide continues to move.

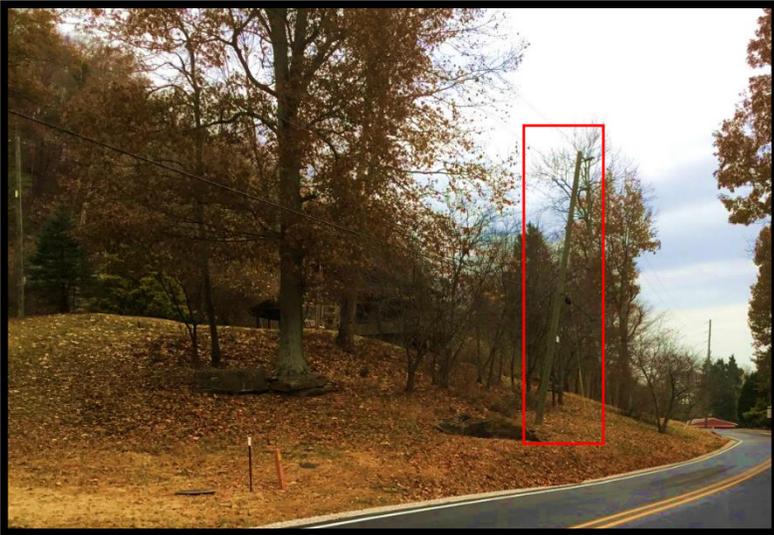
Pole leaning near SR 66 Perry County, Indiana

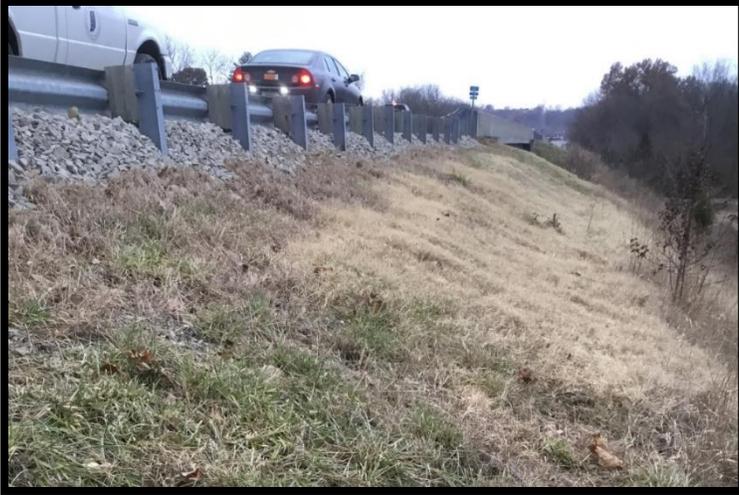
Drop in guardrail on SR 66 Vanderburgh County, Indiana

Landslides can cause a drop or a bend in the guardrail along the roadway.

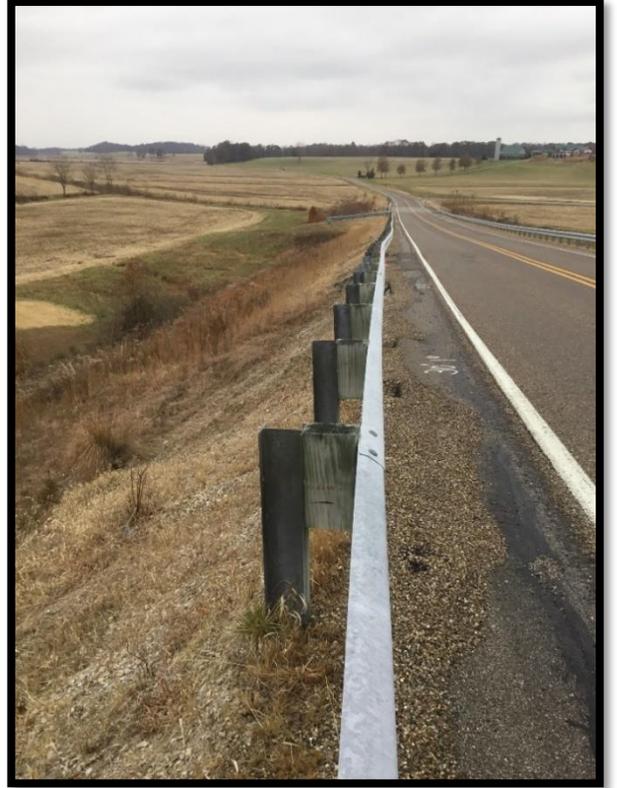
Guardrail bending on SR 245
Spencer County, Indiana

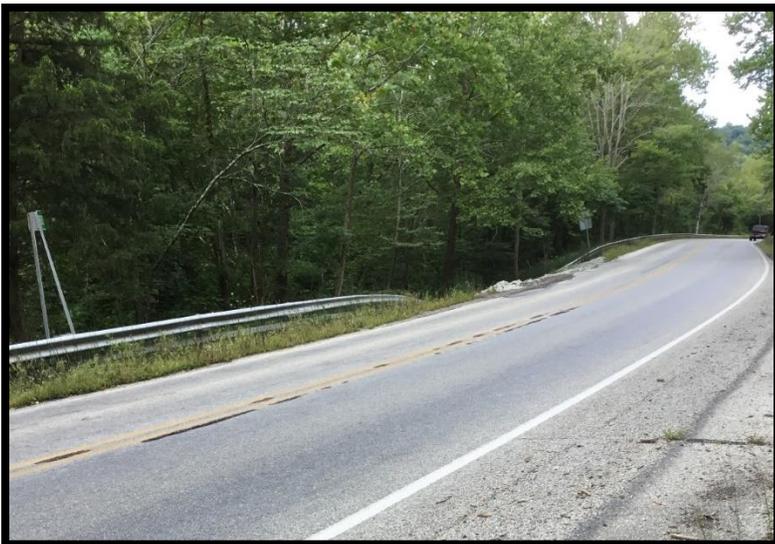
Guardrail bending and disappearing downslope on SR 1
Franklin County, Indiana

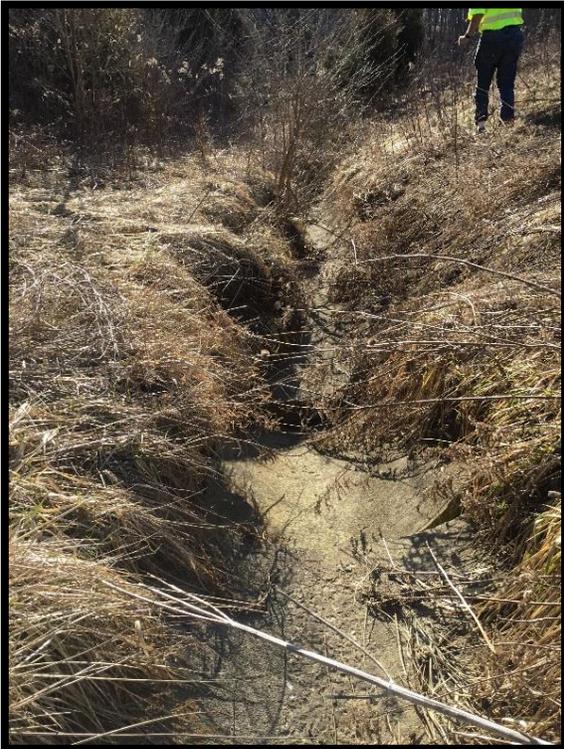
Broken paved ditch near SR 350,
Ripley County Indiana

Landslides can cause separation of paved gutters or pipe sections depending on the type of slope movement.

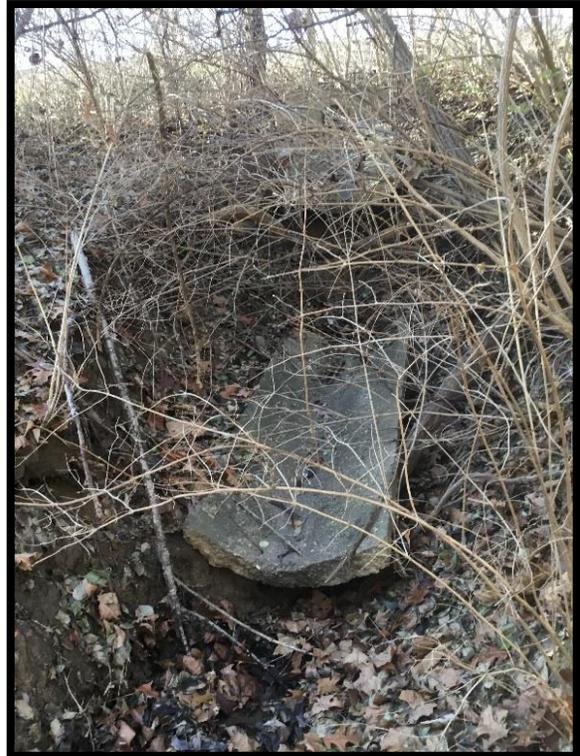
Broken paved swale near SR 63
Vigo County, Indiana

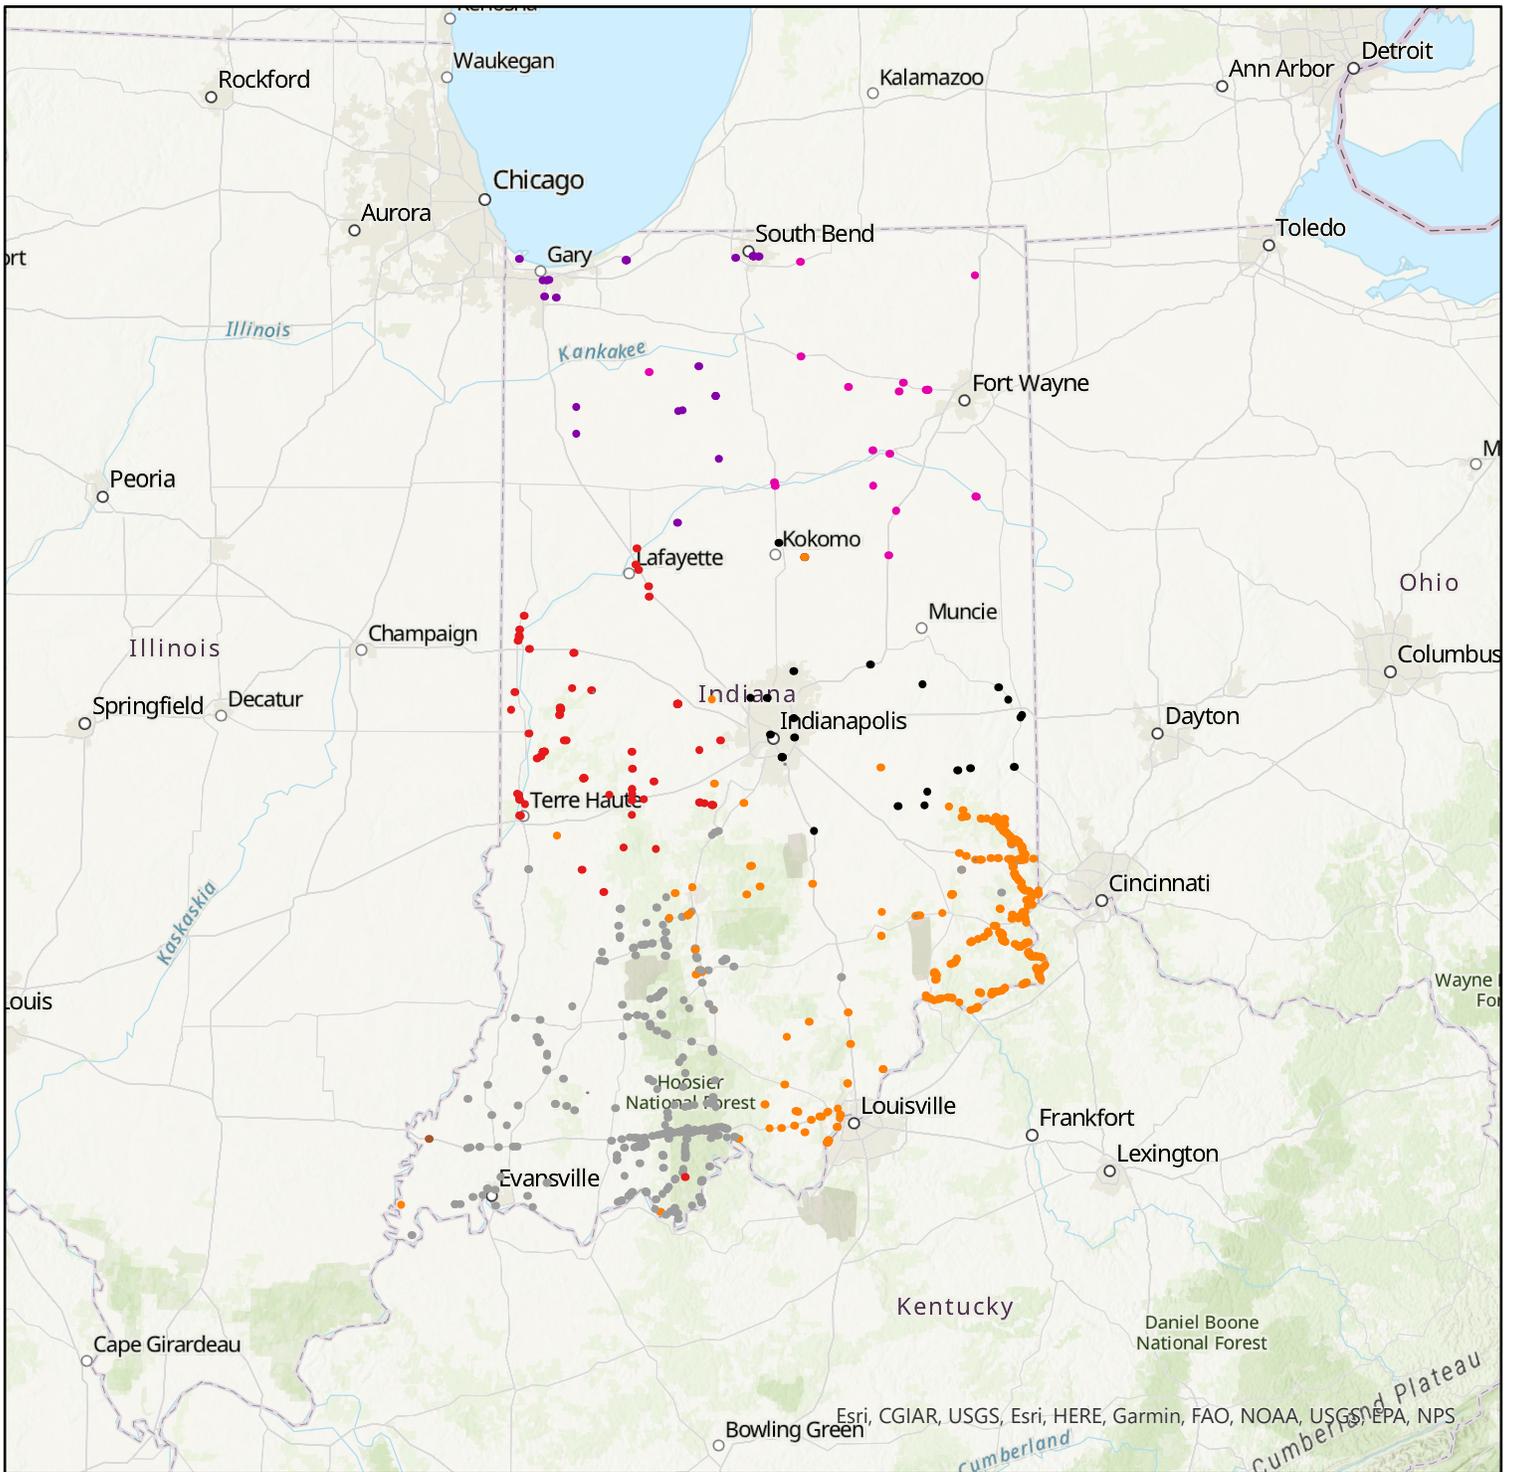
INDOT Slides

August 23, 2021
Data Collected by INDOT Geotech
