SR 66 Small Structures Replacements (INDOT Des. No. 2100830 and 2100831) Luce and Ohio townships, Spencer County, Indiana Photographs taken on September 14, 2023

Culvert Inspection Report

Structure Information								
Structure:	CV 066-074-51.62		Facility Carried:	SR 66				
Structure Number:	93007883		Features Intersected:	UNT				
Inspection Information								
Inspection Date:	10/16/2024		Lead Inspector:	James Hefferman				
Inspection Type:	Culvert		Additional Inspectors:	Tony Hoover, James Hefferman				
Condition Ratings Summary								
Culvert:		4	Substructure:		7			
Deck:		N	Channel & Channel Protection:		7			
Superstructure:		4						
TO THE TOTAL PARTY OF THE PARTY

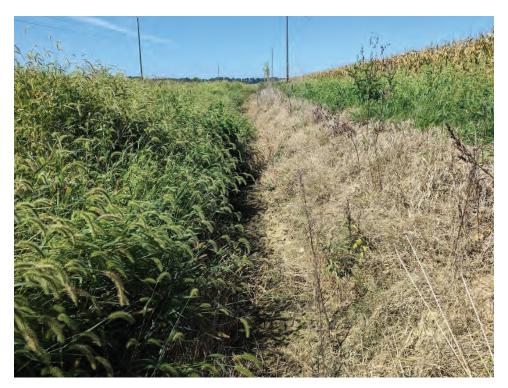
Photograph 41. View of UNT to Willow Pond Ditch, which drains to the west within the northern SR 66 roadway swale between the roadway and agricultural field, looking west.

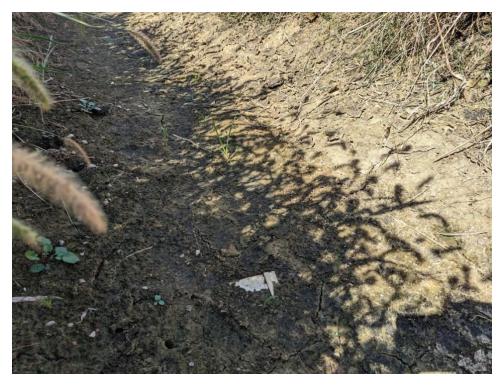
Photograph 42. View of the unvegetated stream bed and substrate of UNT to Willow Pond Ditch which included sand, silt, and gravel and contained no flow during the time of the field investigation.

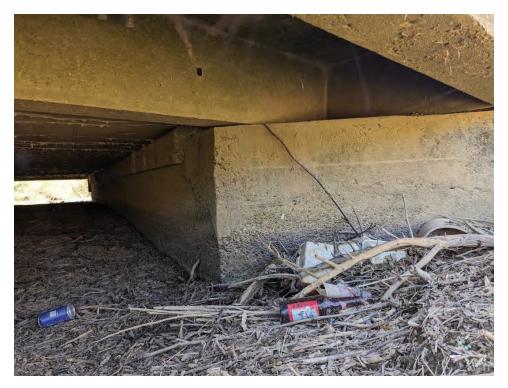
Photograph 44. View of the slab and abutments of CV 066-074-51.62, where no evidence of bird or bat use was observed, looking southeast.

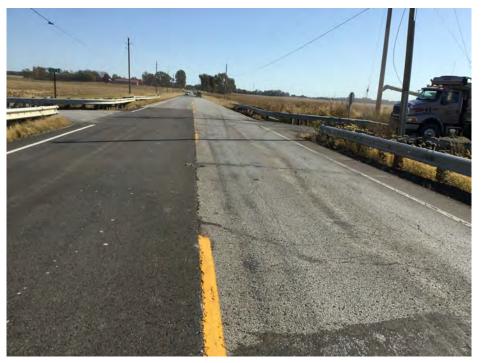
PHOTO 1

Alignment looking east

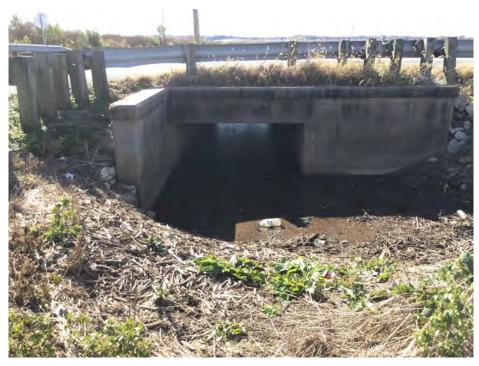
РНОТО 3

Description North elevation

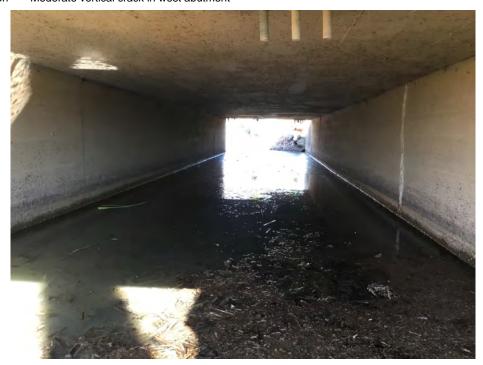
РНОТО 6

Description South interior overall condition

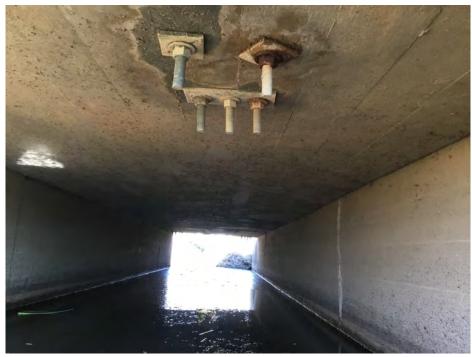
PHOTO 7

Description Underside overall condition

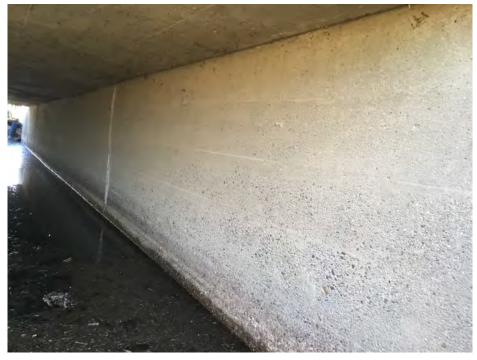
РНОТО 9

Description East wall overall condition

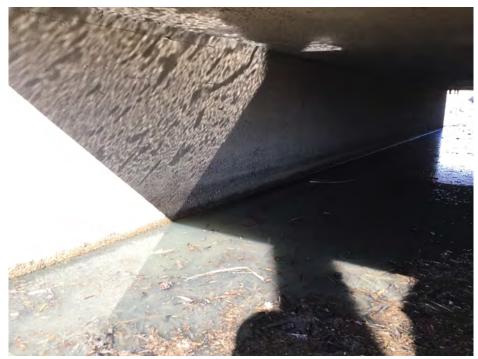
PHOTO 10

Description West wall overall condition

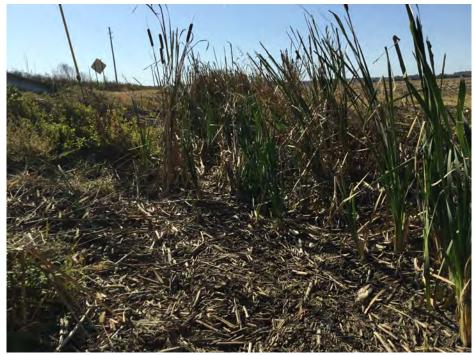
PHOTO 11

Description South upstream channel conditions

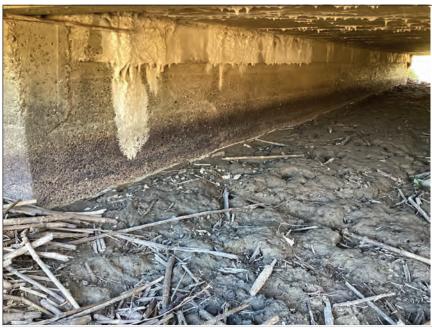
PHOTO #: Abutment 2 overall condition.

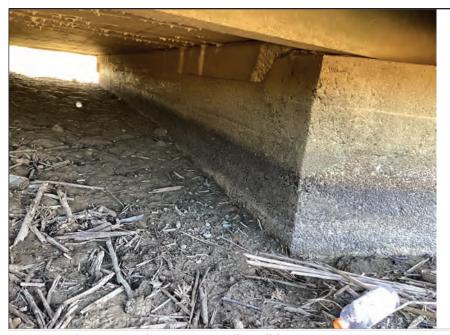
PHOTO #Abutment 1: Abutment 1 overall condition.

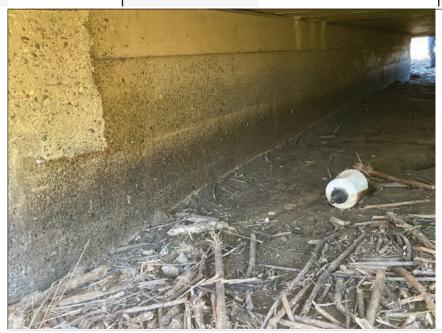
PHOTO #Abutment 1: Abutment 1 overall condition.

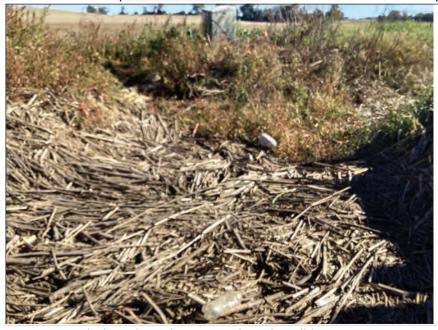
PHOTO #North channel: North upstream channel condition.

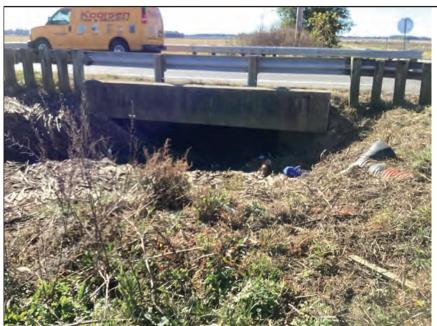
PHOTO #North elevation.: North elevation.

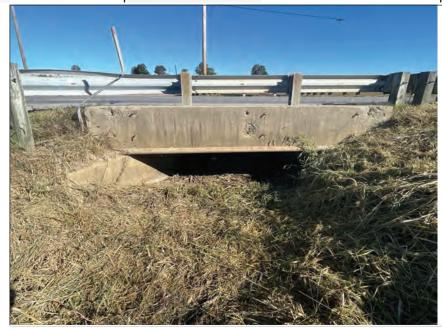
PHOTO #South elevation: South elevation.

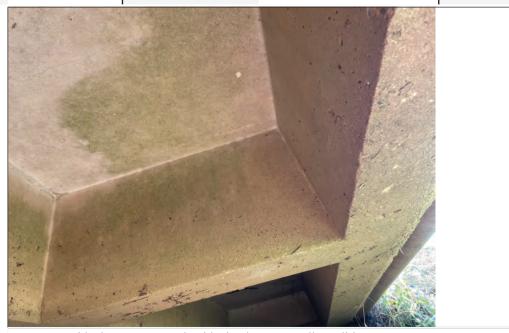
PHOTO #Widening Beam: South widening beam overall condition.
