BRIDGE HYDRAULIC REPORT

Bridge Number: I70-59-05180 CEBL & JCWB

Crossing: Branch of McCracken Creek

Prepared by:
Robyn M. Toole, P.E.
WSP | Parsons Brinckerhoff
September 22, 2016

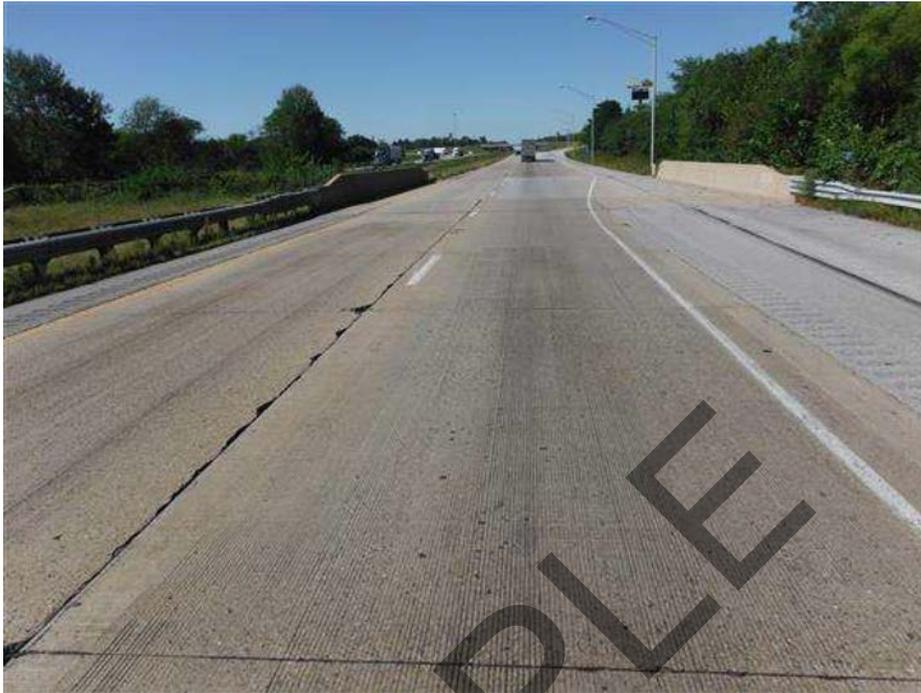
PHOTO 1

Description 9-14-2015 I70-60-05180JCWB (1) Road alignment looking West

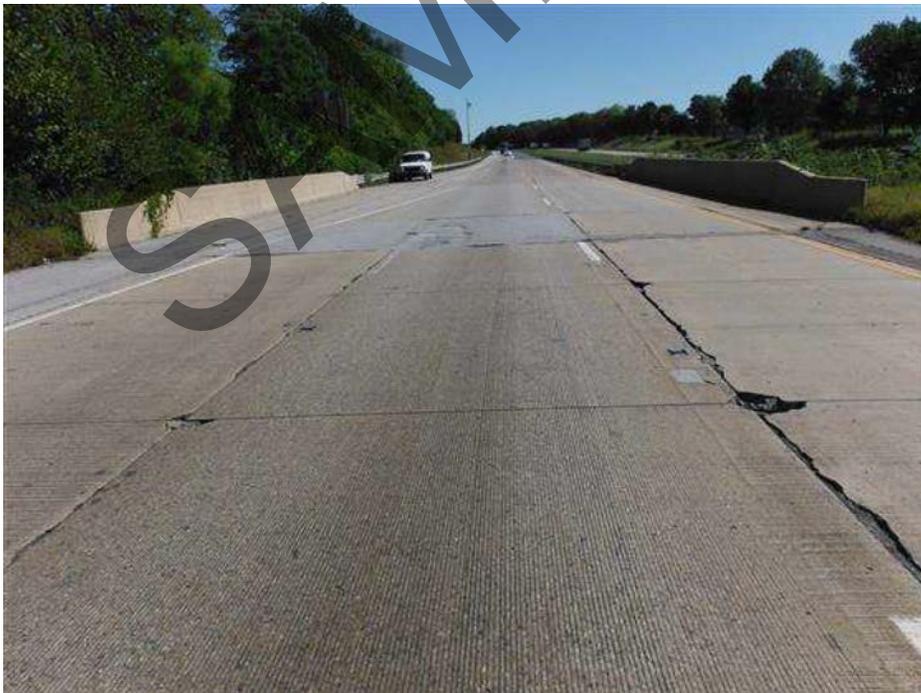
PHOTO 2

Description 9-14-2015 I70-60-05180JCWB (17) Road alignment looking East

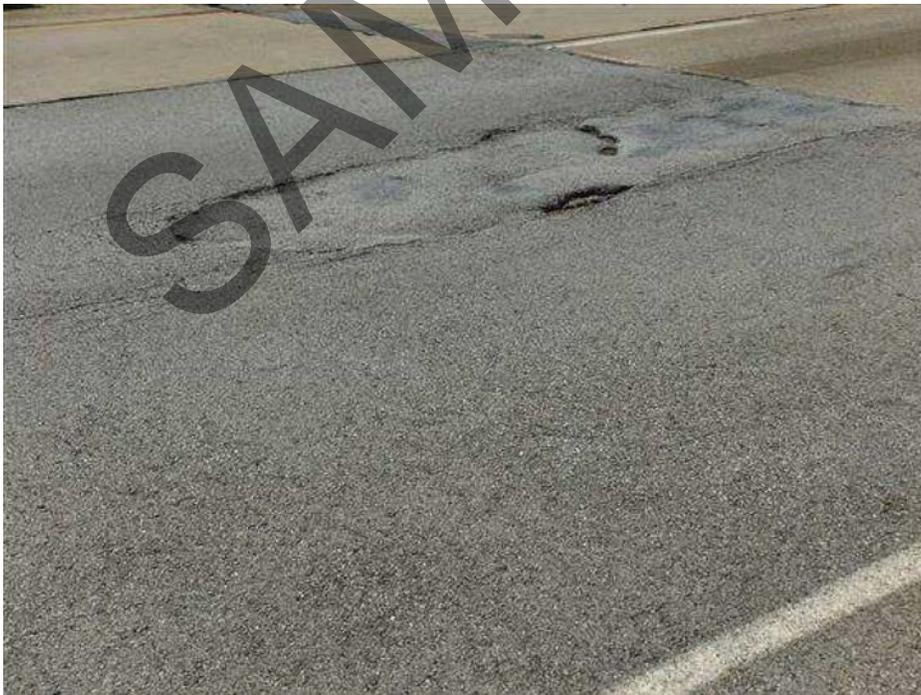
PHOTO 6

Description 9-14-2015 I70-60-05180JCWB (15) West asphalt approach slab has an asphalt patch on the right lane

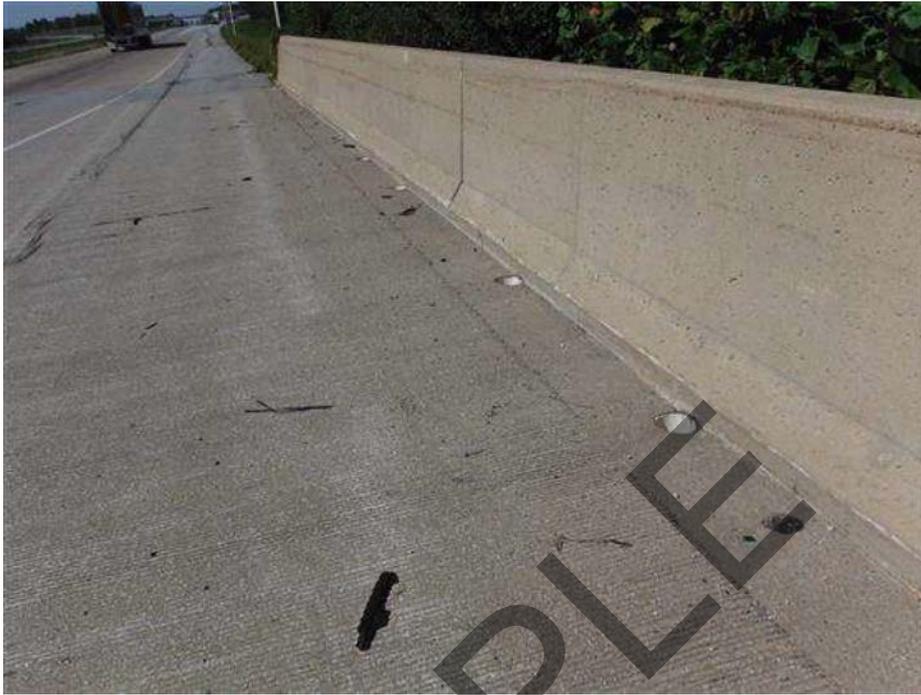
PHOTO 17

Description 9-14-2015 I70-60-05180JCWB (10) North parapet wall is in good condition

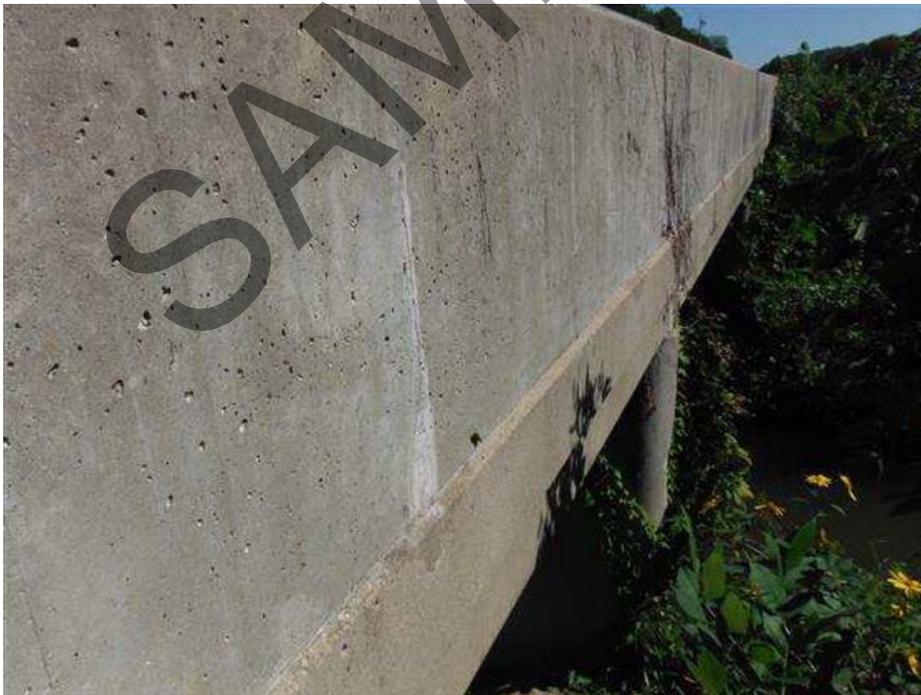
PHOTO 18

Description 9-14-2015 I70-60-05180JCWB (19) South coping condition

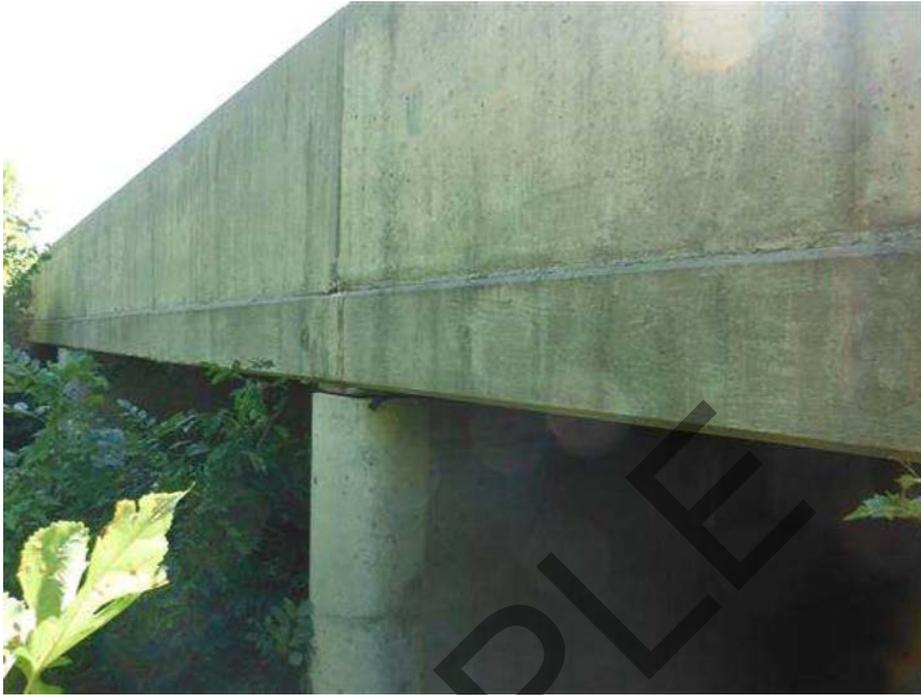
PHOTO 19

Description 9-14-2015 I70-60-05180JCWB (27) North coping condition

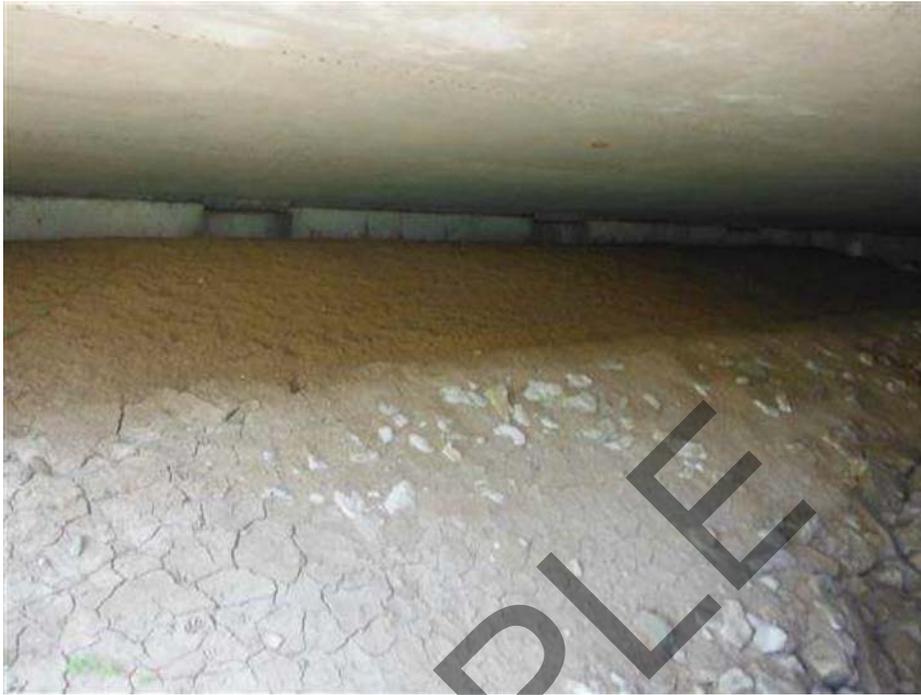
PHOTO 21

Description 9-14-2015 I70-60-05180JCWB (20) West abutment condition

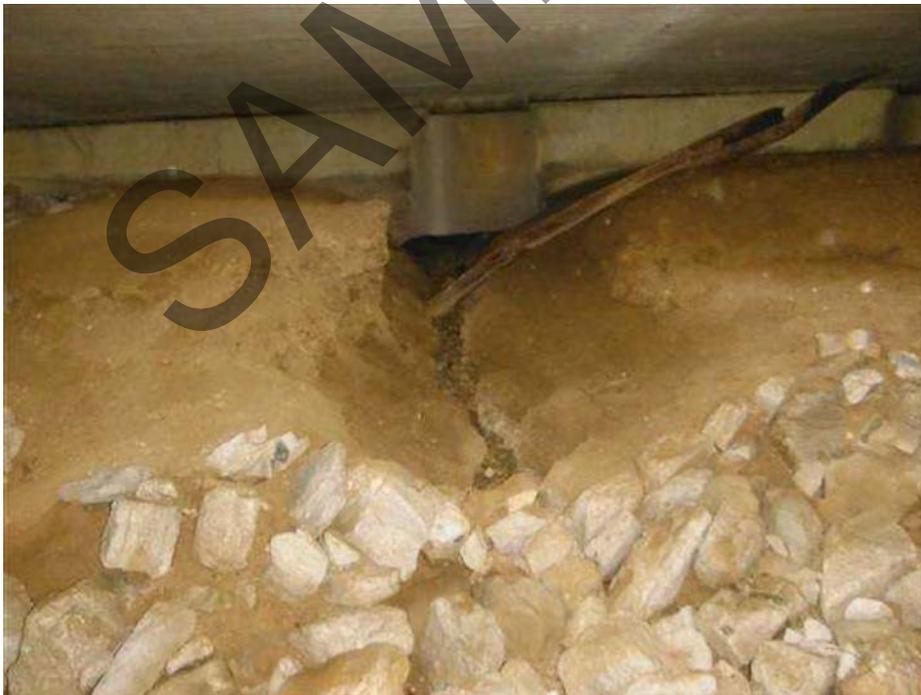
PHOTO 22

Description 9-14-2015 I70-60-05180JCWB (32) East abutment condition

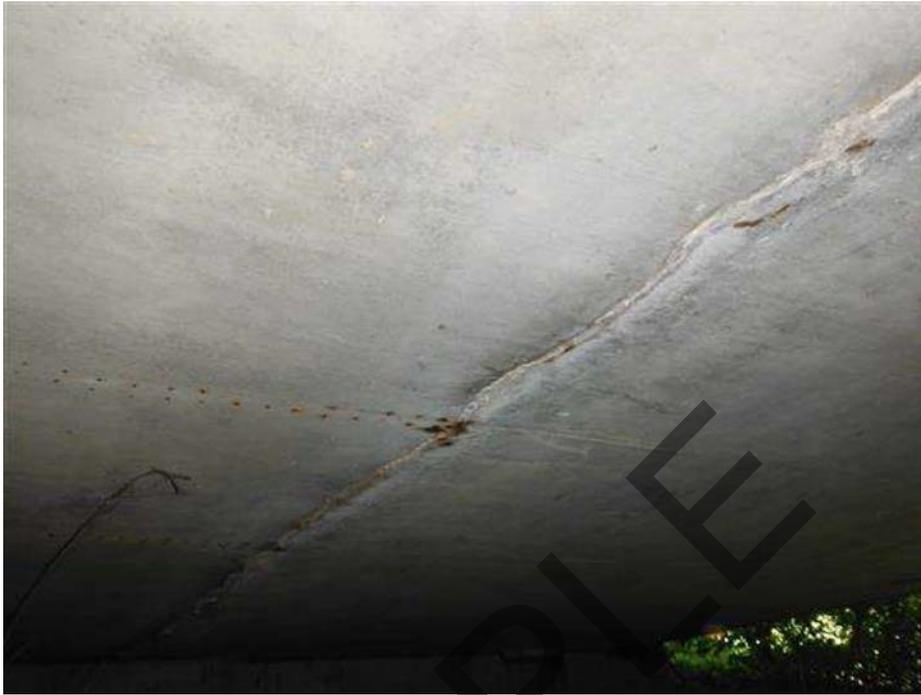
PHOTO 25

Description 9-14-2015 I70-60-05180JCWB (22) The West span has efflorescence on the North cold joint

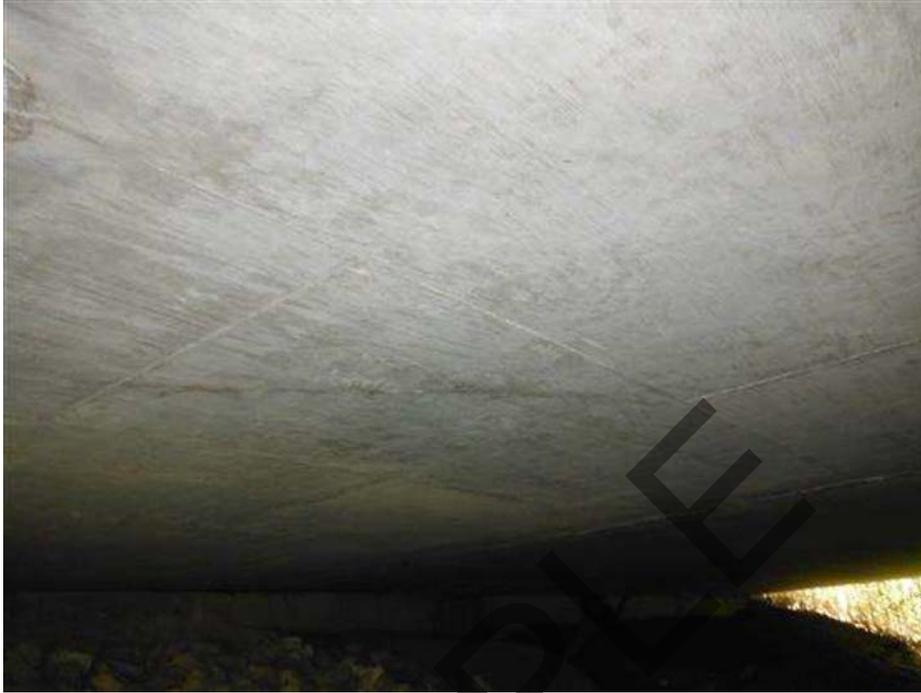
PHOTO 27
Description 9-14-2015 I70-60-05180JCWB (30) East span condition

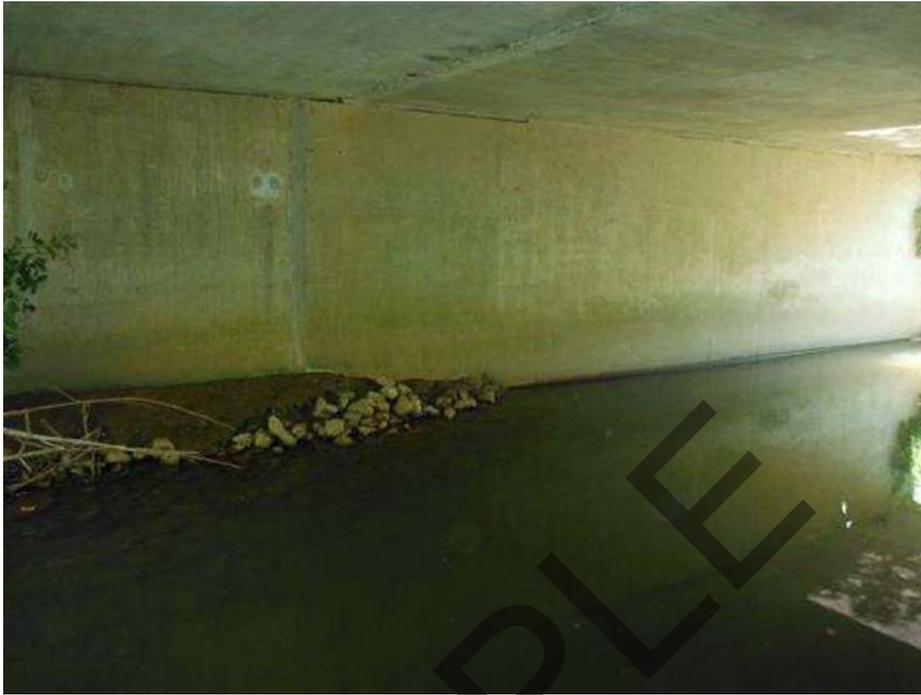
PHOTO 29
Description 9-14-2015 I70-60-05180JCWB (24) East interior pier condition West face

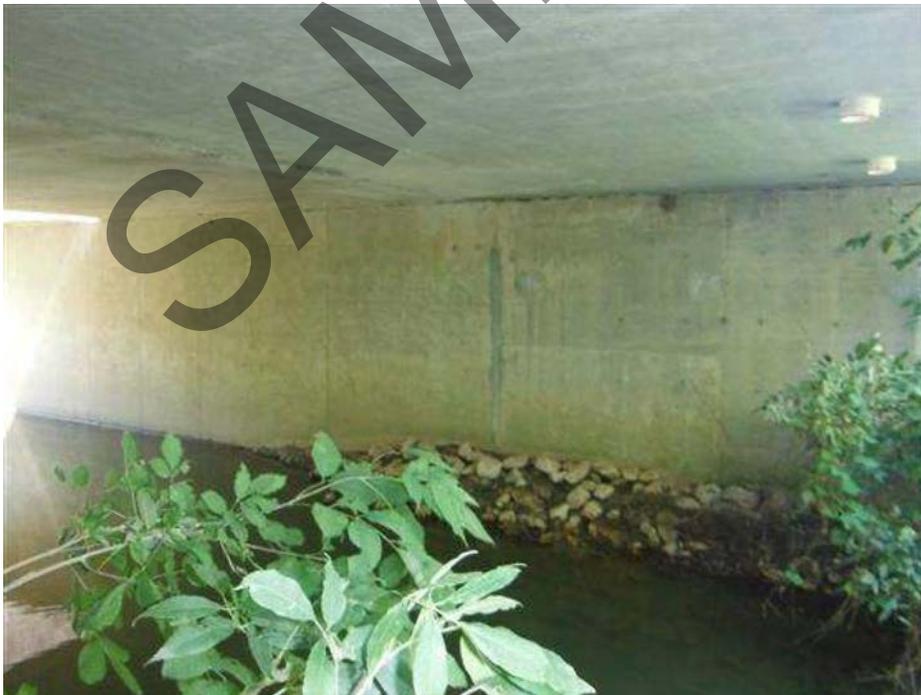
PHOTO 30
Description 9-14-2015 I70-60-05180JCWB (29) West interior pier condition East face

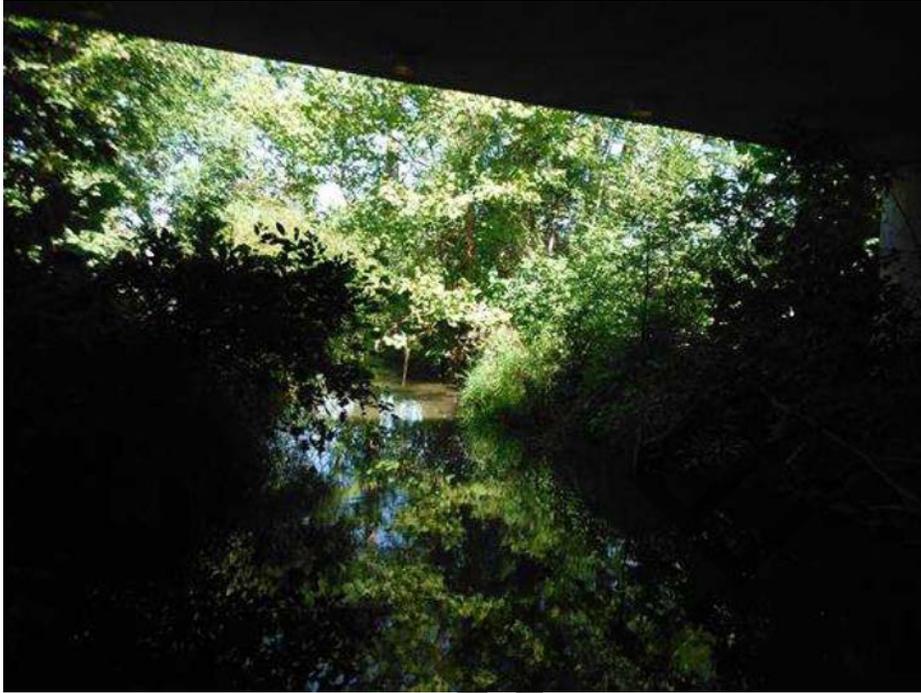
PHOTO 33

Description 9-14-2015 I70-60-05180JCWB (26) Up stream alignment or looking North from below the bridge

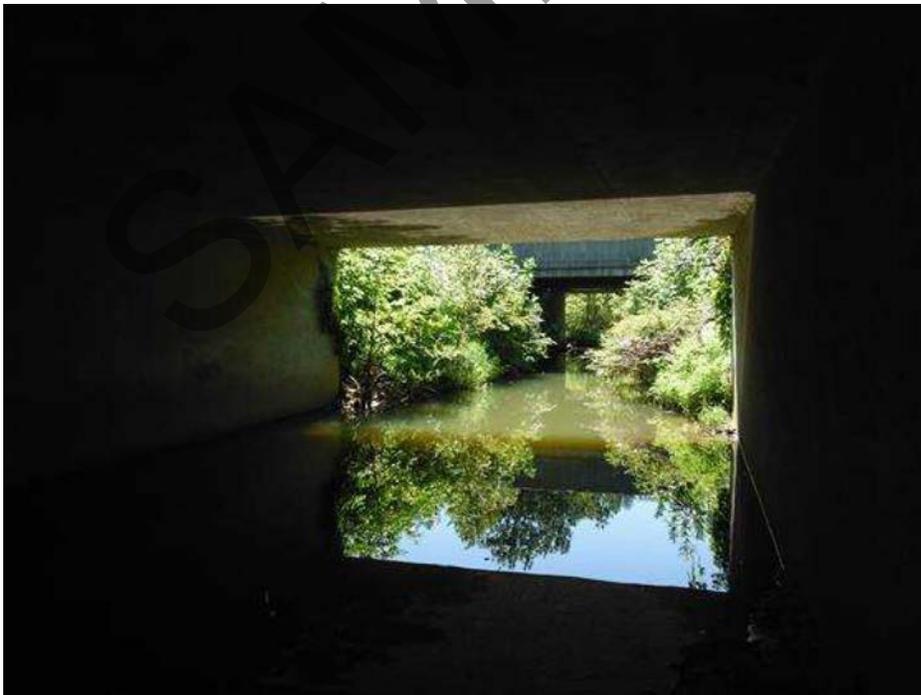
PHOTO 34

Description 9-14-2015 I70-60-05180JCWB (23) Down stream alignment or looking South from below the bridge

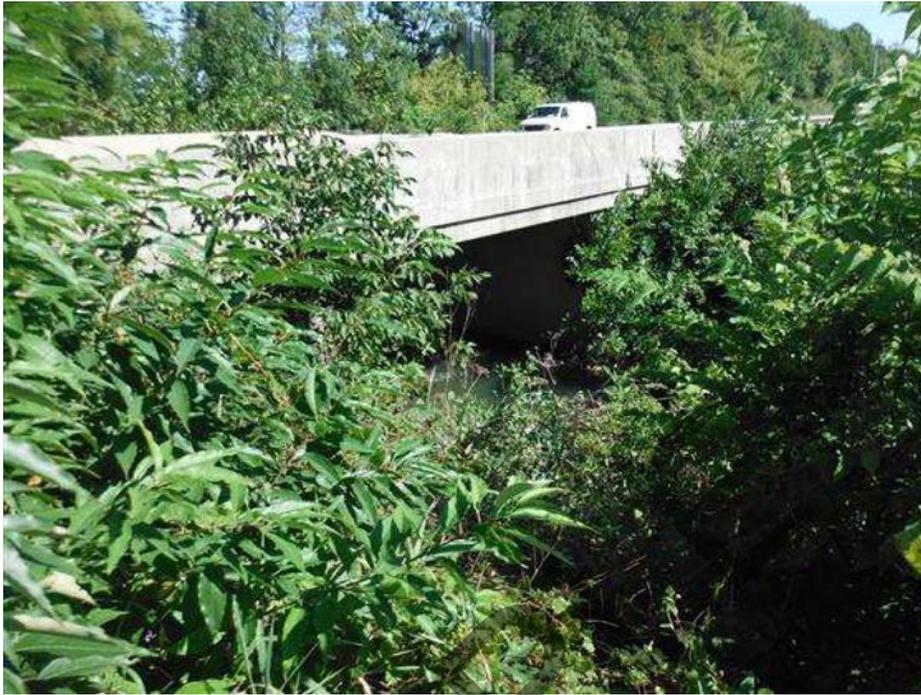
PHOTO 35
Description 9-14-2015 I70-60-05180JCWB (18) Profile looking NE

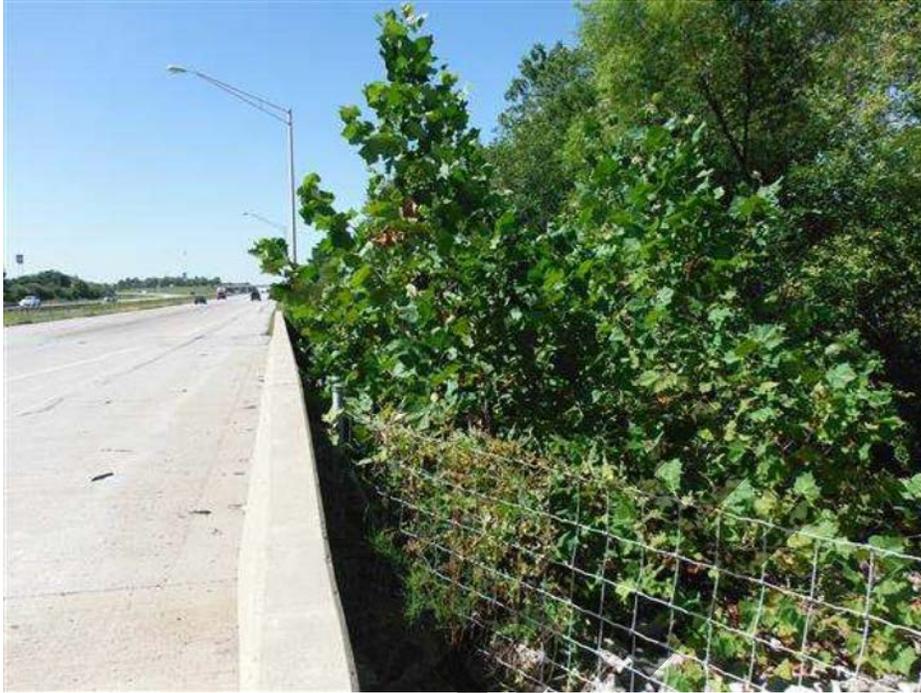
PHOTO 37

Description 9-14-2015 I70-60-05180JCWB (37) Trees growing over the North parapet wall

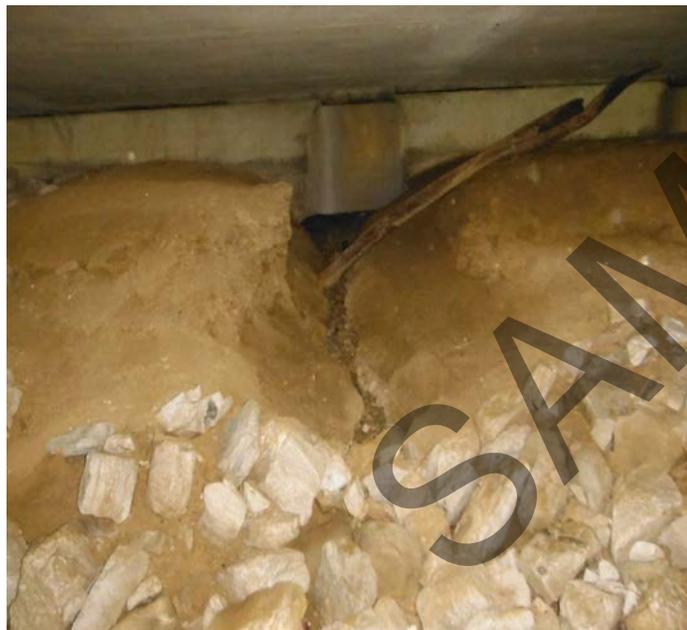
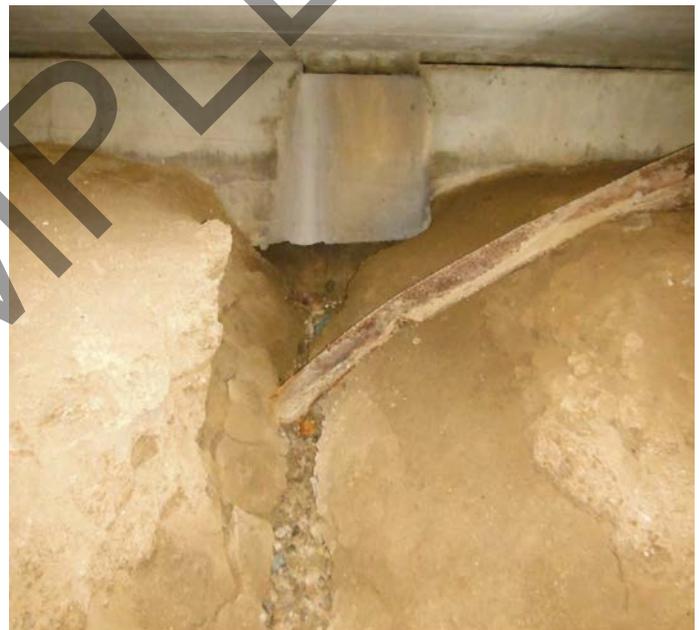
Deficiency Description:
Erosion is occurring mid span of the East abutment.
Work Description:

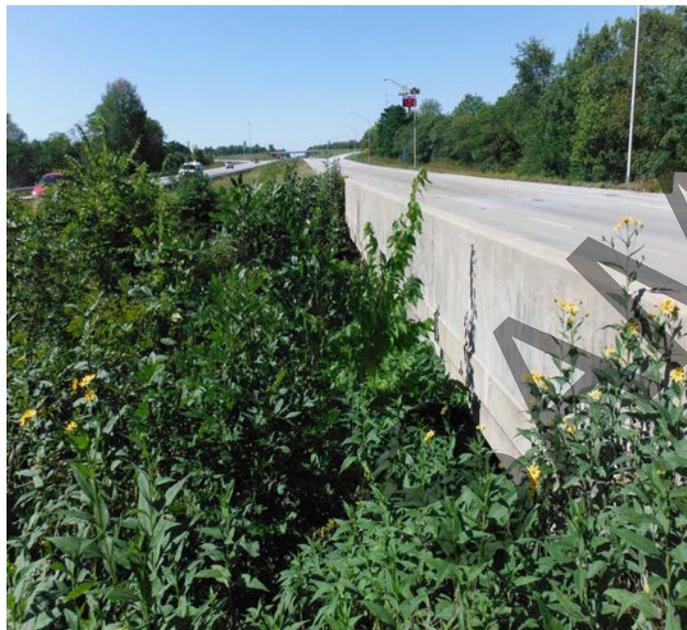
Deficiency Description:
Trees growing along both sides of the structure.
Work Description:

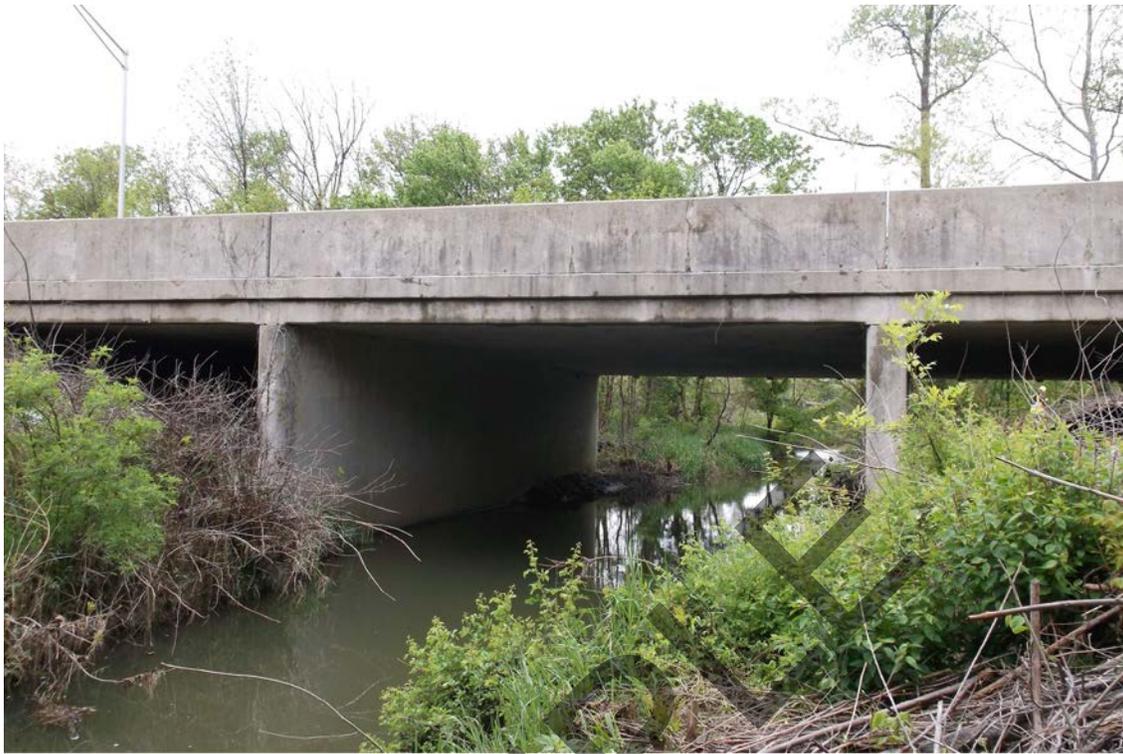
Photo 1: Upstream Face of Eastbound Bridge (facing south)

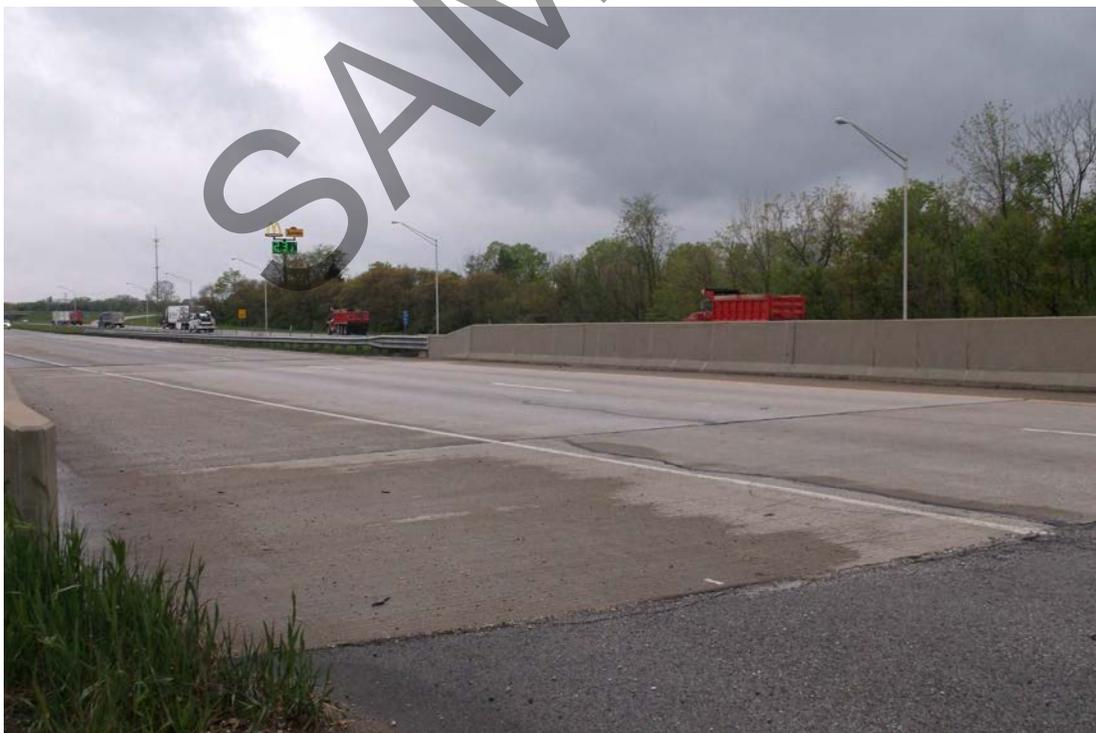
Photo 2: Roadway over Eastbound Bridge (facing northwest)

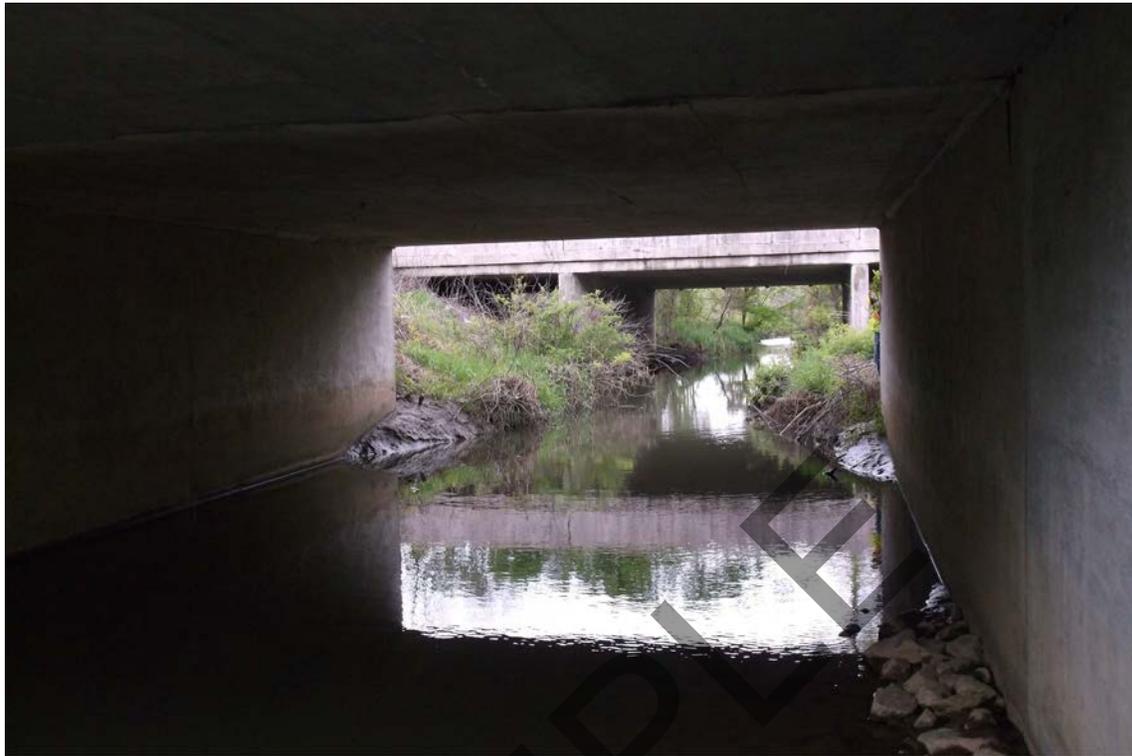
Photo 2: Looking Upstream from beneath the Eastbound Bridge (facing north)

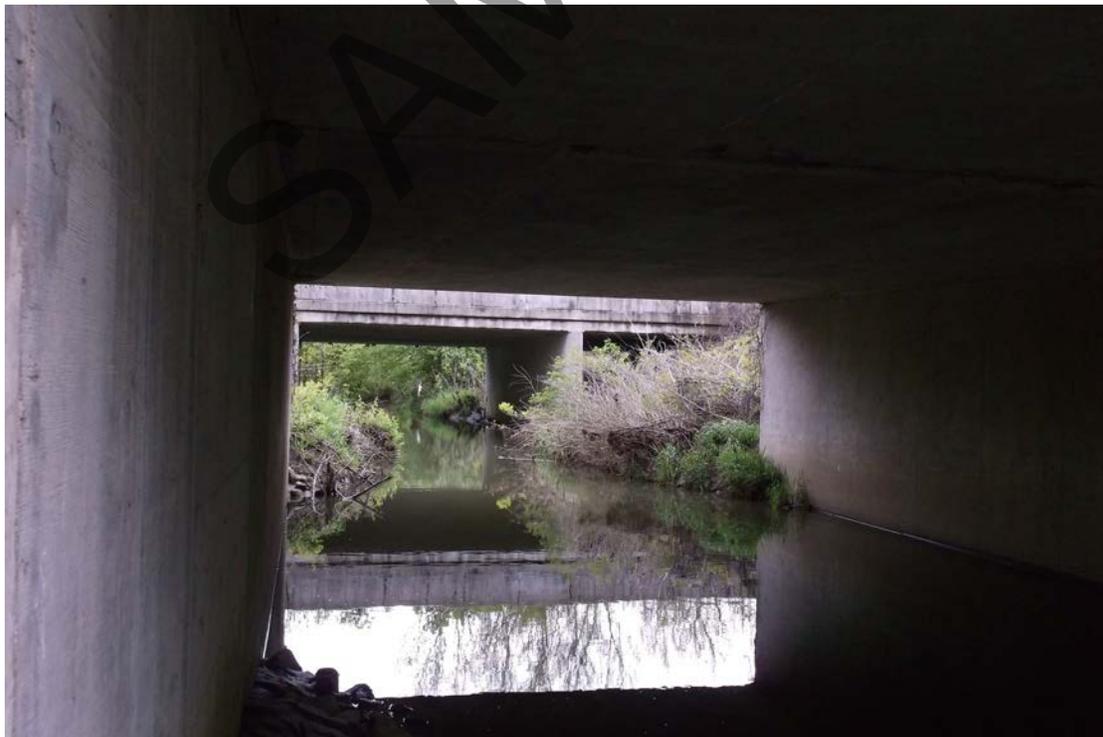
Photo 3: Looking Downstream from beneath the Westbound Bridge (facing south)

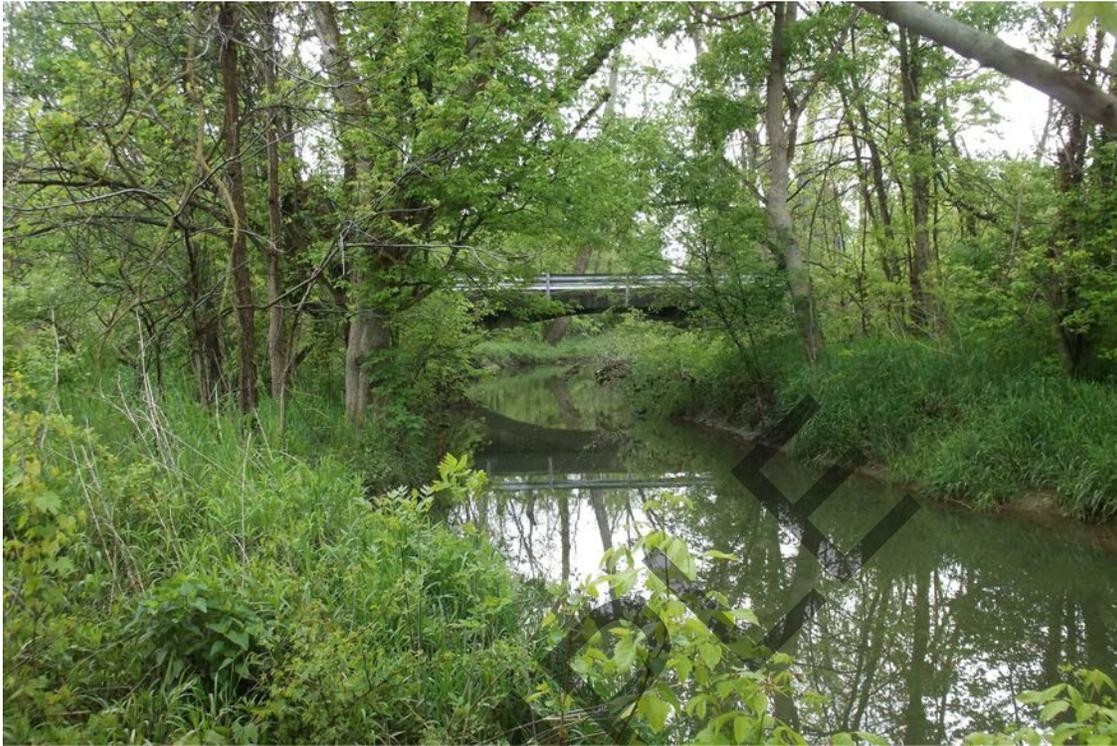
Photo 4: Downstream Channel (facing south)

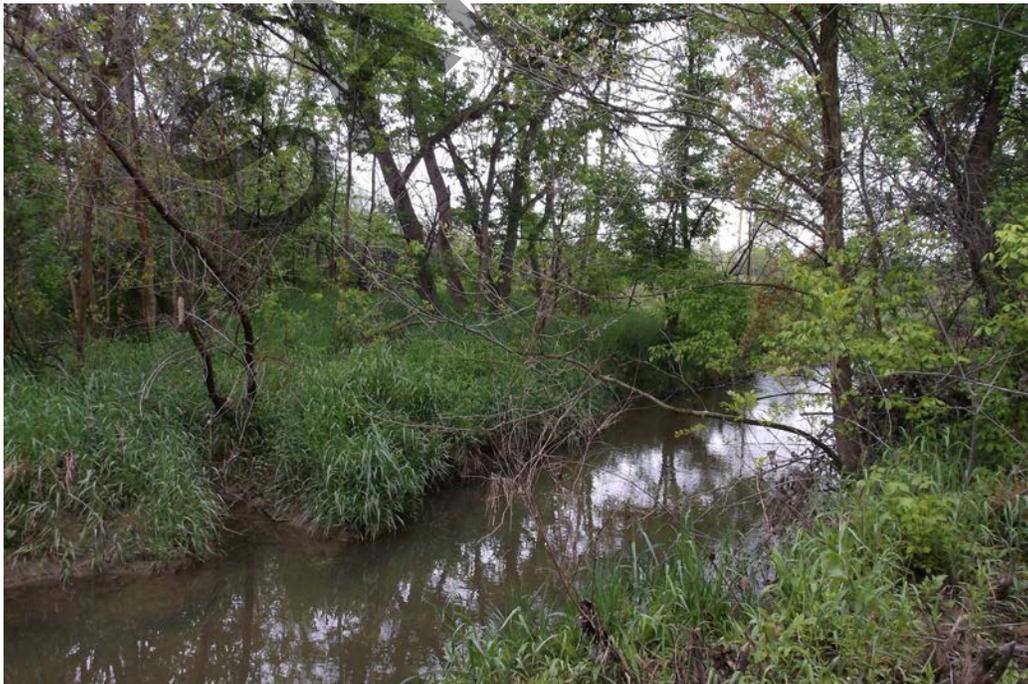
Photo 5: Upstream Channel (facing north)
